# METHODOLOGIES OF FORENSIC ARCHITECTURE INVESTIGATIONS

NELSON  
FORENSICS

# DESIGN AND CONSTRUCTION DEFECT

# WATERFRONT TOWNHOMES

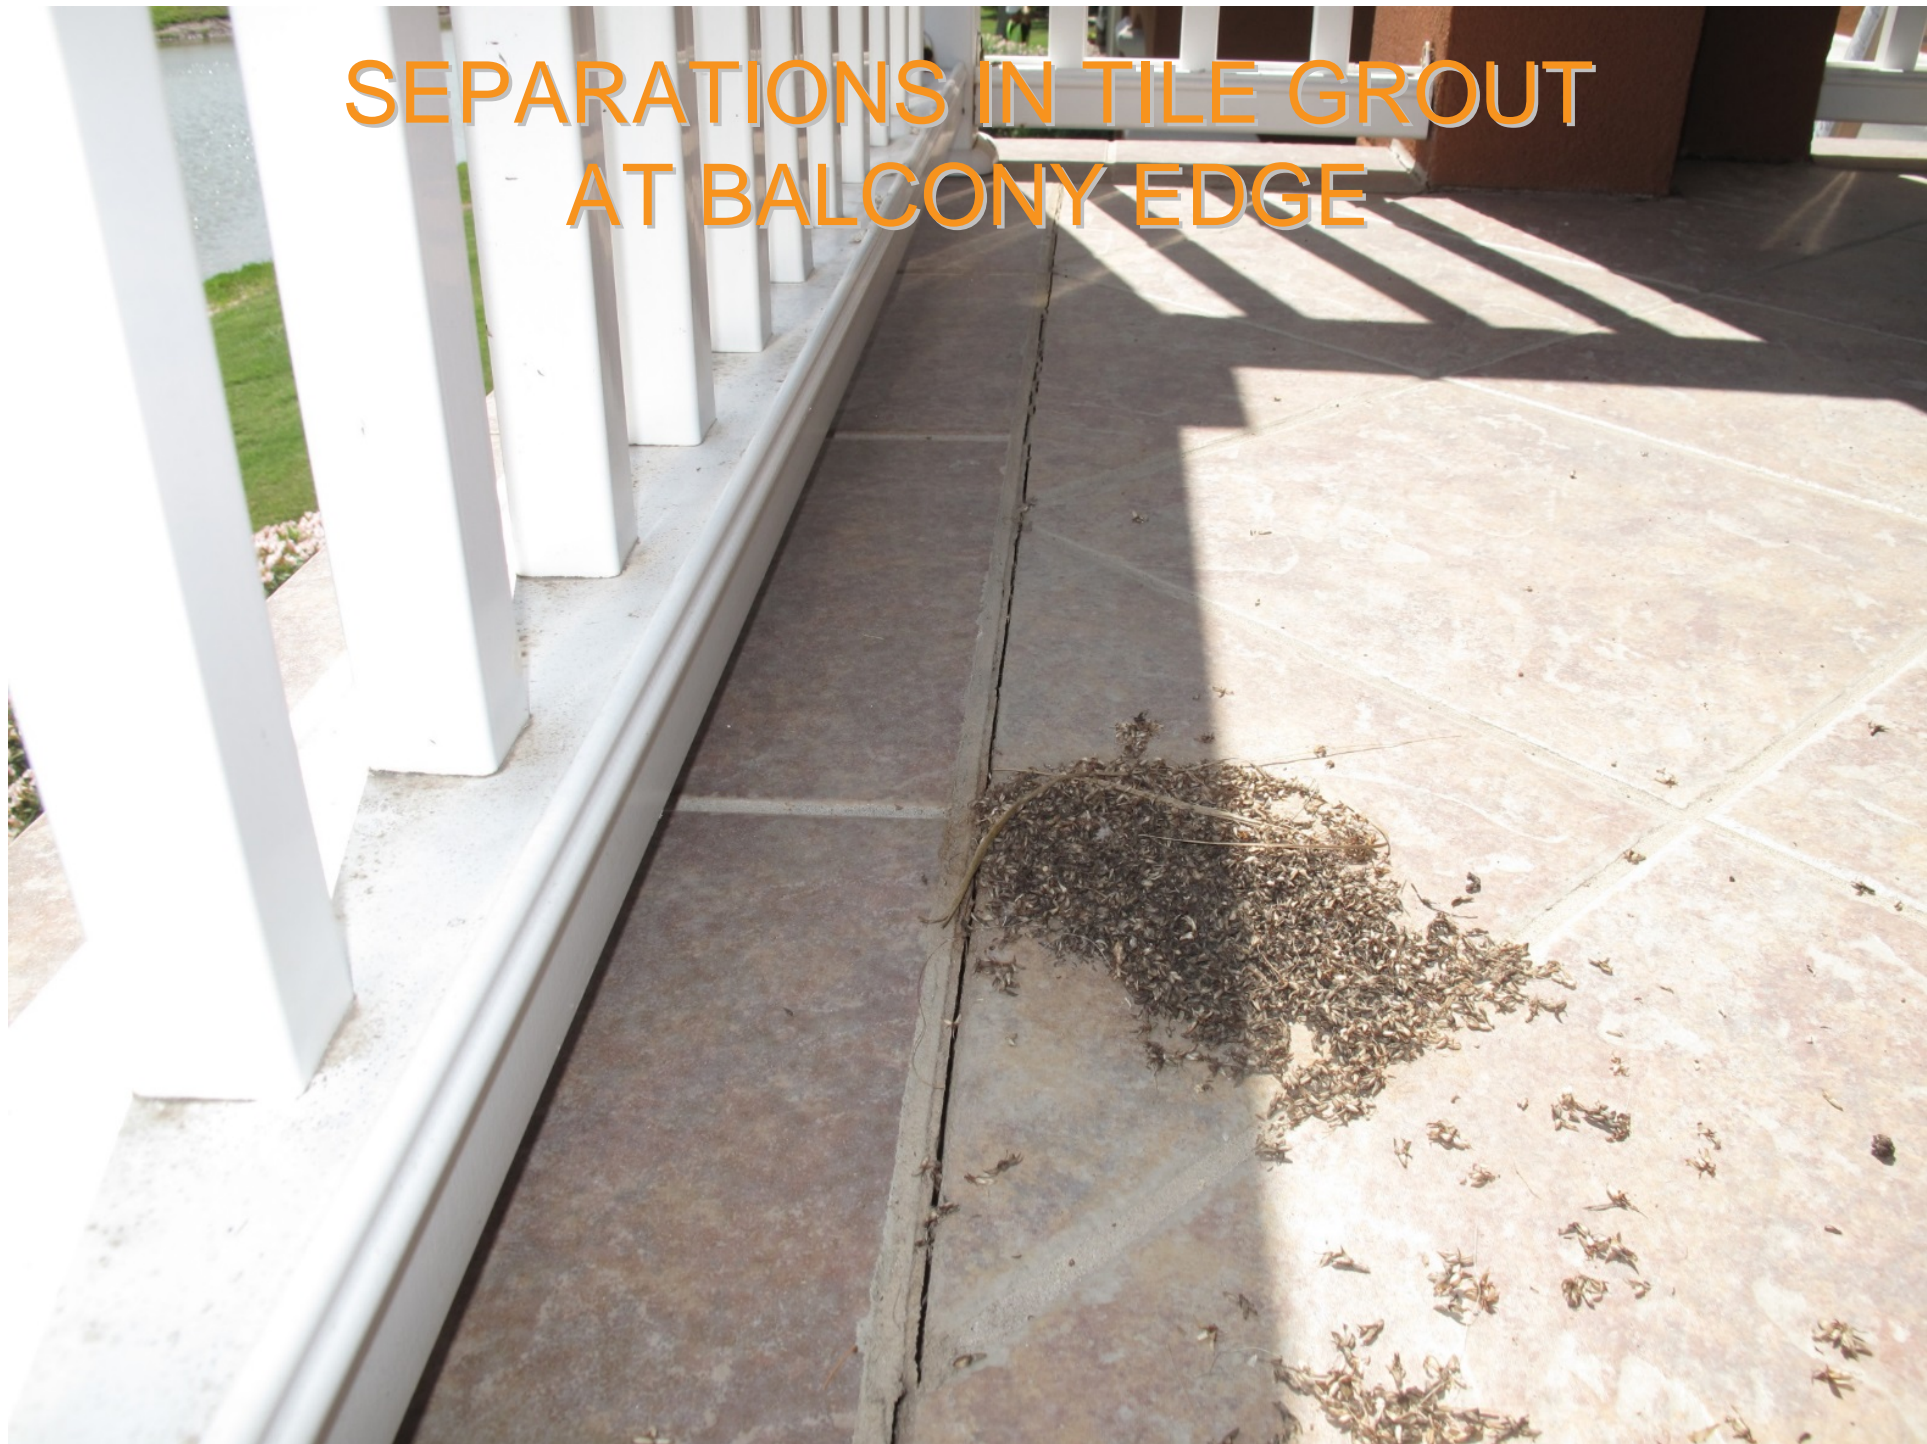
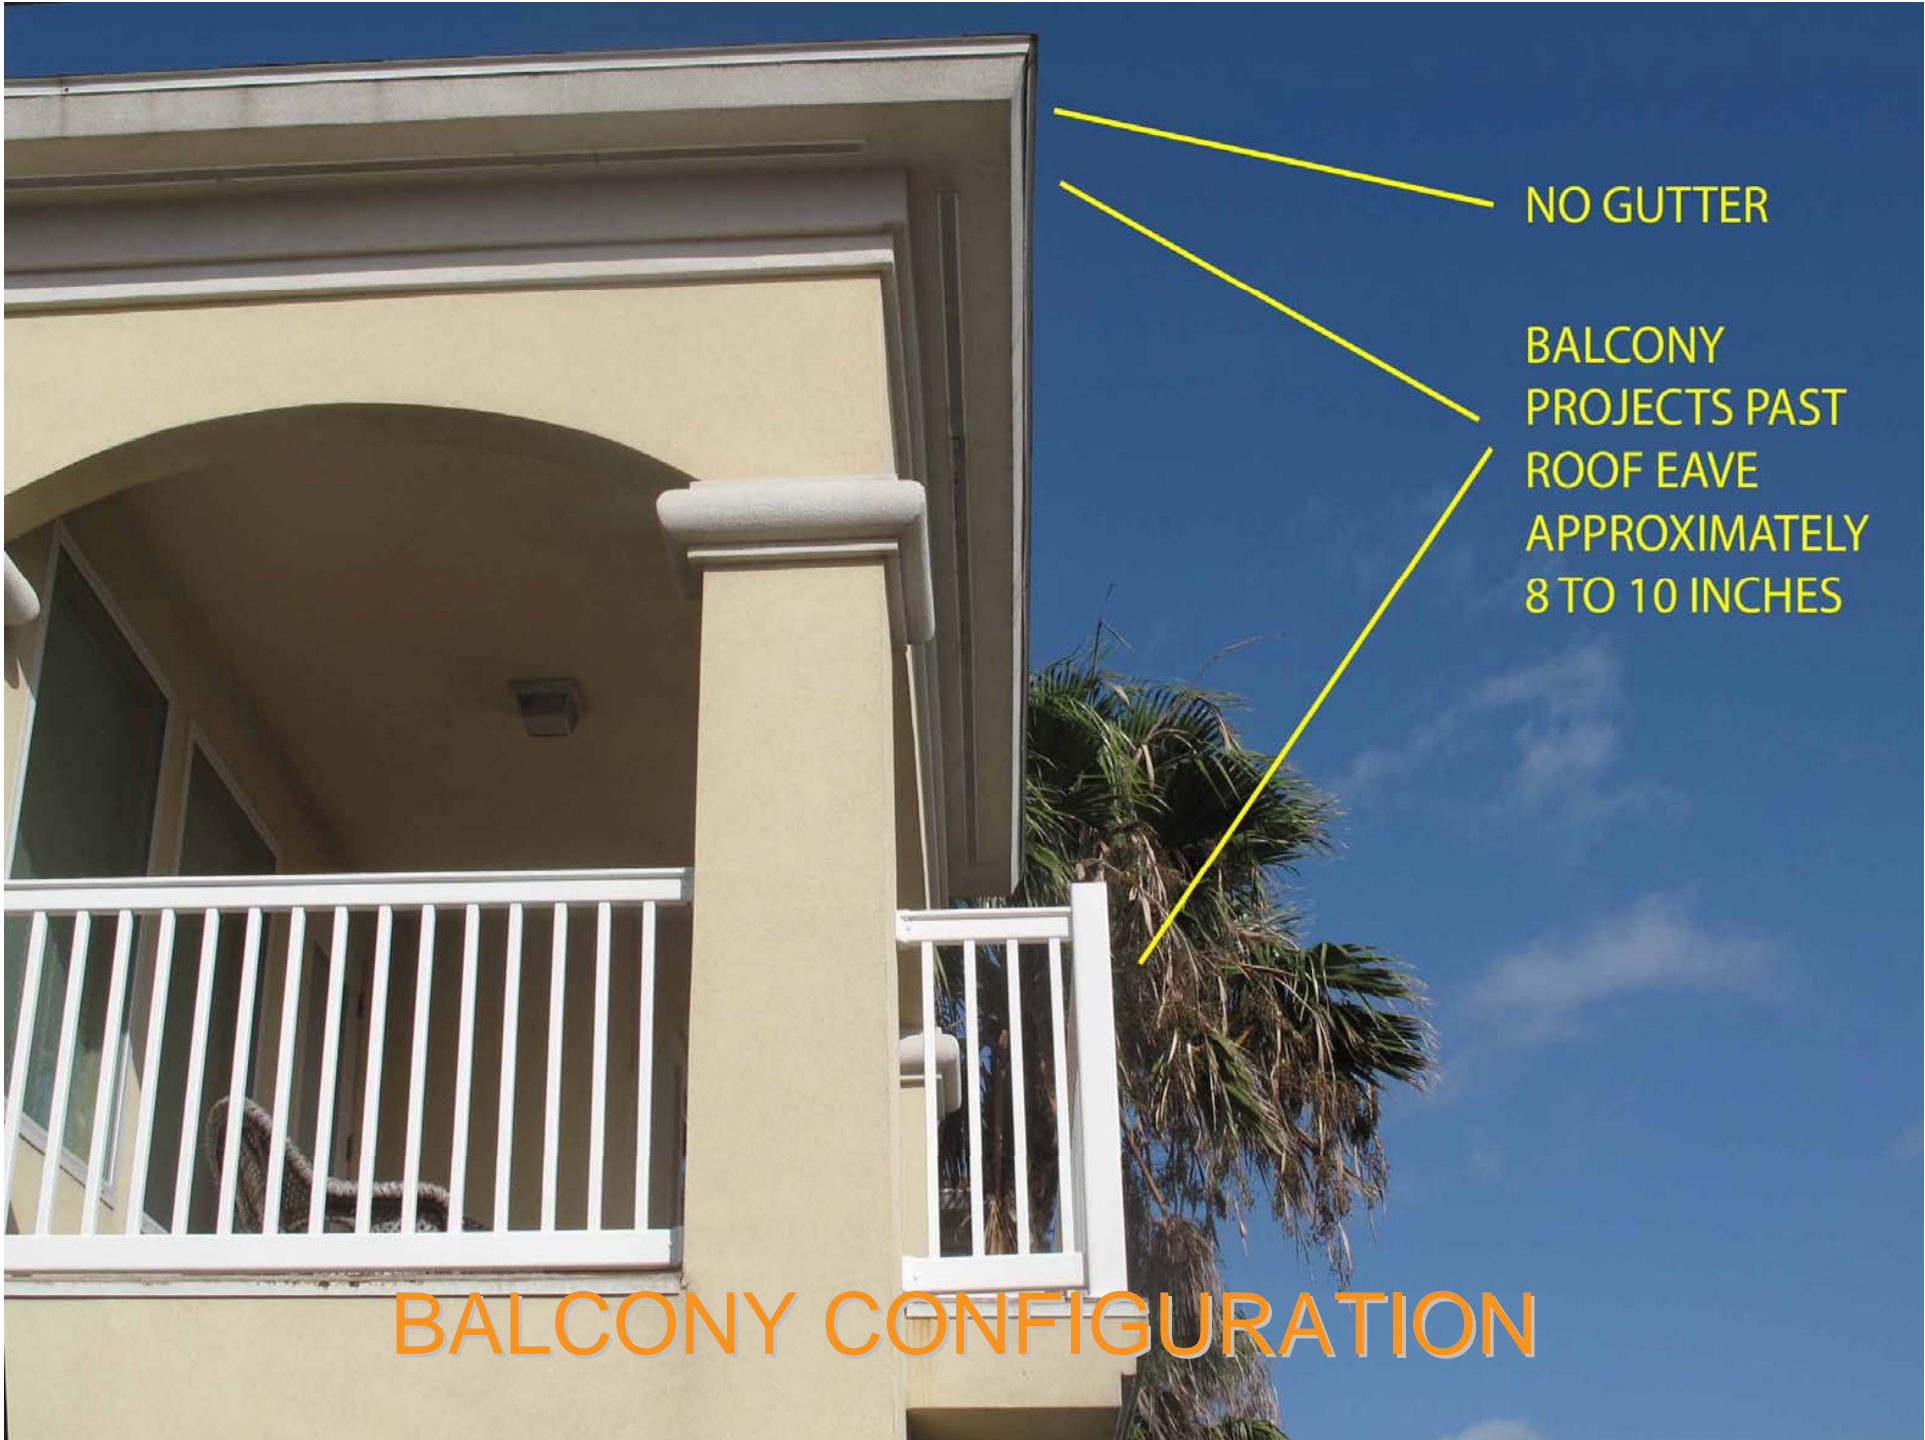
BALCONY CONFIGURATION

# SEPARATIONS IN TILE GROUT AT BALCONY EDGE

NO GUTTER

BALCONY  
PROJECTS PAST  
ROOF EAVE  
APPROXIMATELY  
8 TO 10 INCHES

- Unprotected roof overhang allowing water discharge directly onto the balcony below.
- Reverse lapped porous waterproofing joint placed directly under the path of water drainage from the roof above.

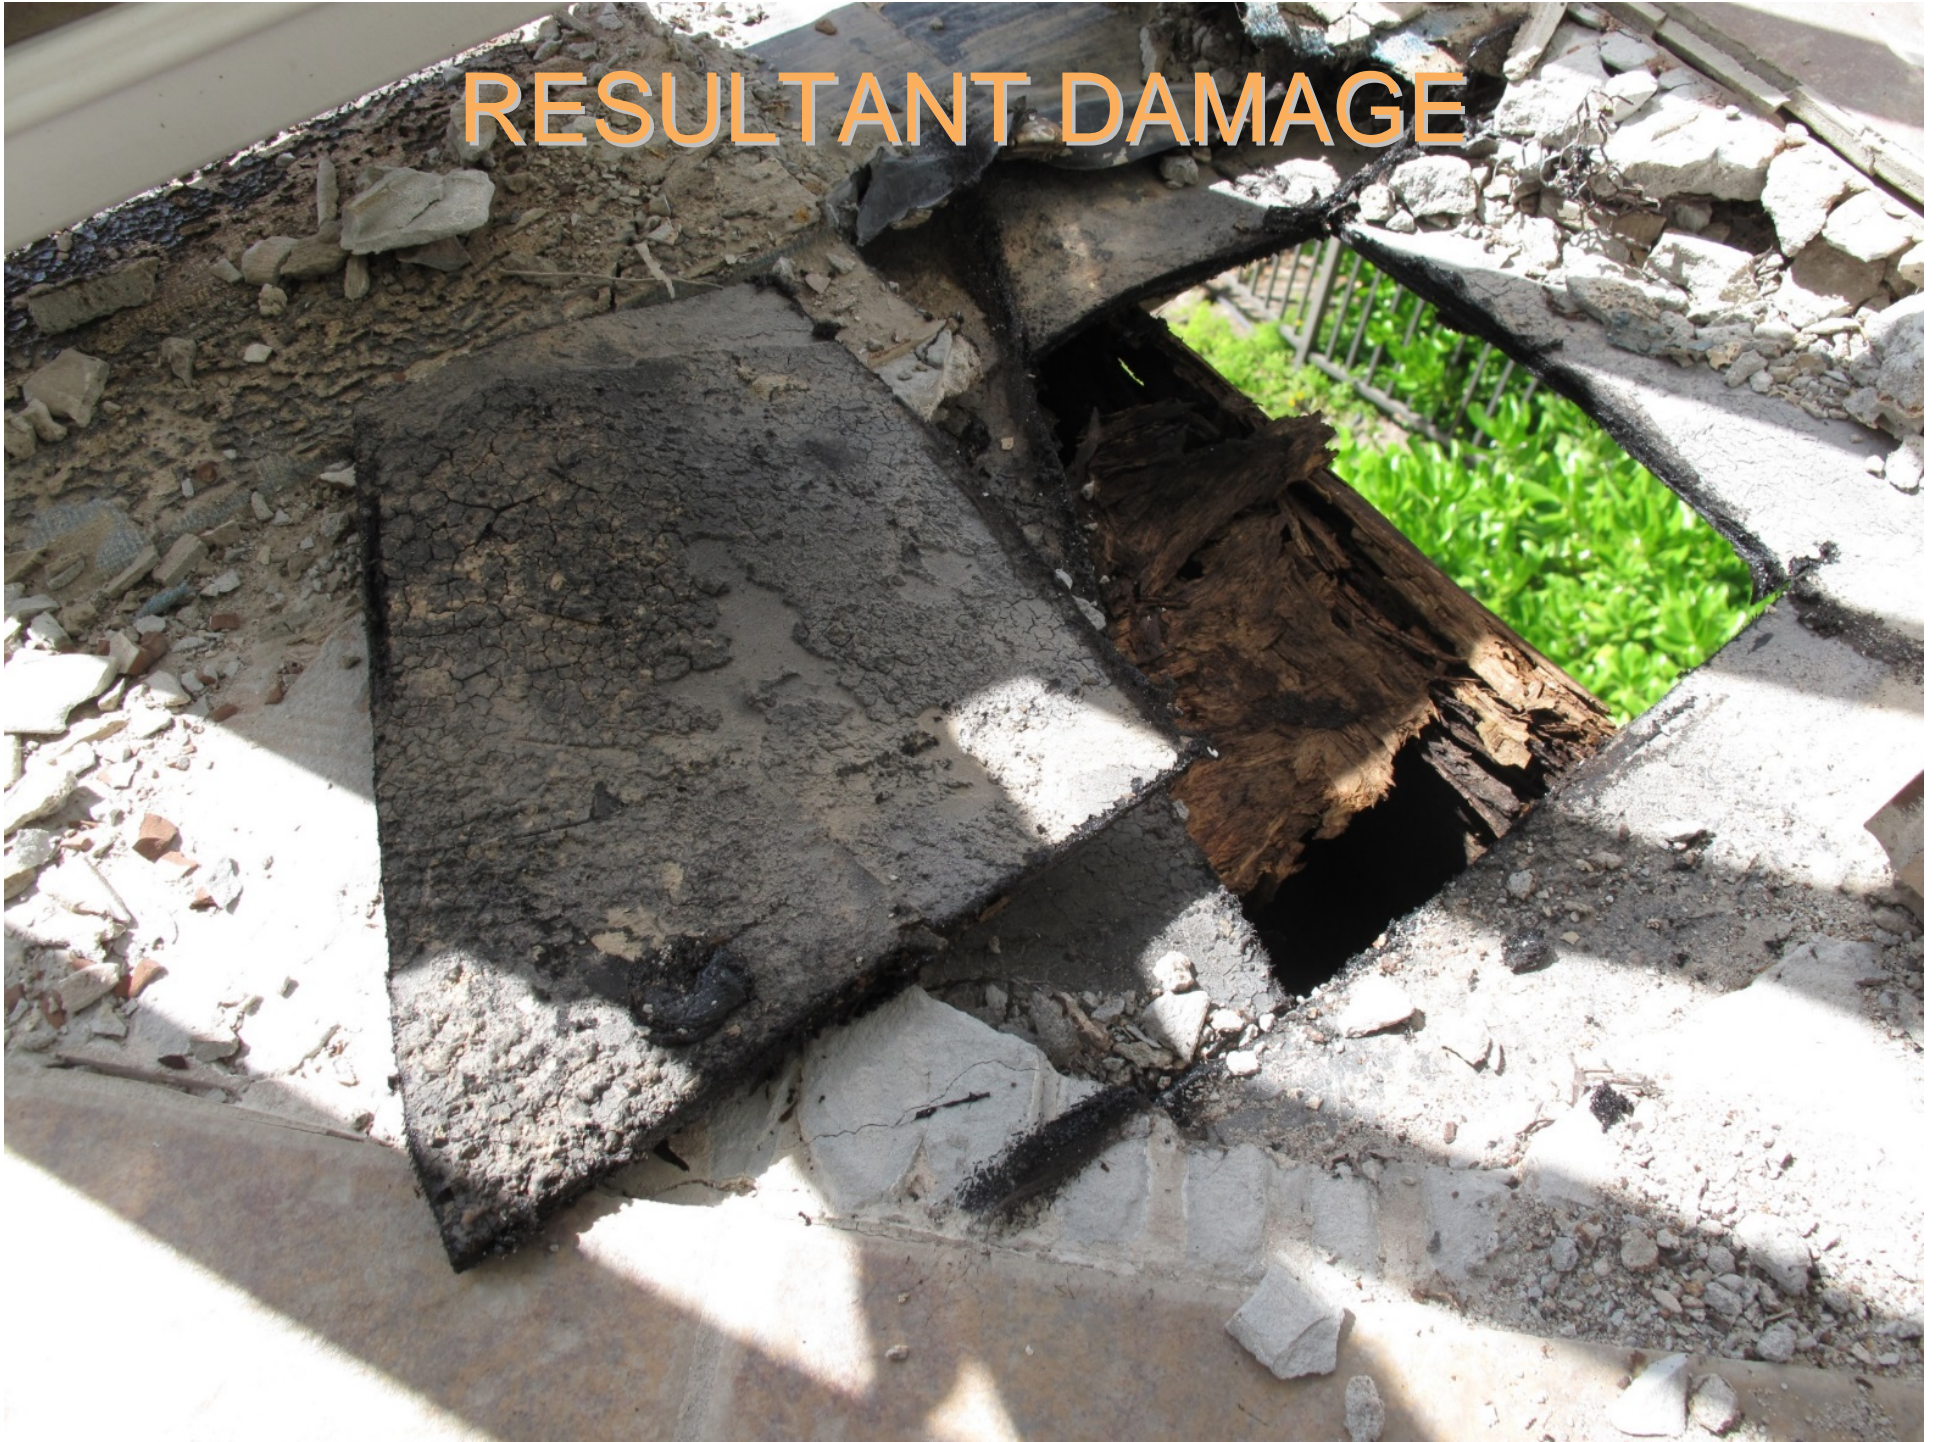
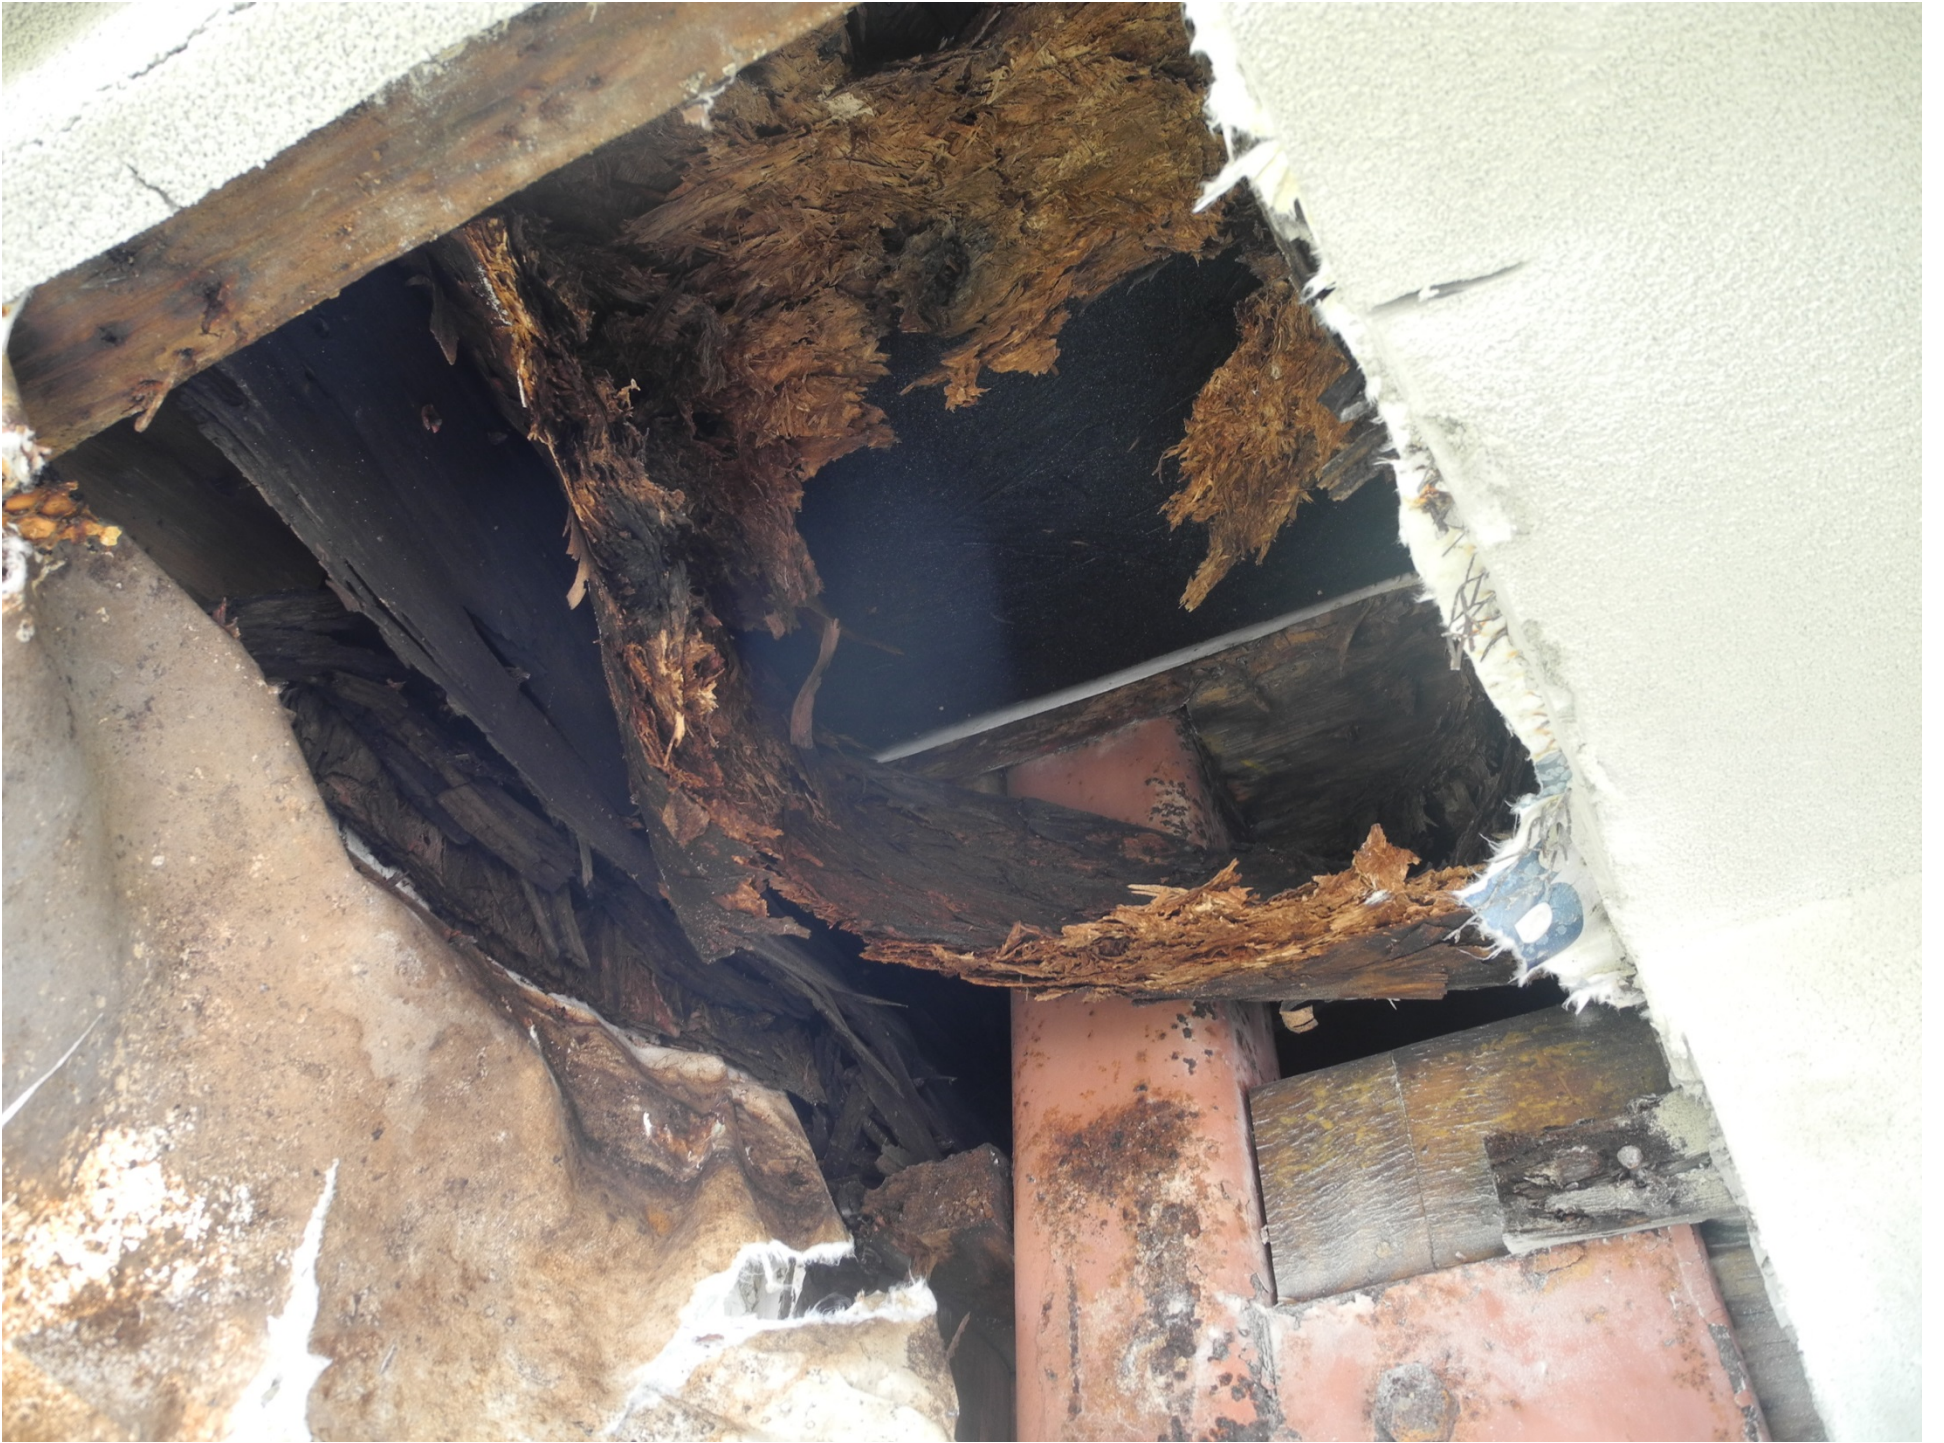
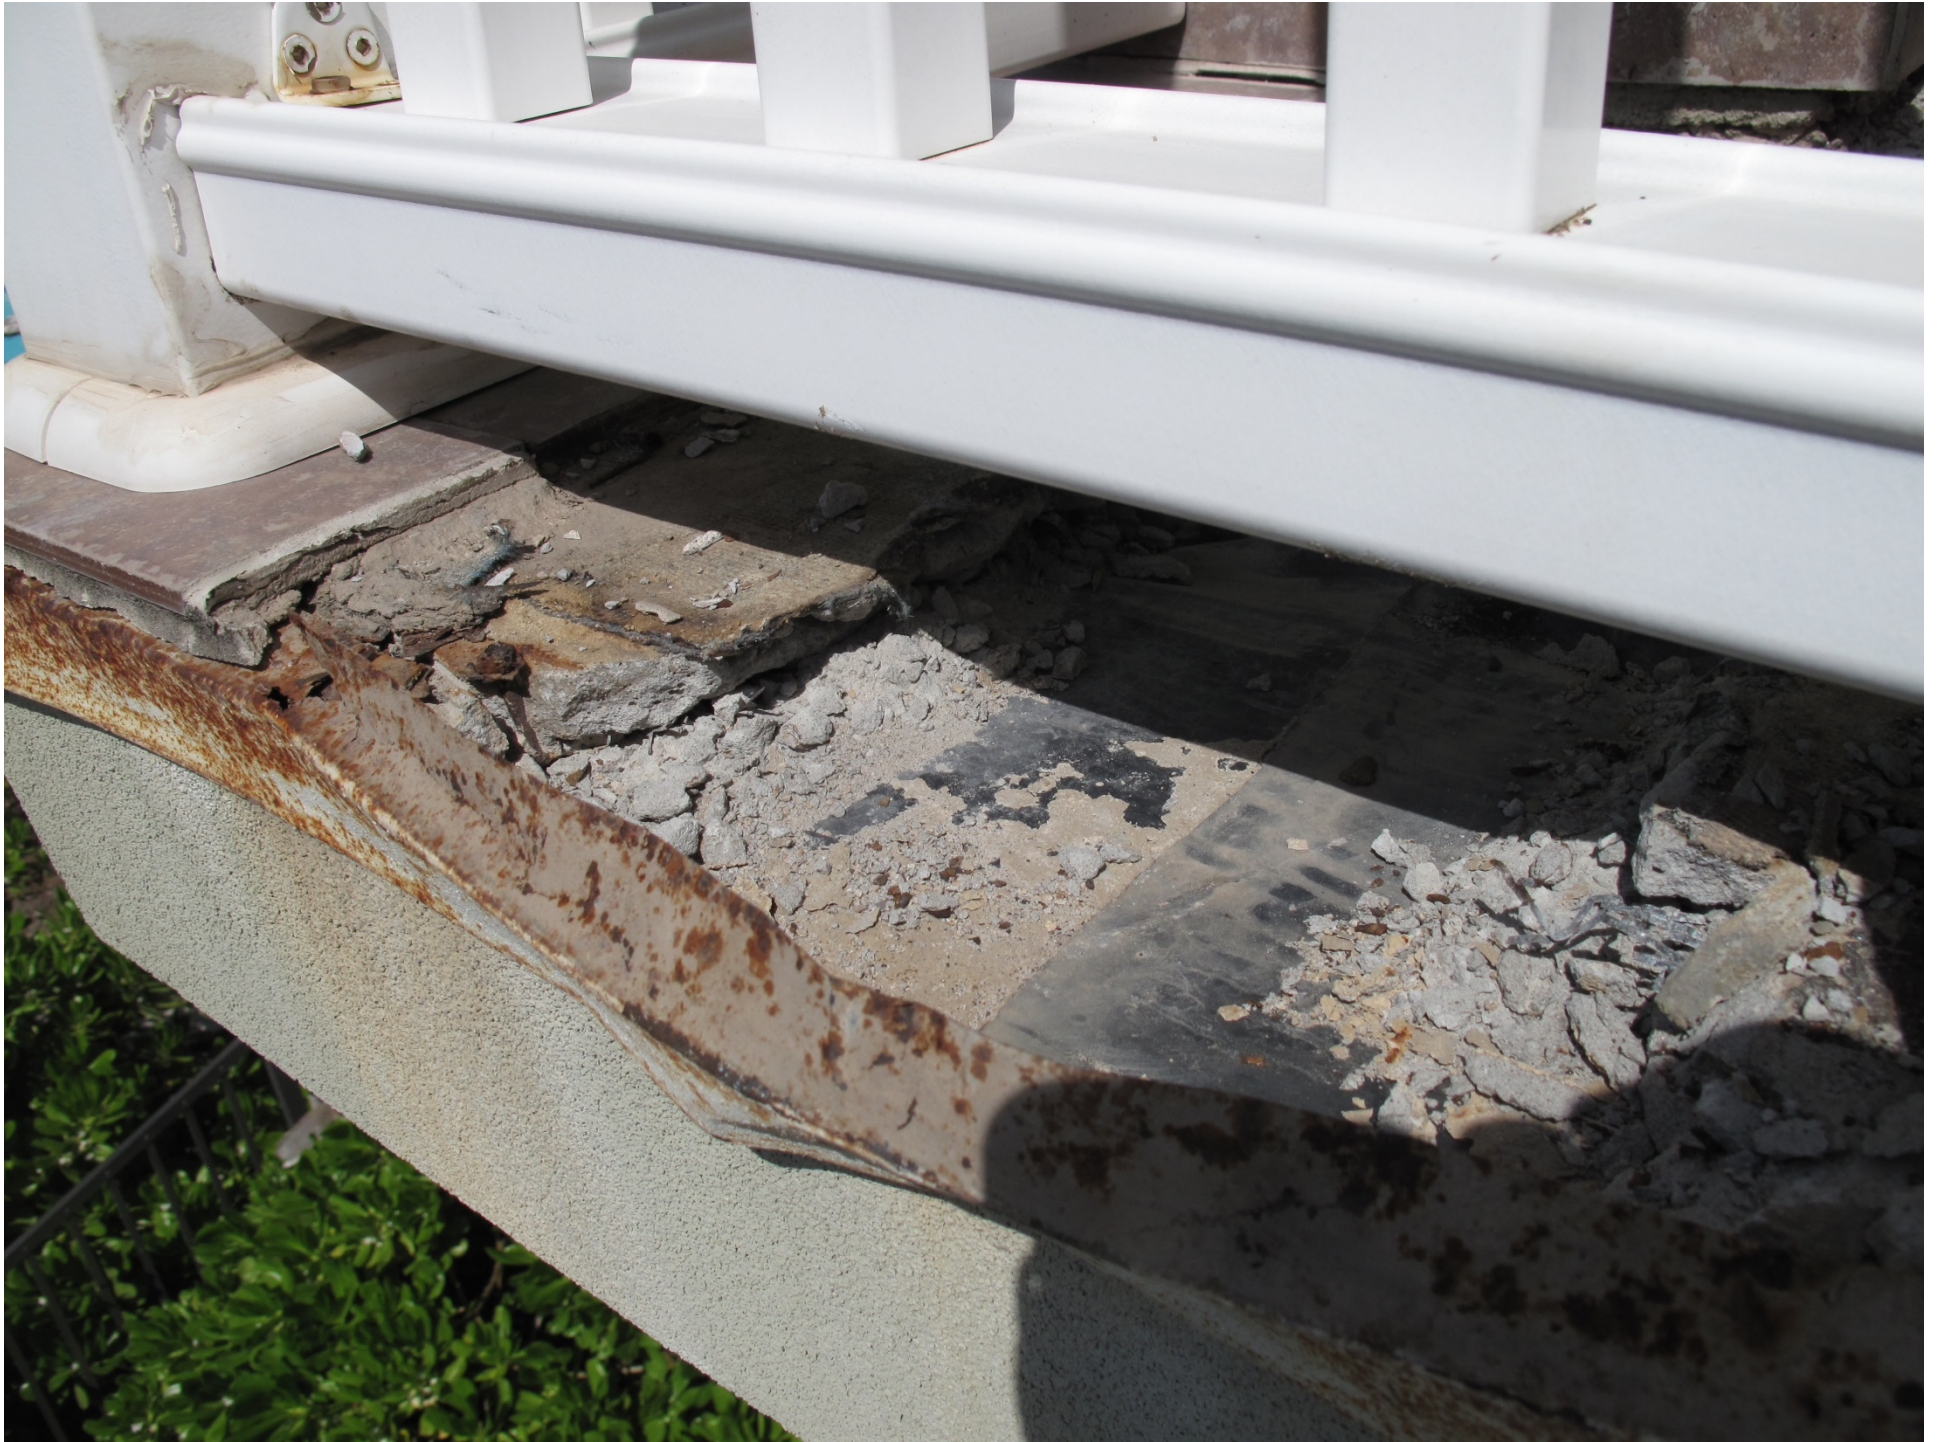
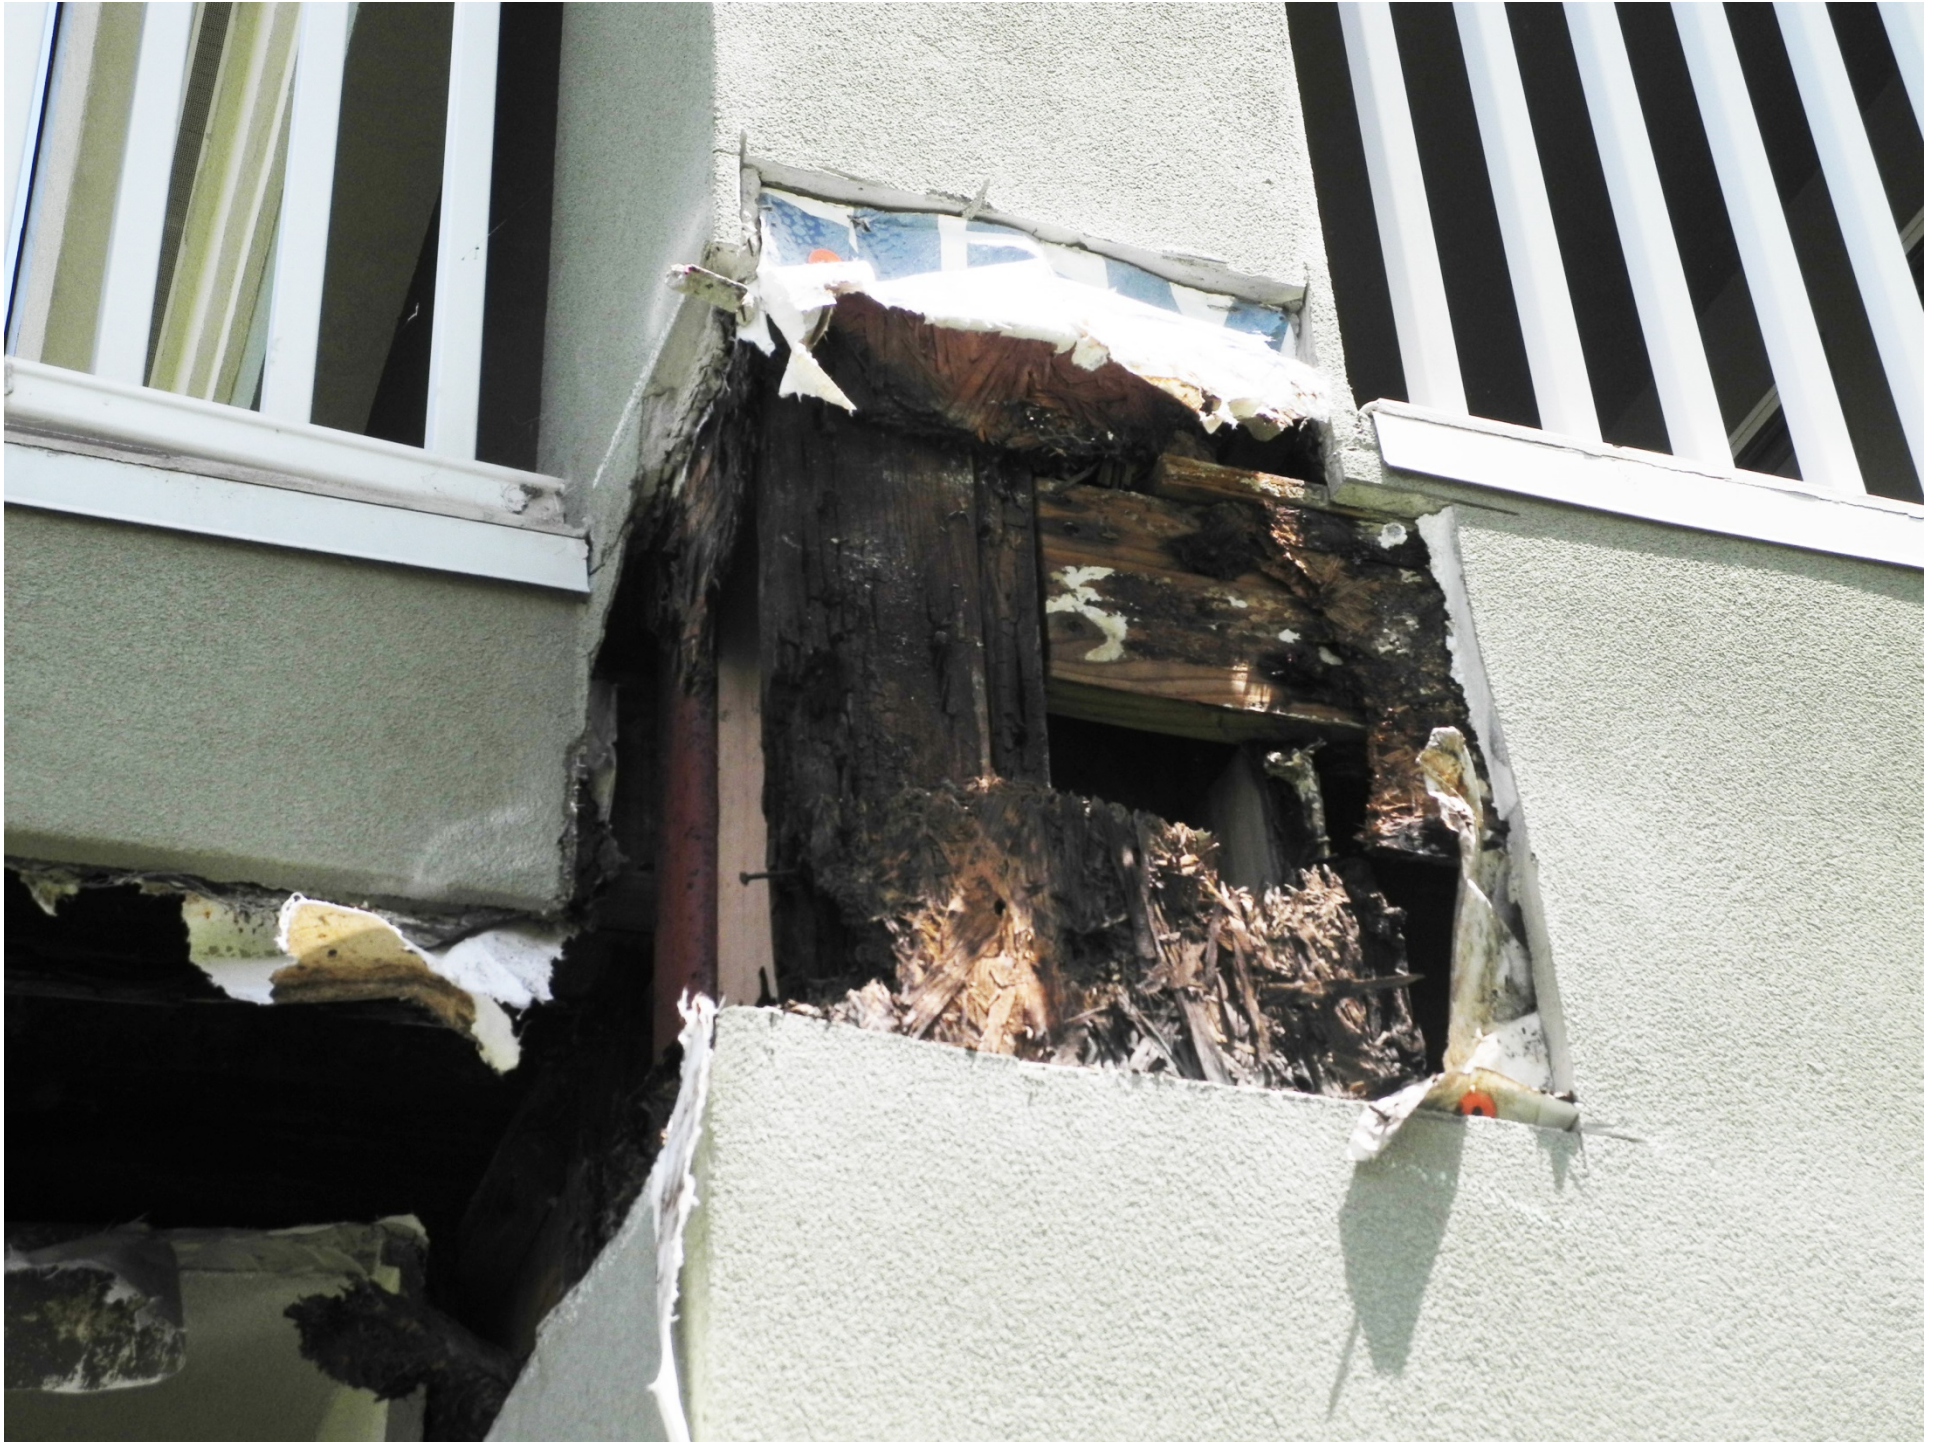
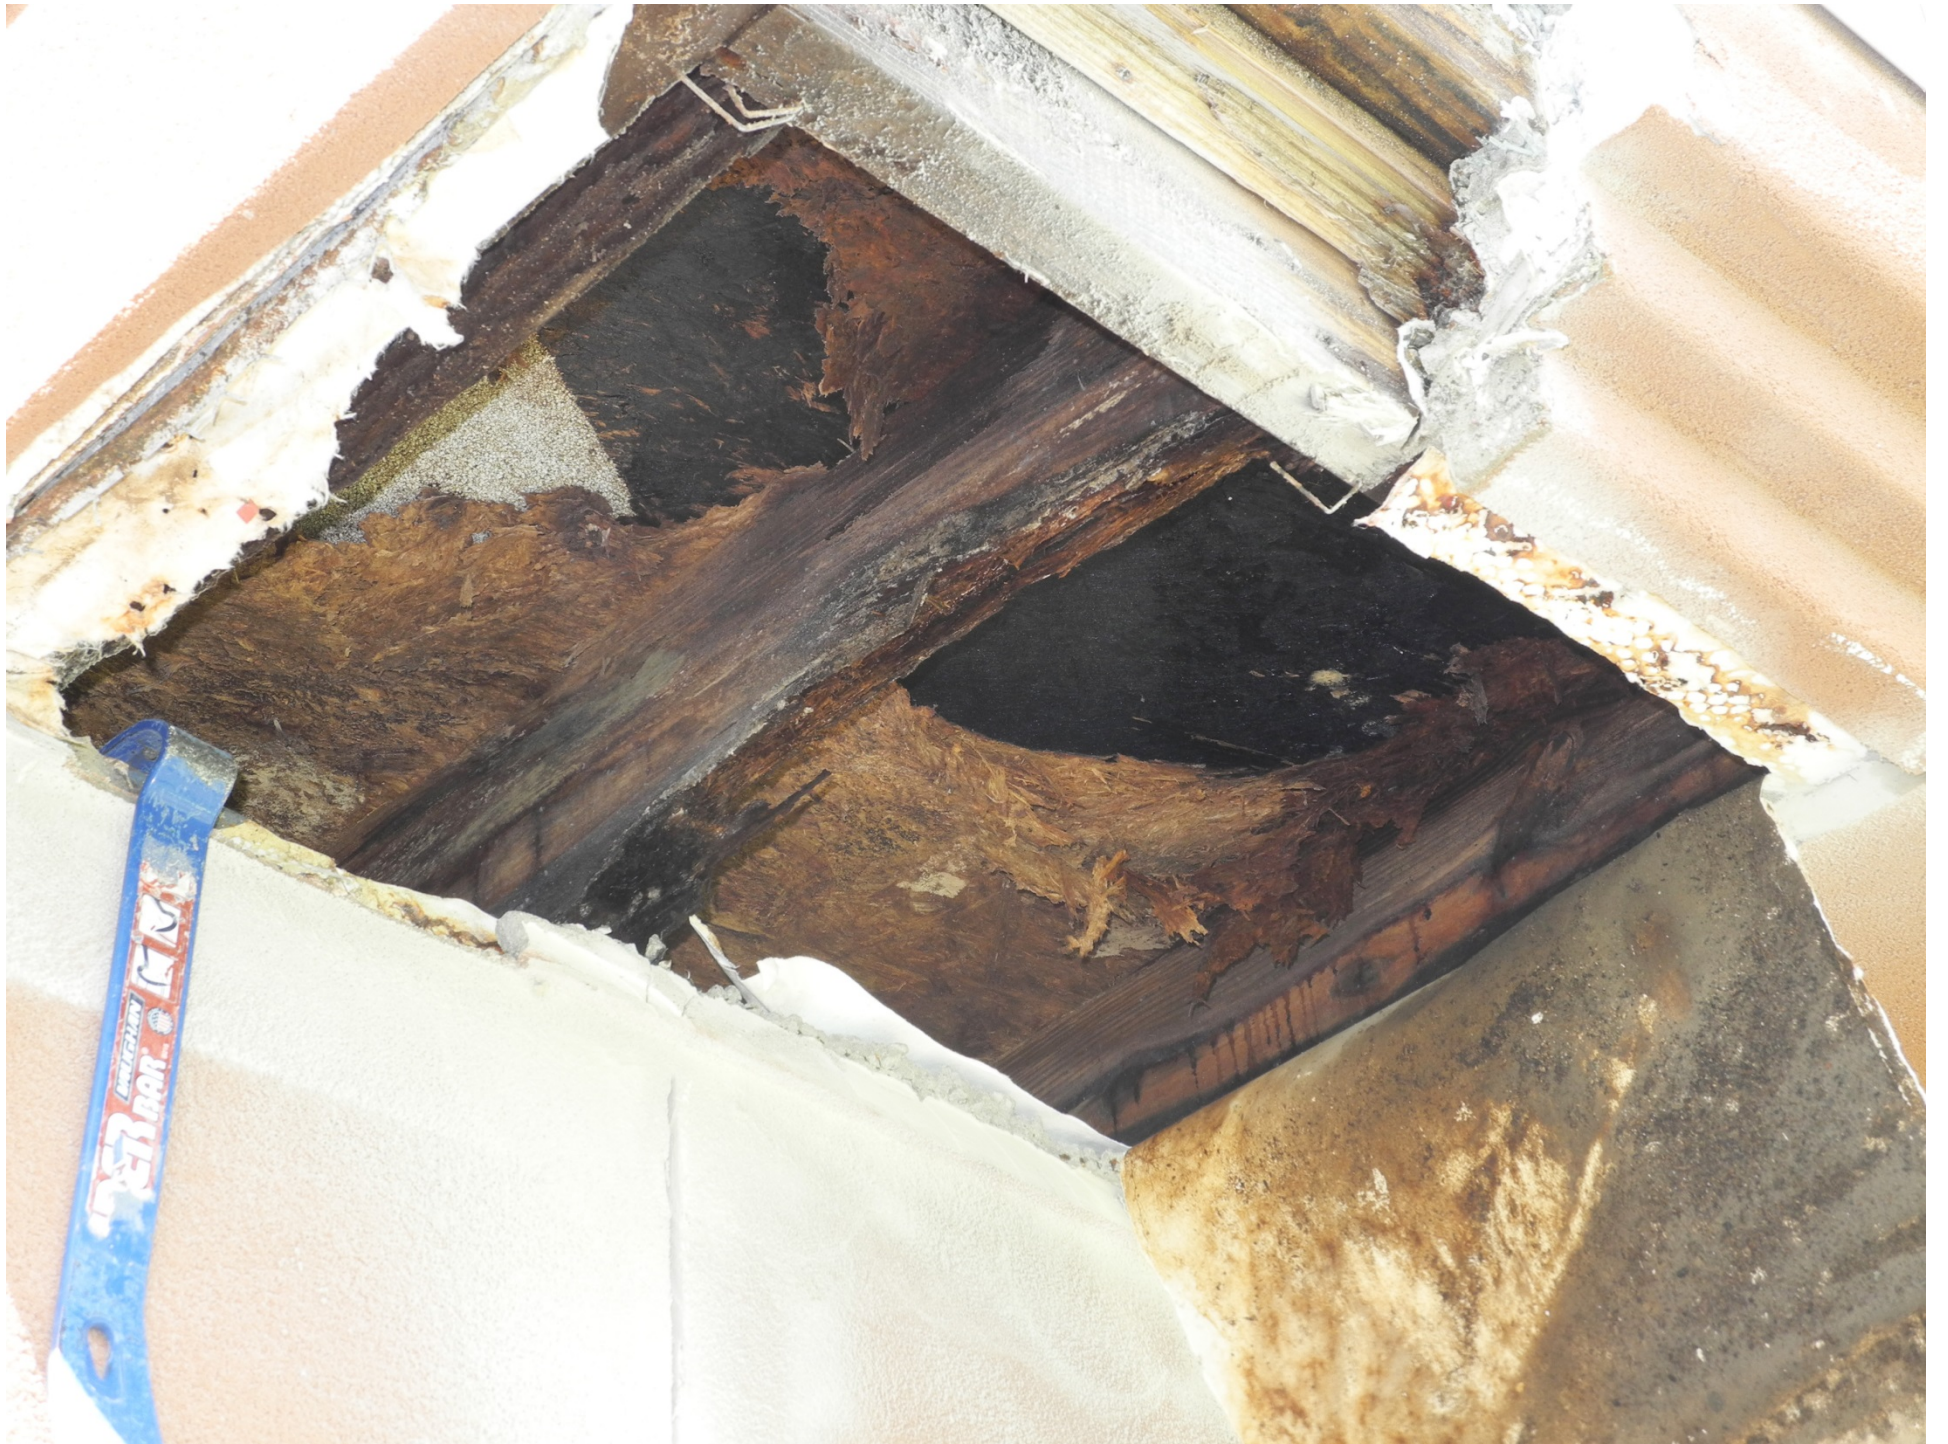
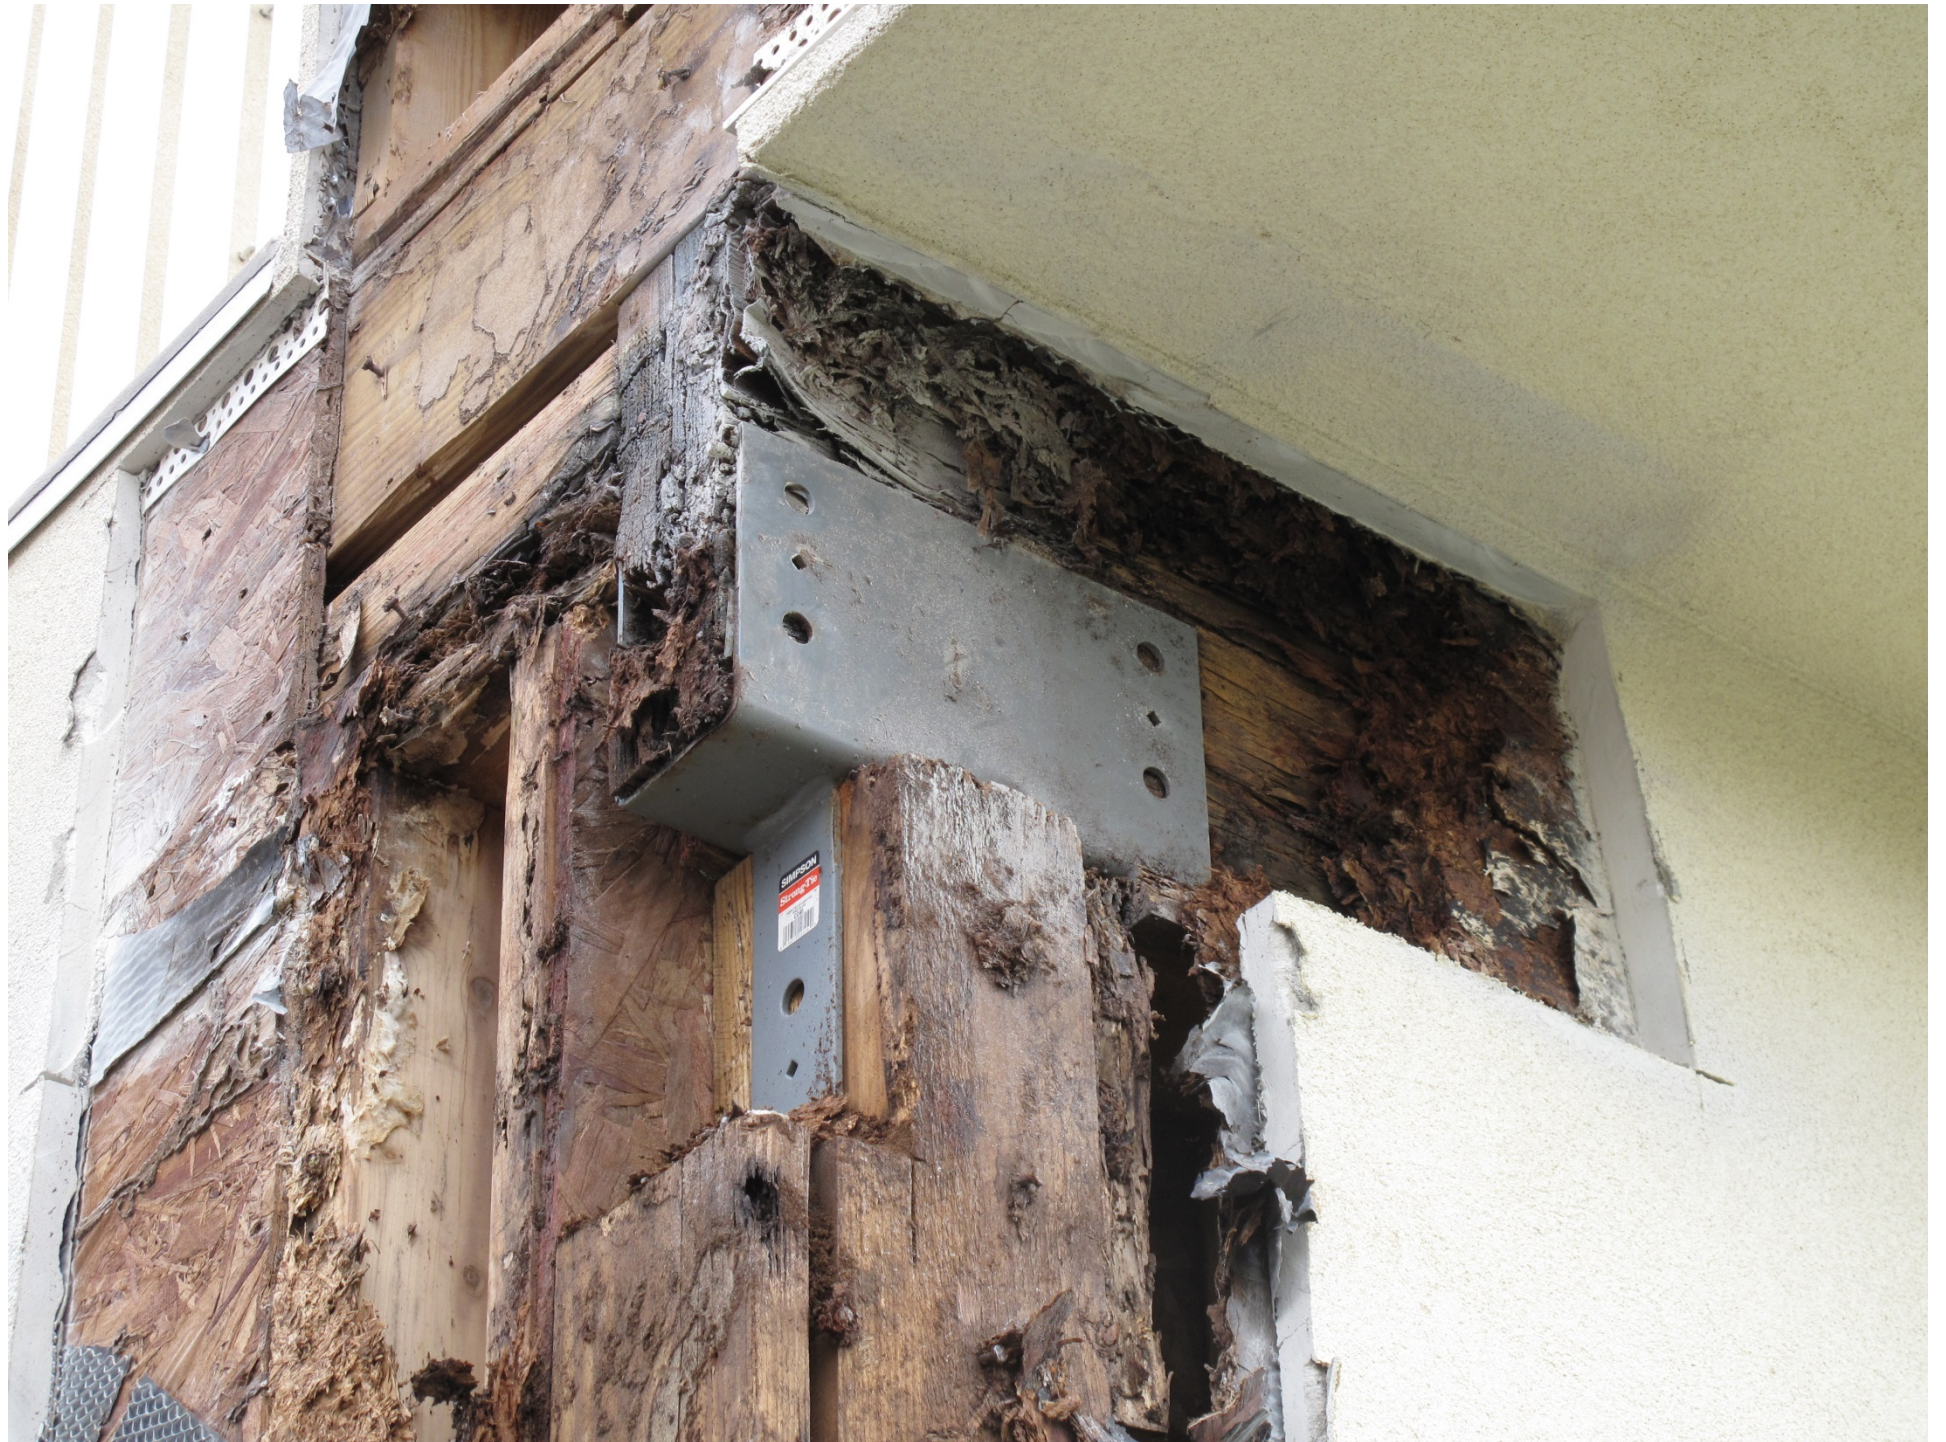
# RESULTANT DAMAGE

Nelson performed destructive testing at several unit balconies to determine the extent of damage to the balconies and cause(s) of damage.
