# METHODOLOGIES OF FORENSIC ARCHITECTURE INVESTIGATIONS

NELSON  
FORENSICS

# DESIGN AND CONSTRUCTION DEFECT

# WATERFRONT TOWNHOMES

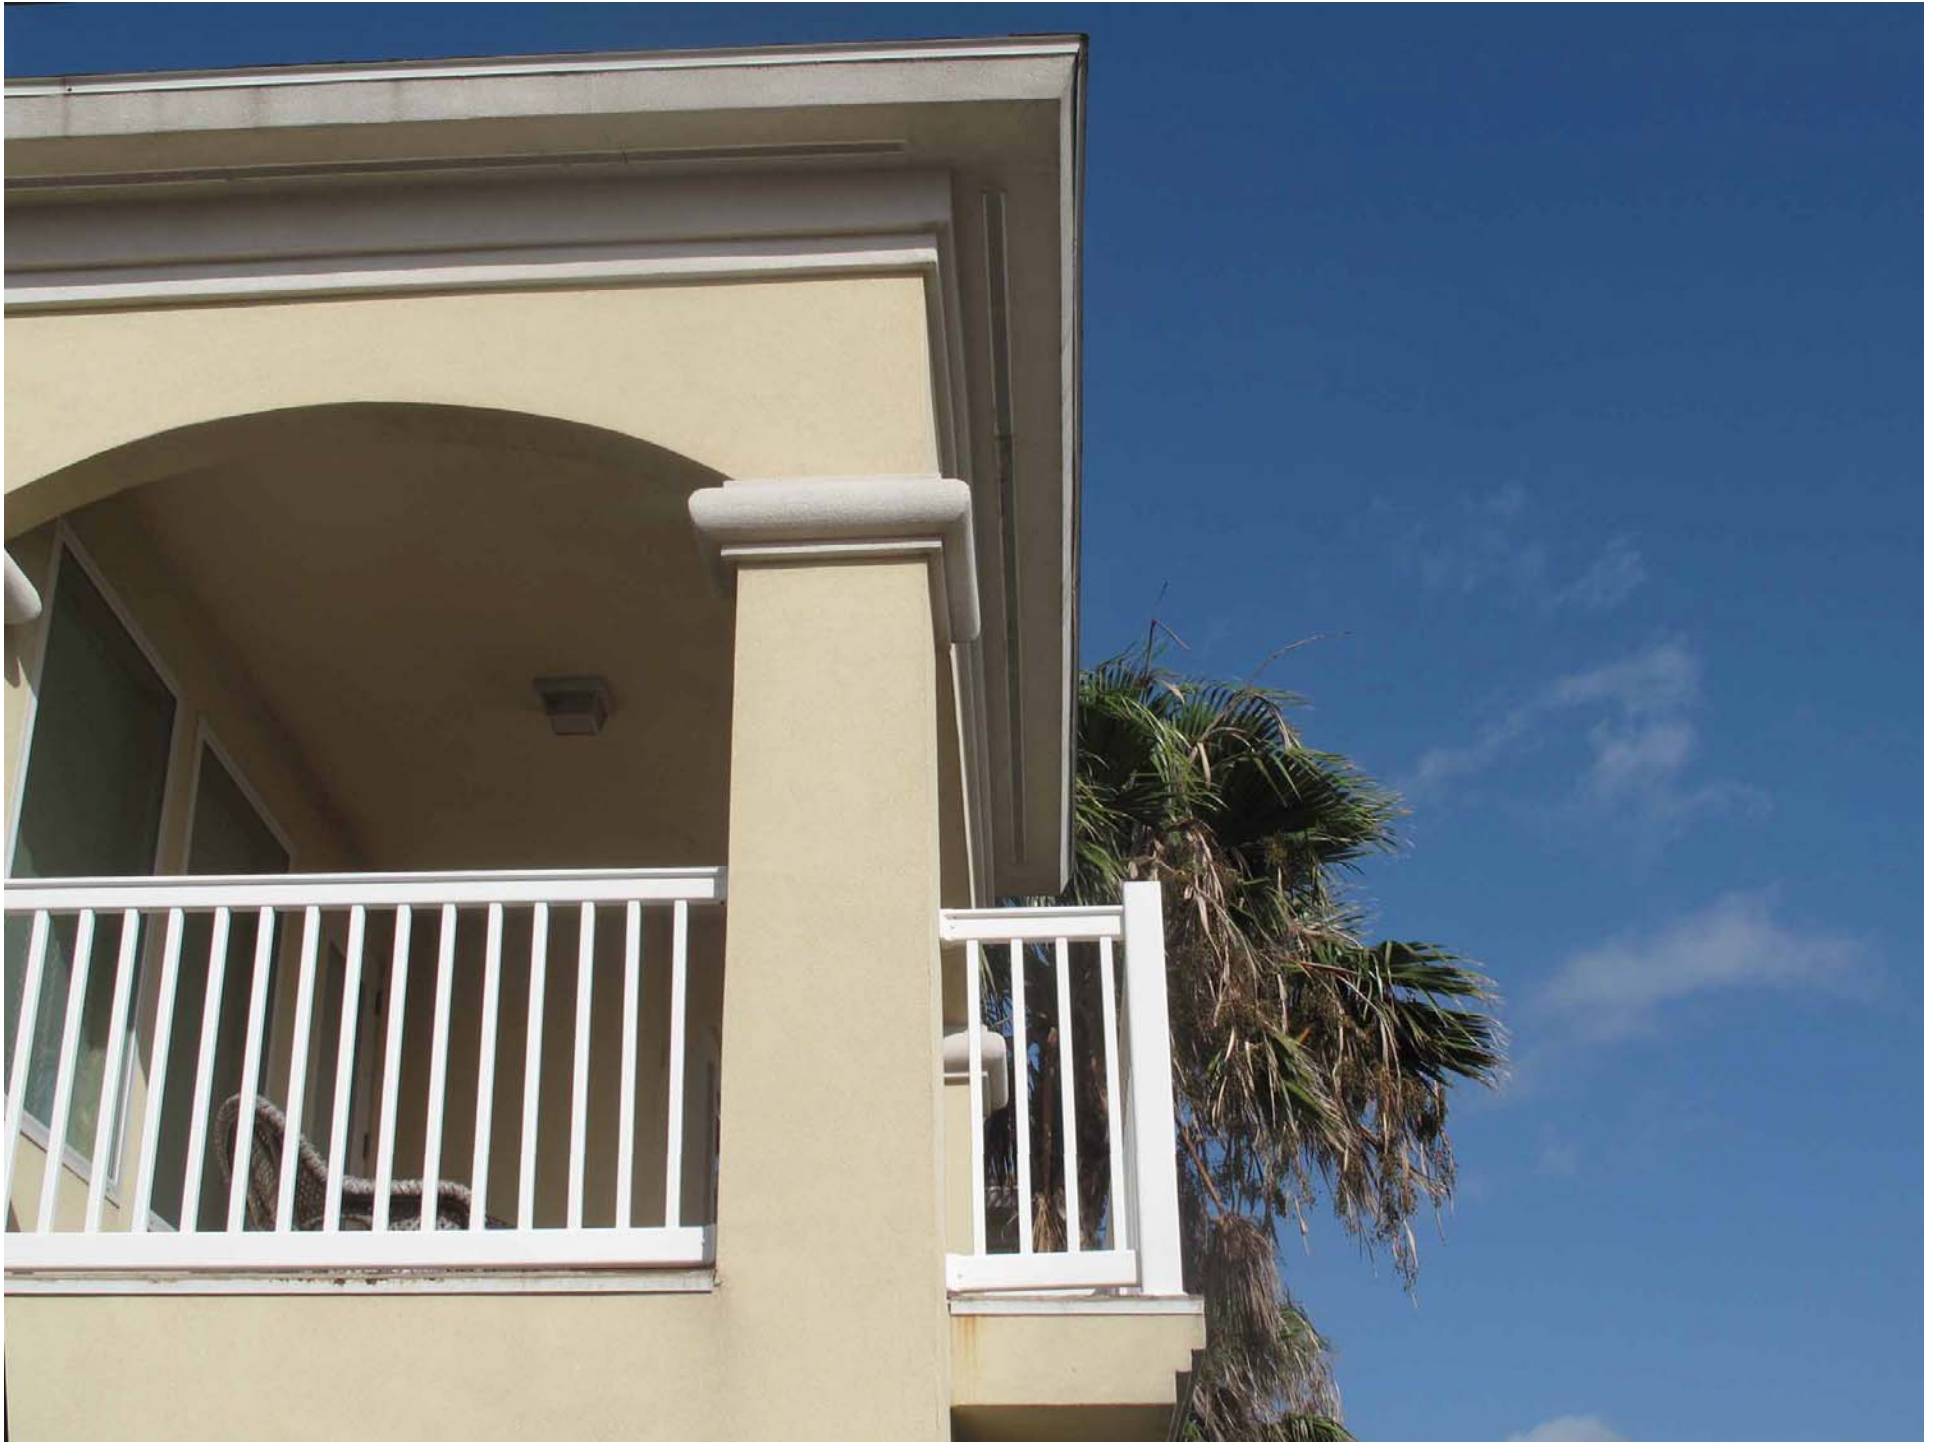
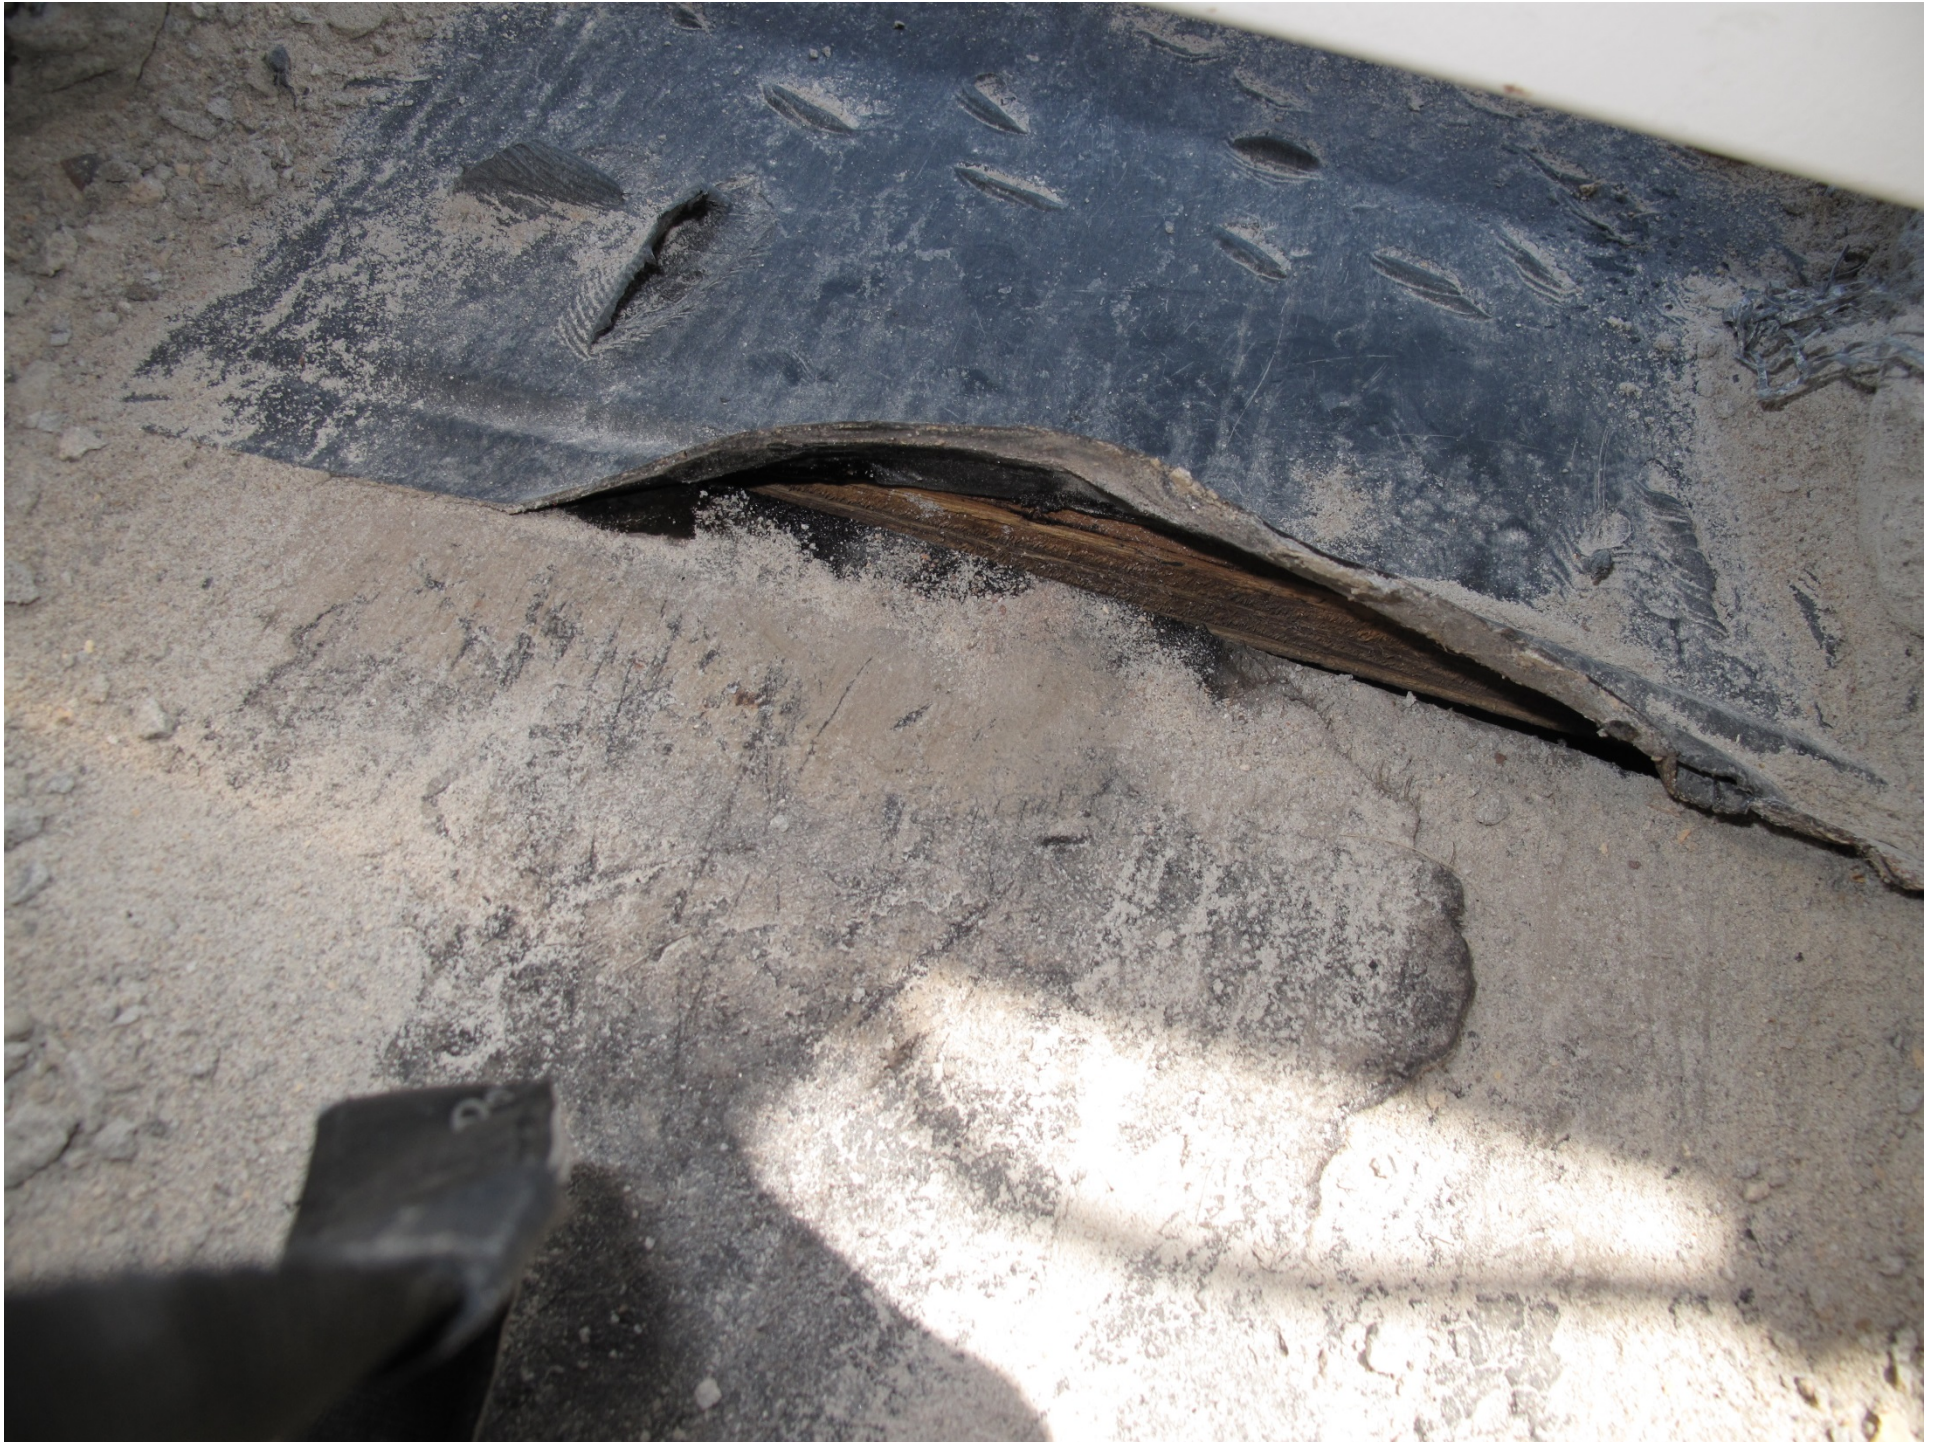
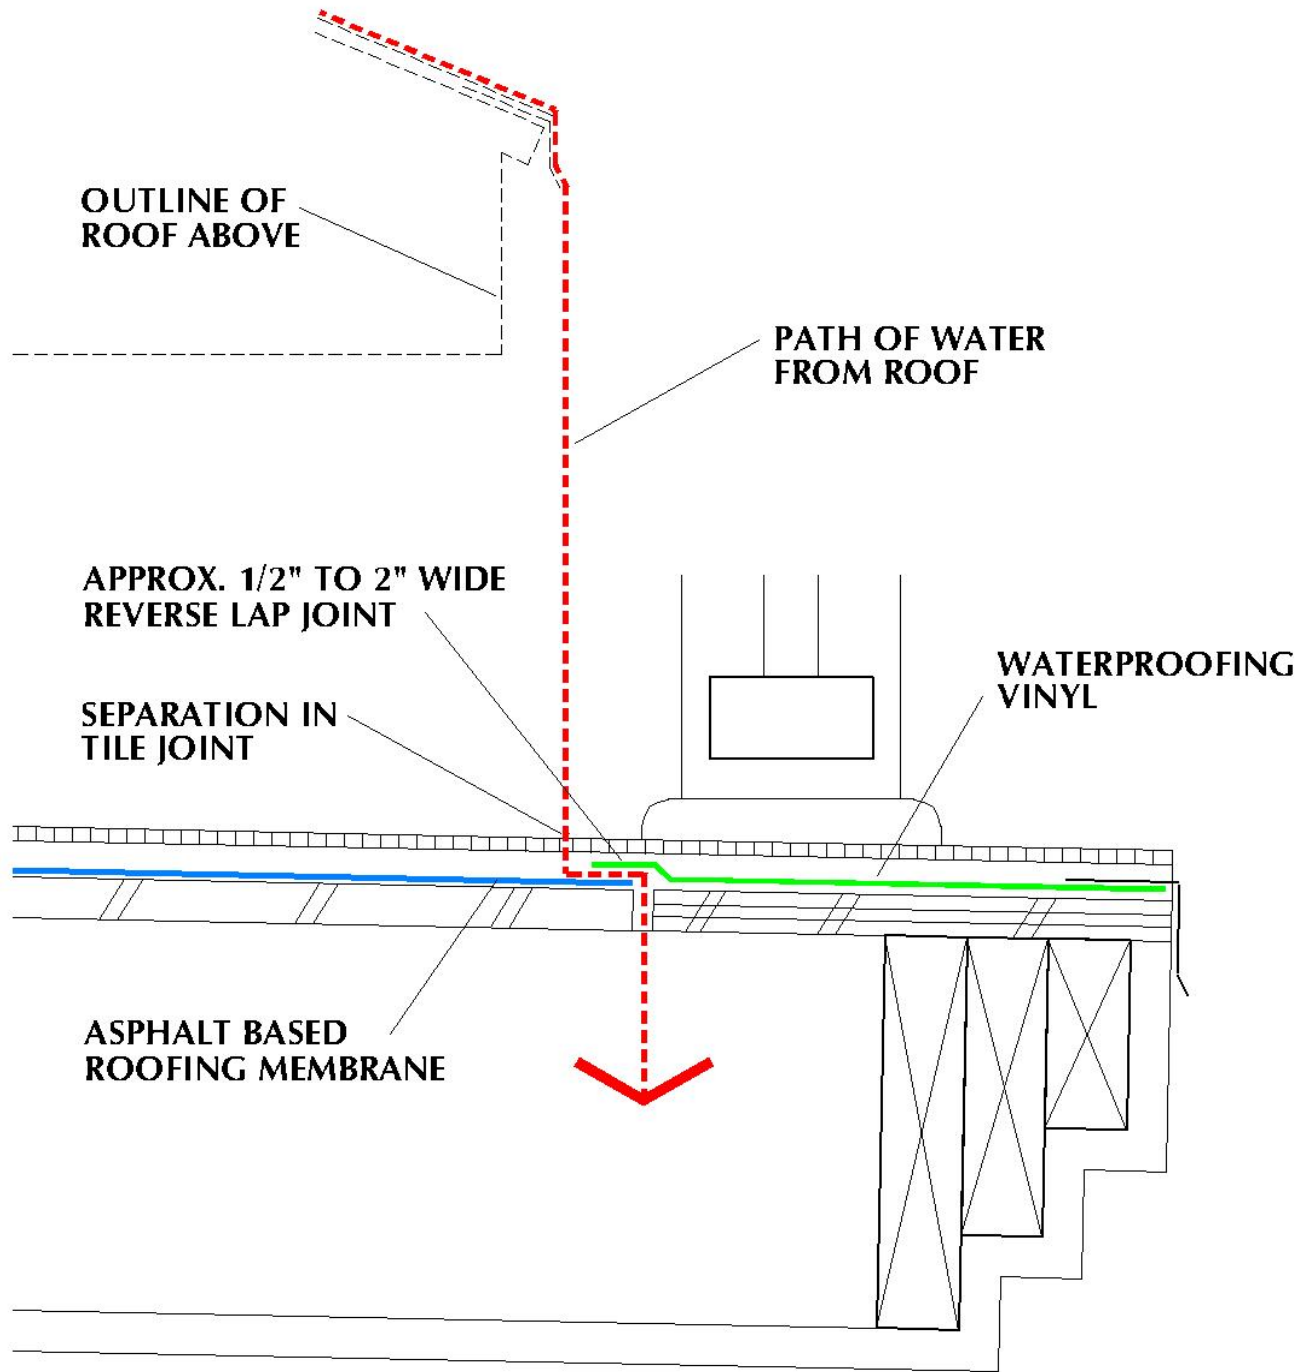
- Unprotected roof overhang allowing water discharge directly onto the balcony below.
- Reverse lapped porous waterproofing joint placed directly under the path of water drainage from the roof above.

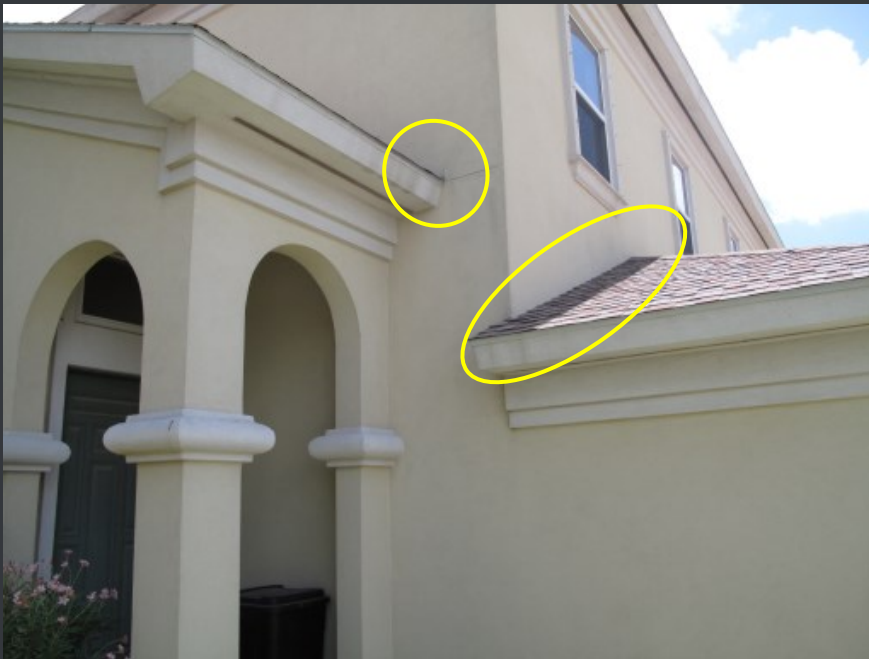
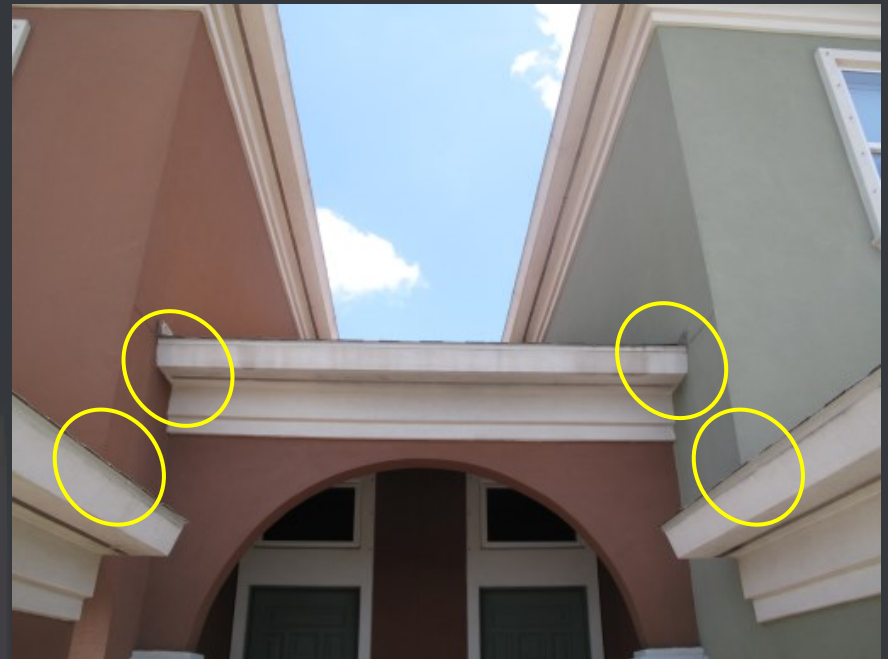
Kick-out flashing

# ISSUE 2 – ROOF RAKE AND EXTERIOR WALL JUNCTURES

- Improper termination of the stucco at the roof line.
- Lack of kick-out flashing installed at the rake line termination.

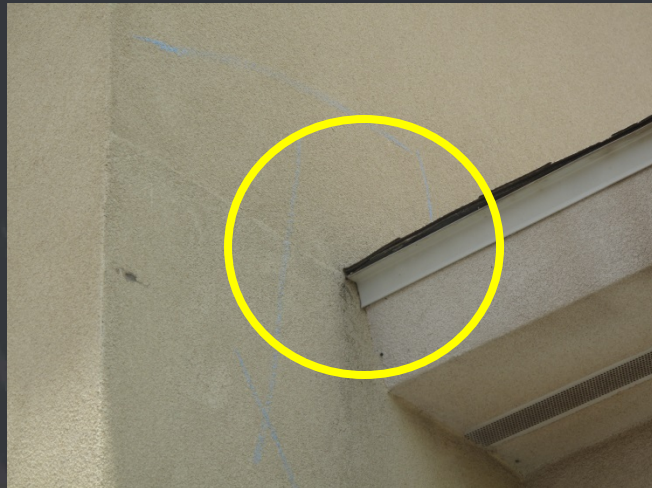
No kick-out flashing

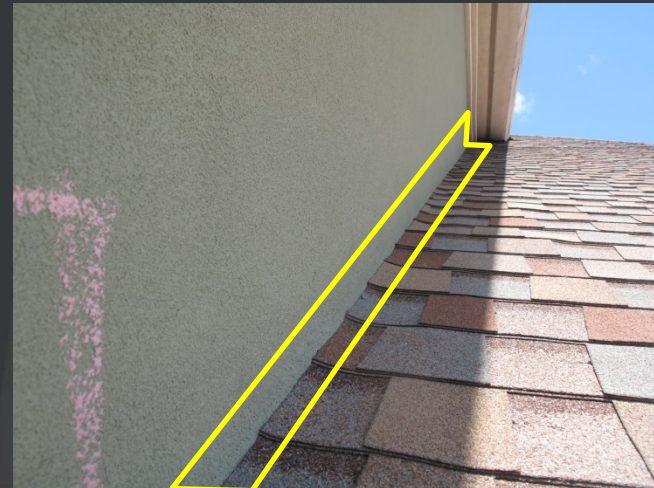
No flashing separation

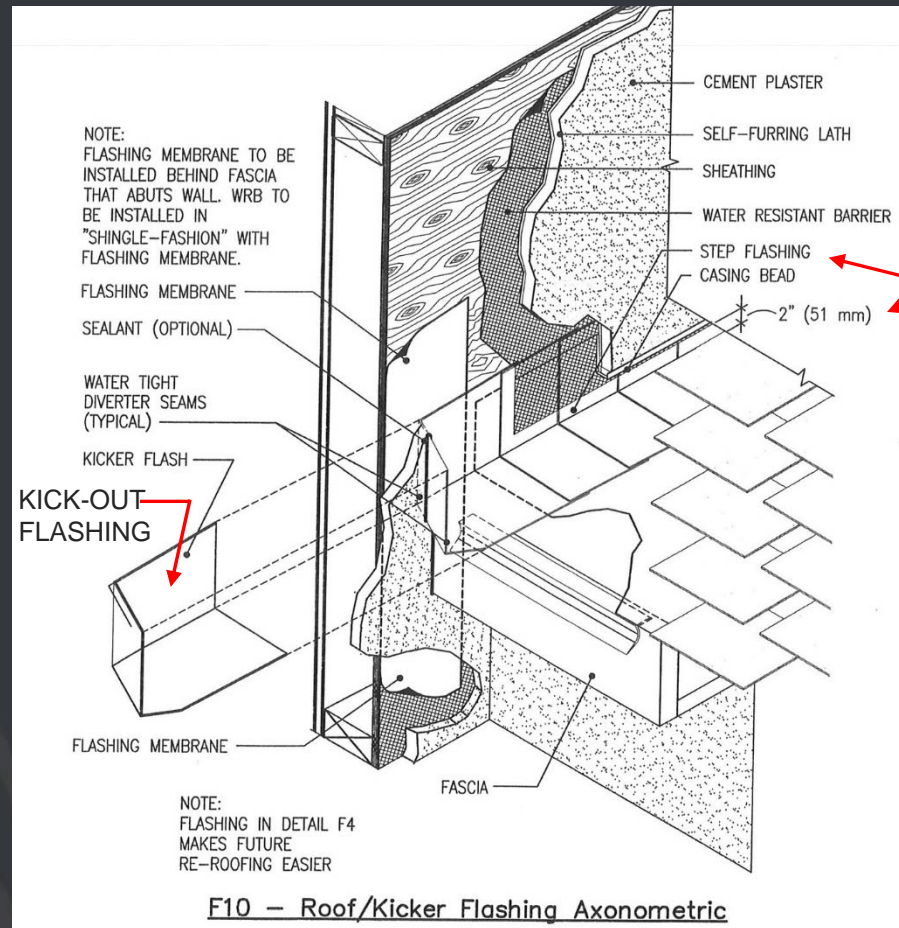
# PROPERLY INTEGRATED ELEMENTS AT ROOF RAKE LINE & EXTERIOR WALL JUNCTURES

FLASHING WITH MINIMUM 2" SEPARATION OF STUCCO FROM ROOF

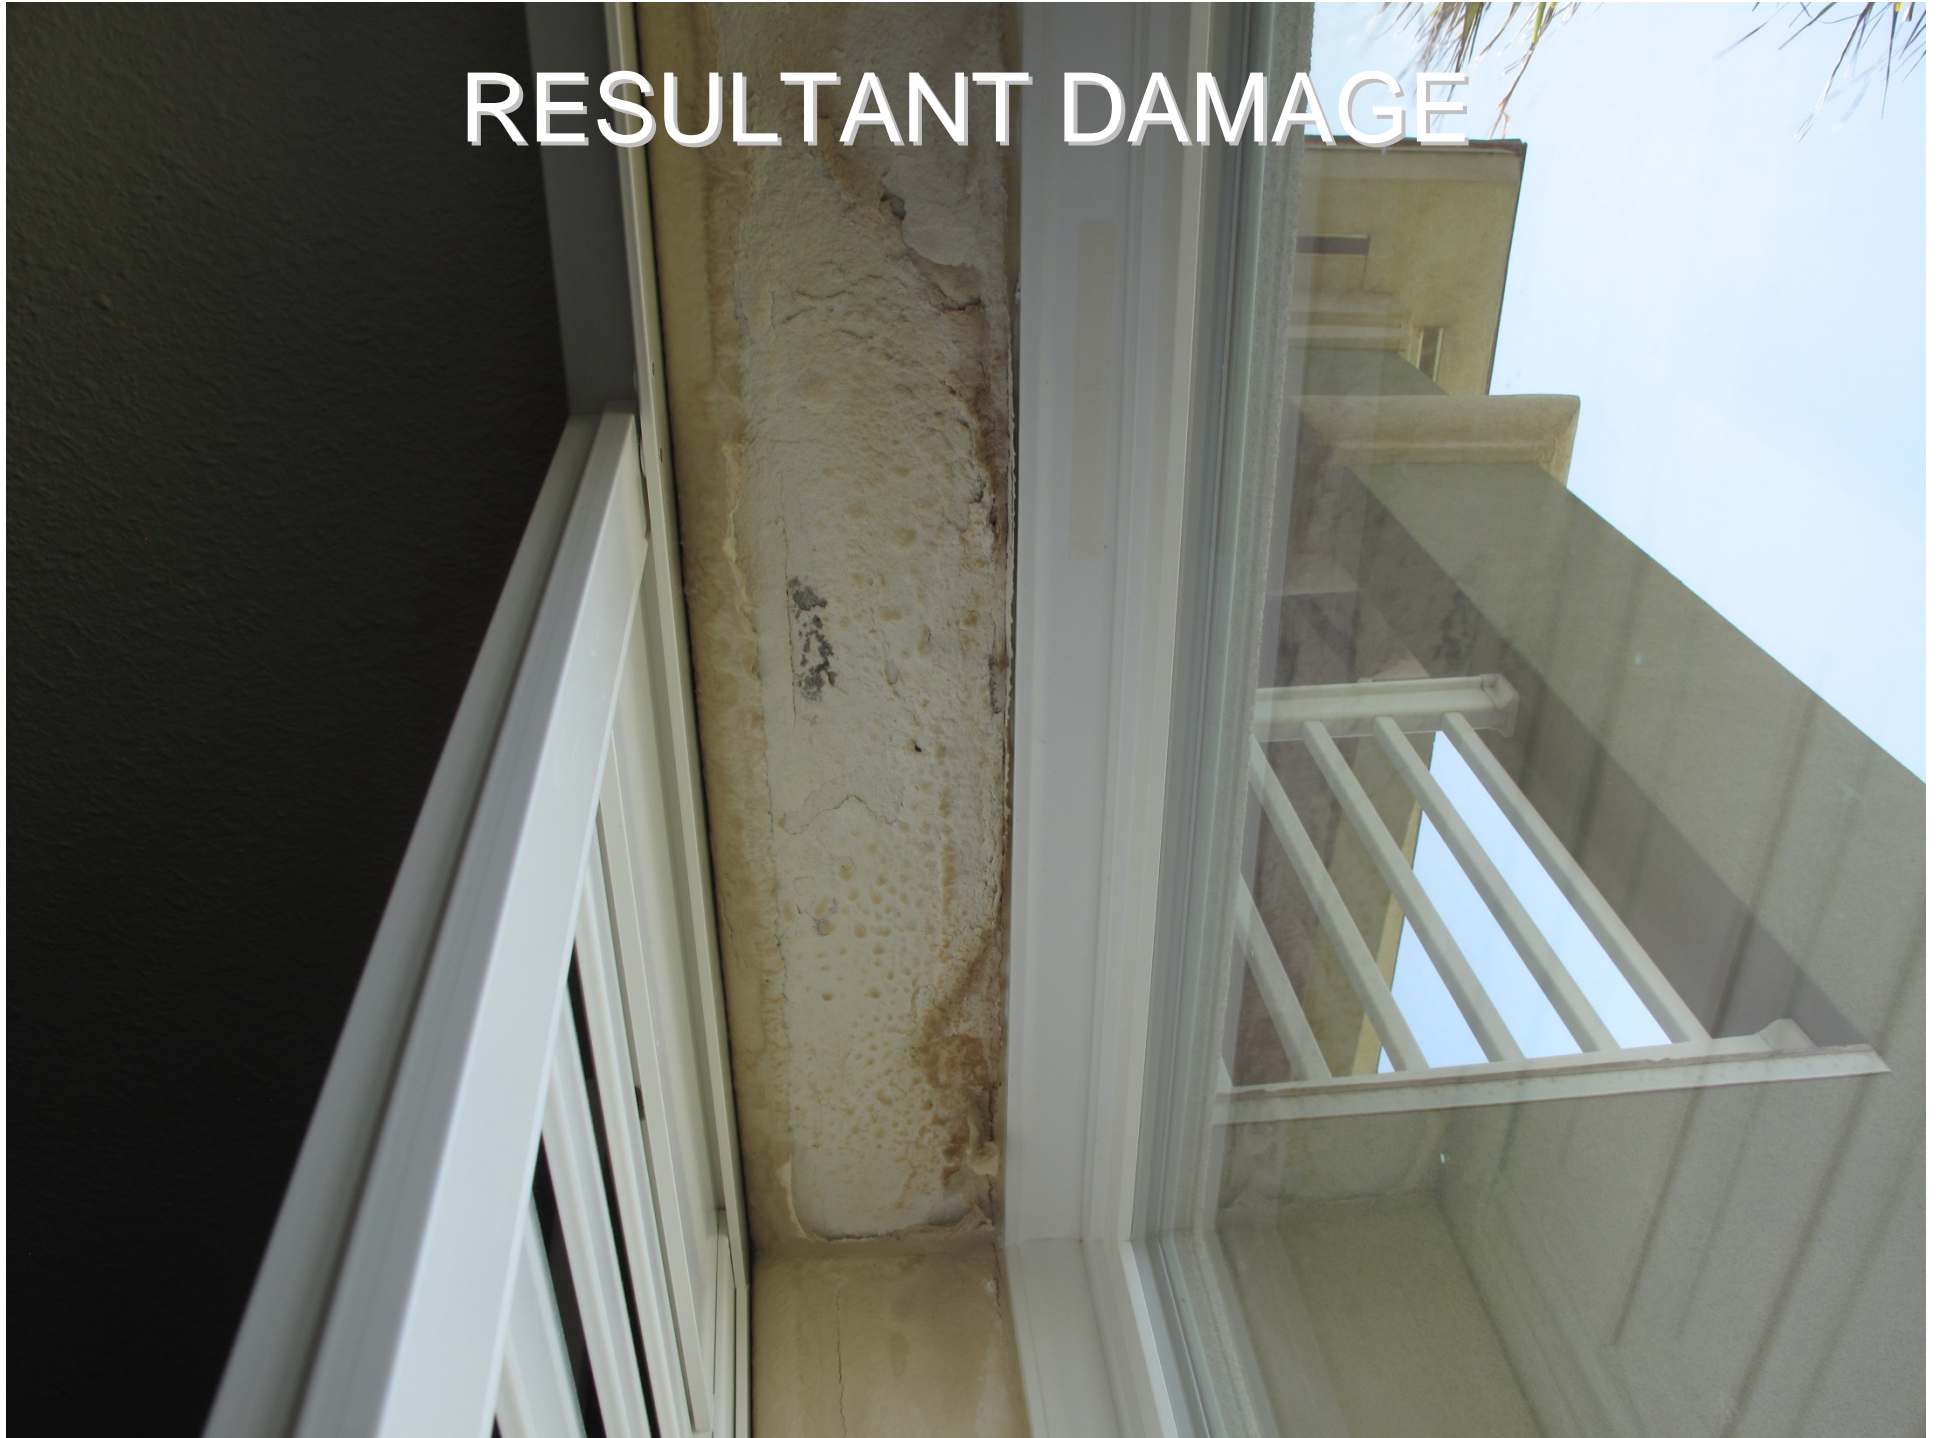
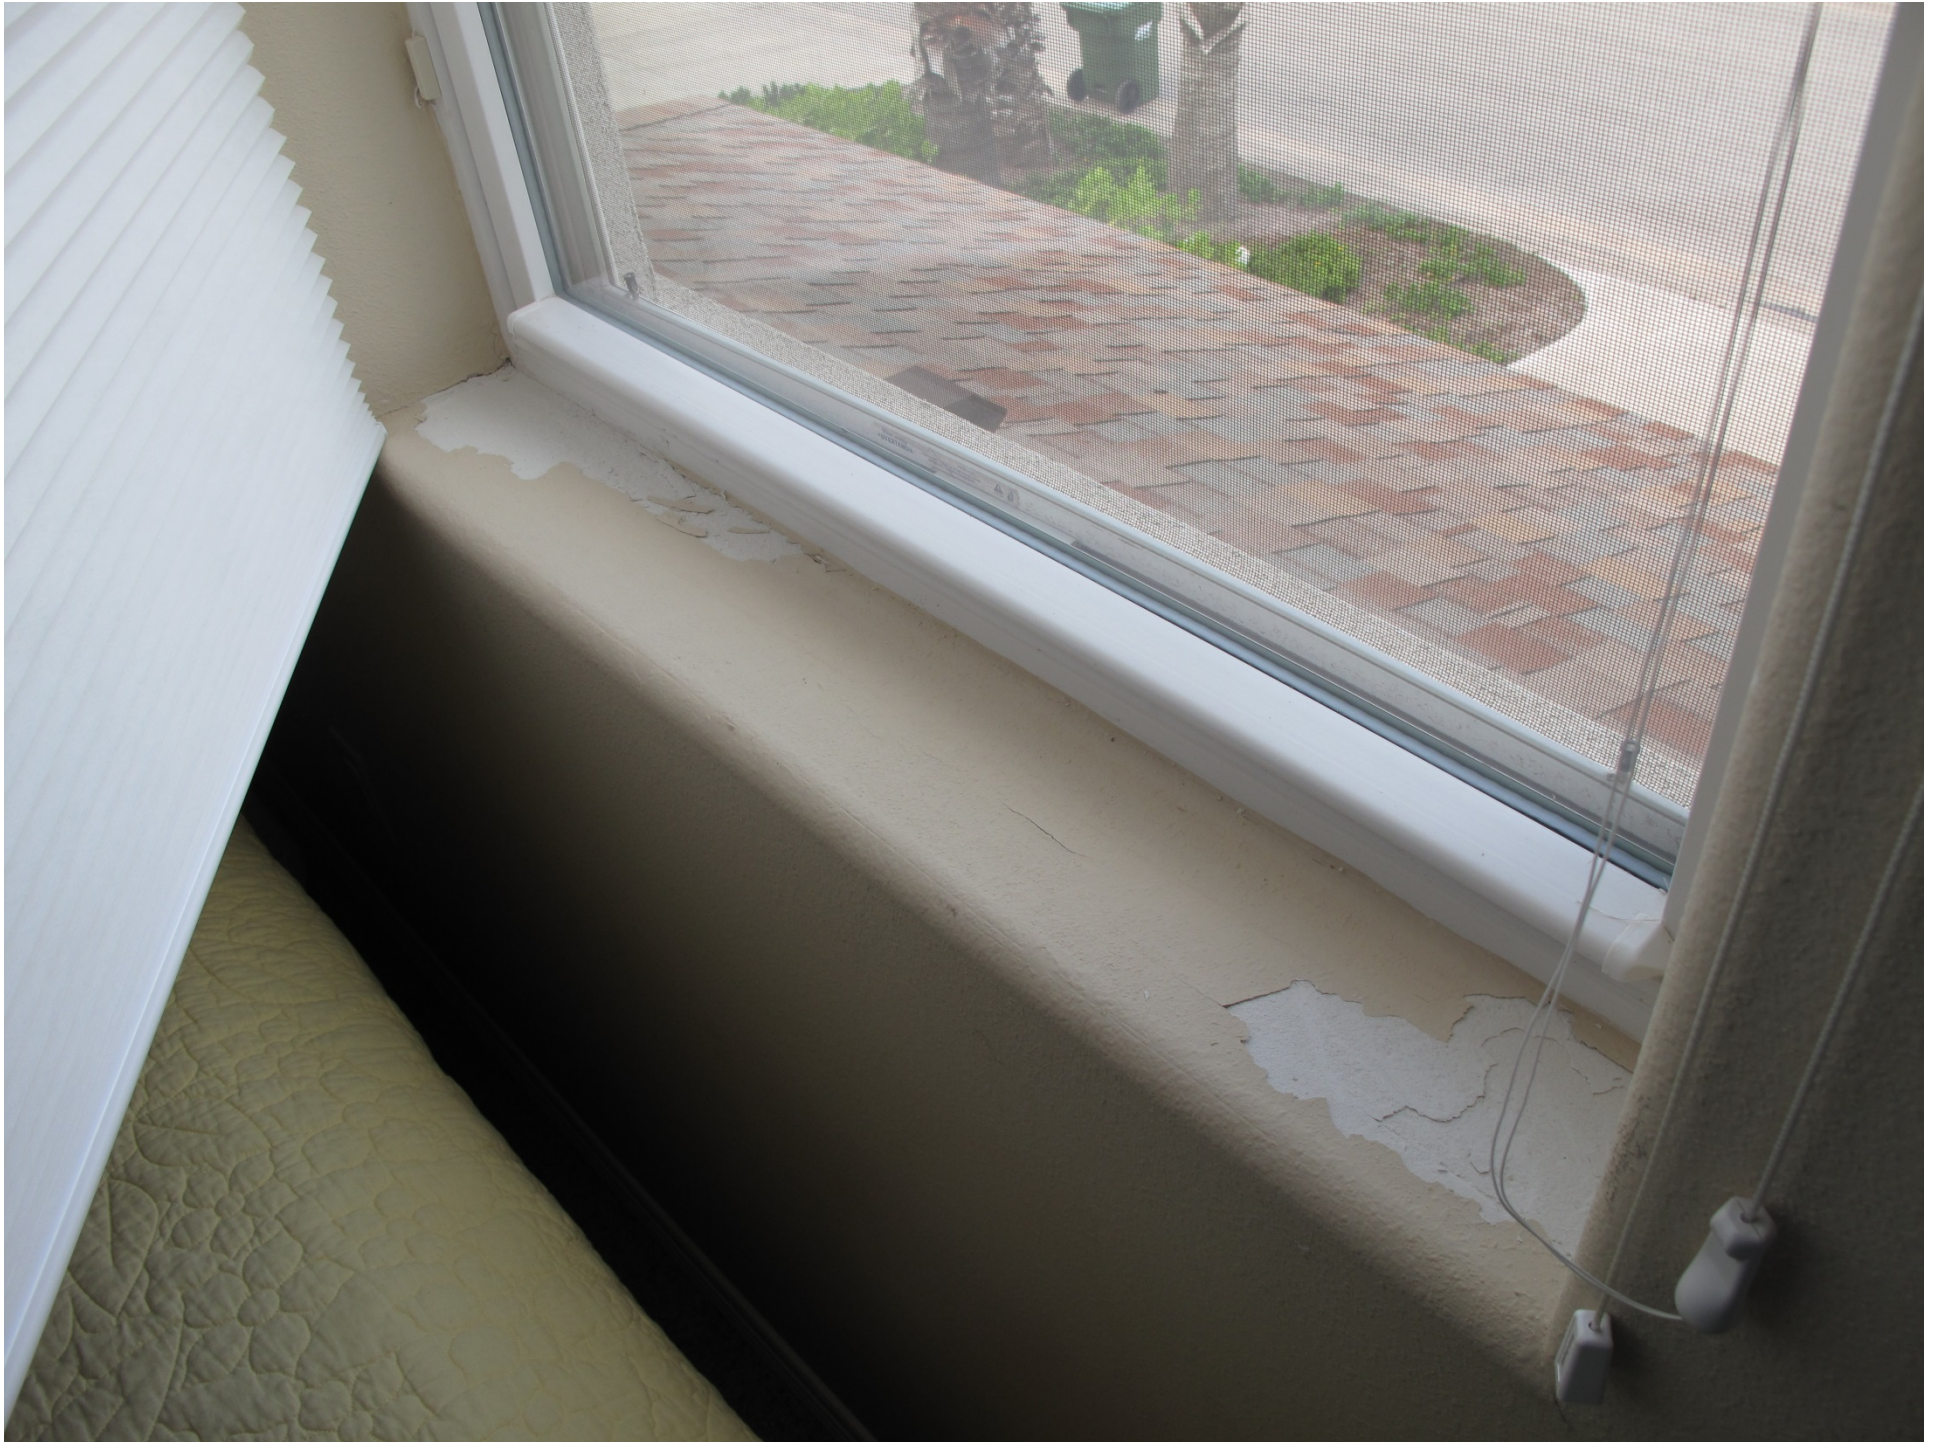
# RESULTANT DAMAGE

- Lack of window flashing installed
  - Approximately 50% of windows tested had no flashing.
- Improper integration of window flashing and water resistive barrier (Tyvek or building paper).
  - Flashing installed improperly at approximately 35% of windows tested.

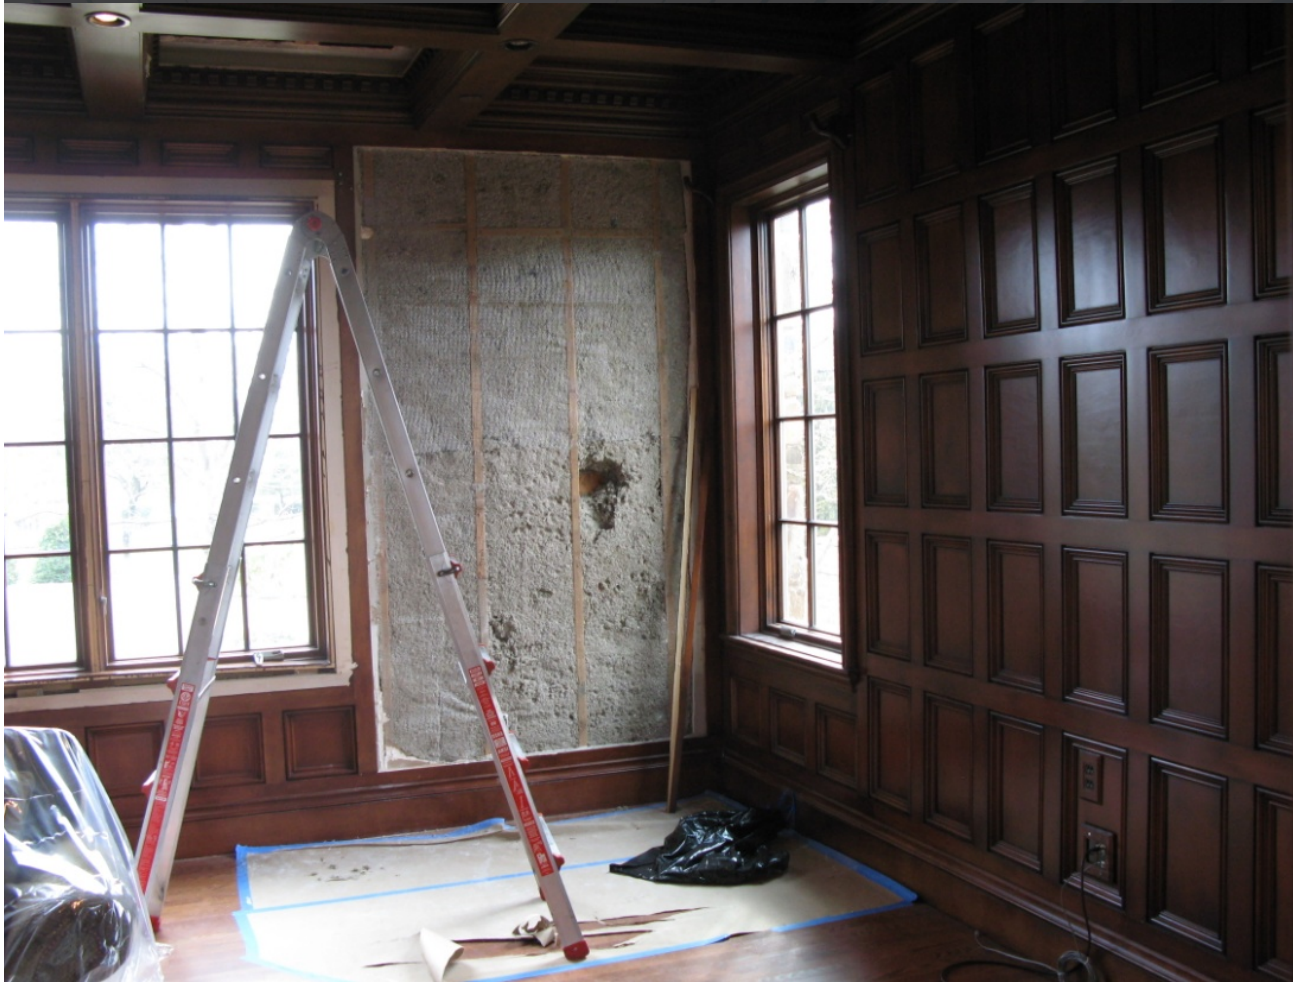
# BACKGROUND

- Latex painted gypsum board
- Enamel-finished wood trim
- Varnished hardwood paneling
- Wet-spray cellulose insulation in exterior stud wall assemblies

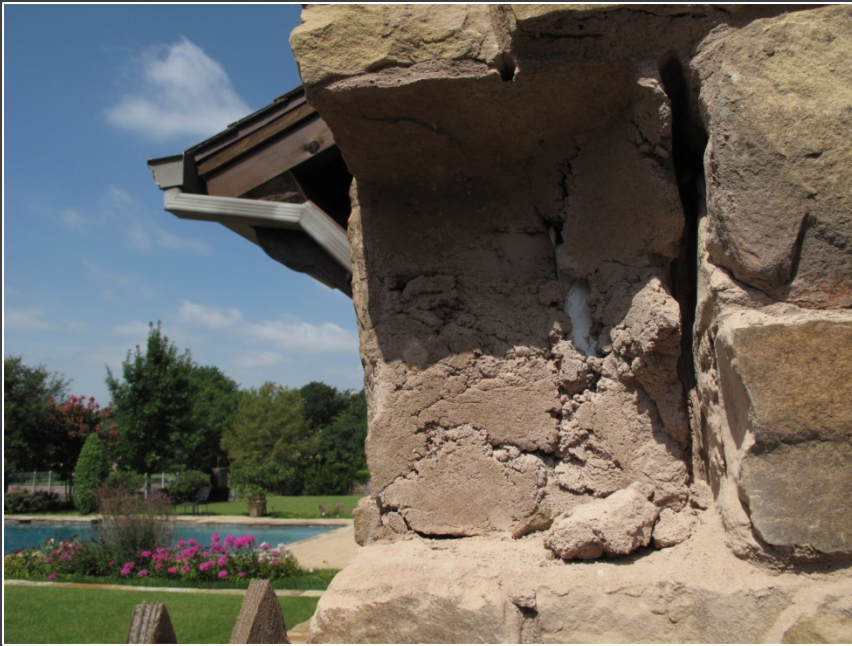
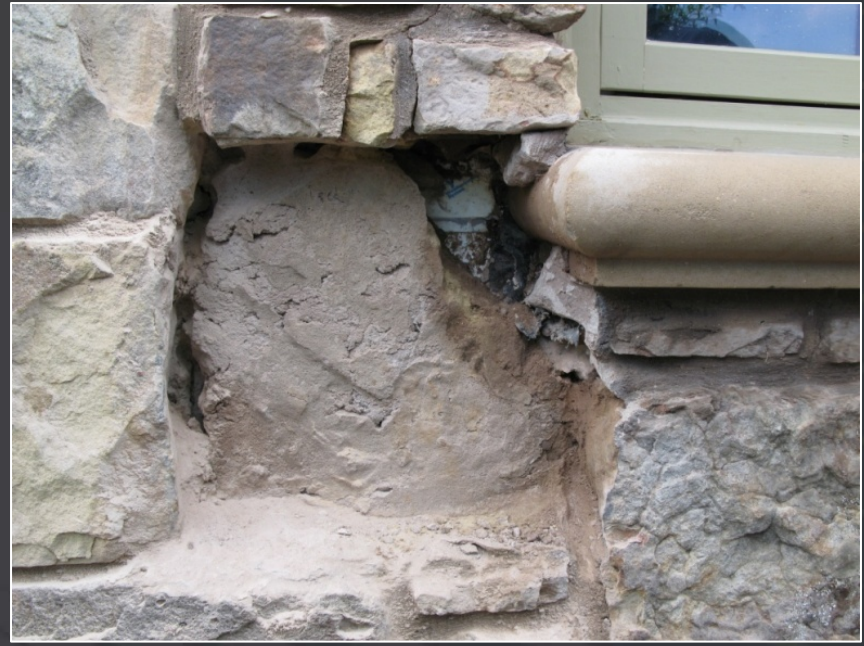
# MASONRY OBSERVATIONS

Stone removal revealed packed mortar

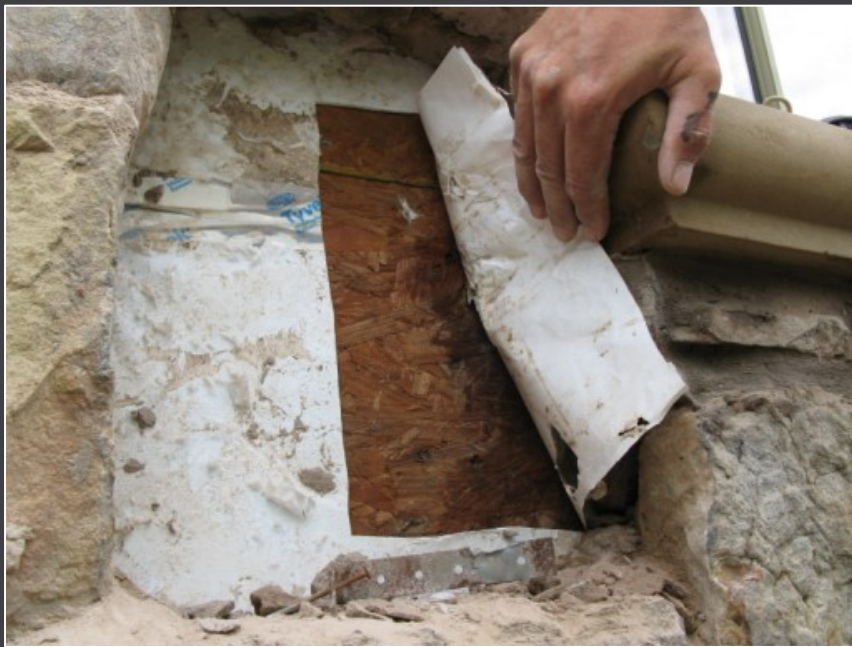
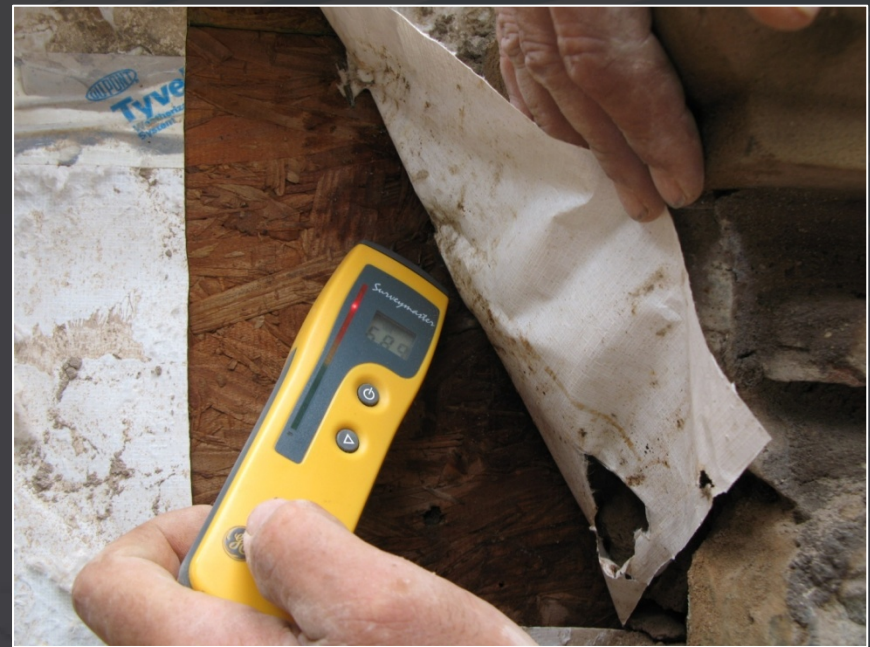
# MASONRY OBSERVATIONS

## Moisture behind Tyvek

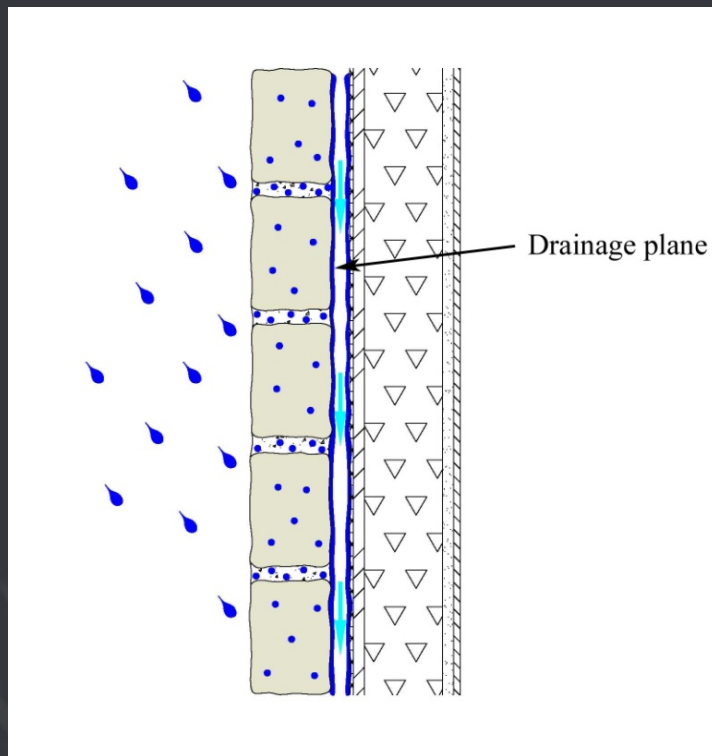
Capillary Break

# A FUNCTIONING AIR SPACE IS VITAL!

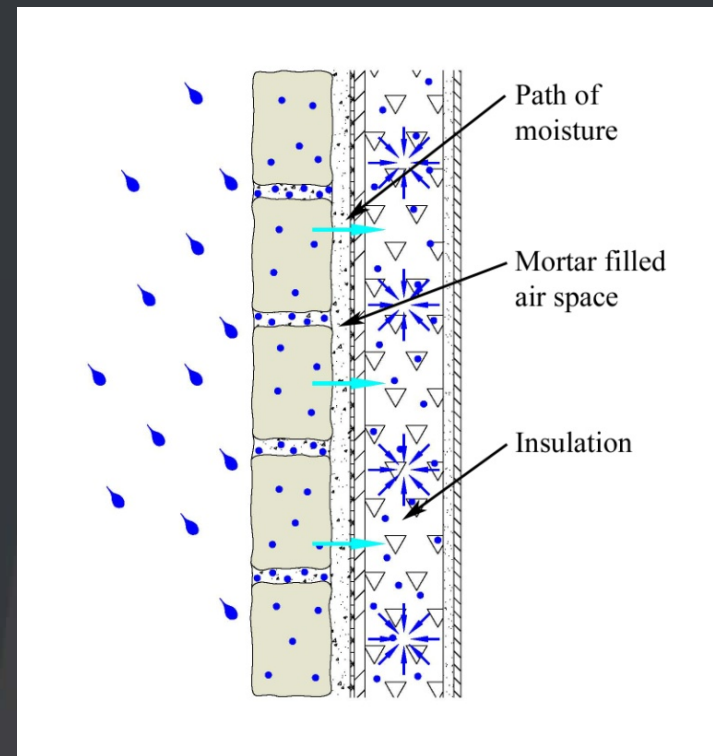
No Capillary Break

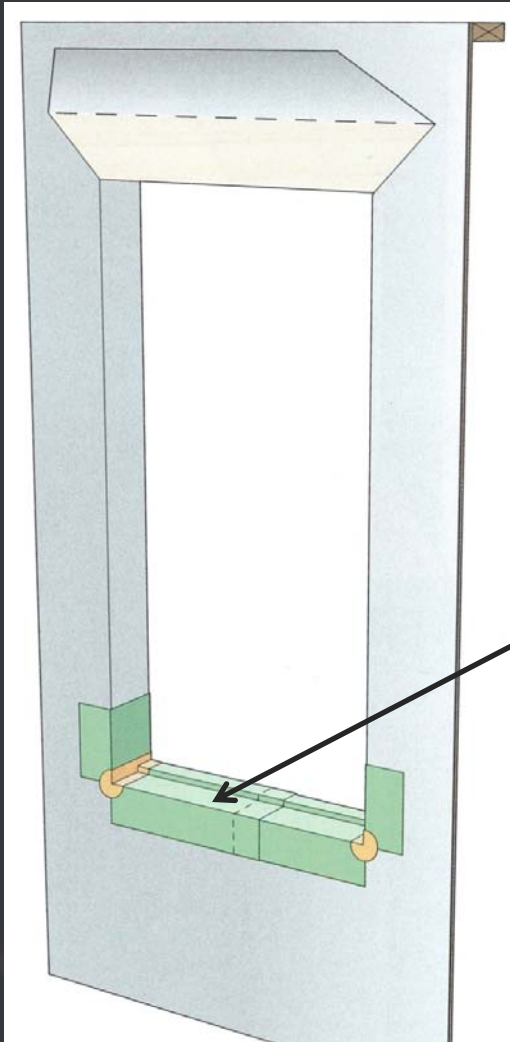
Sill flashing

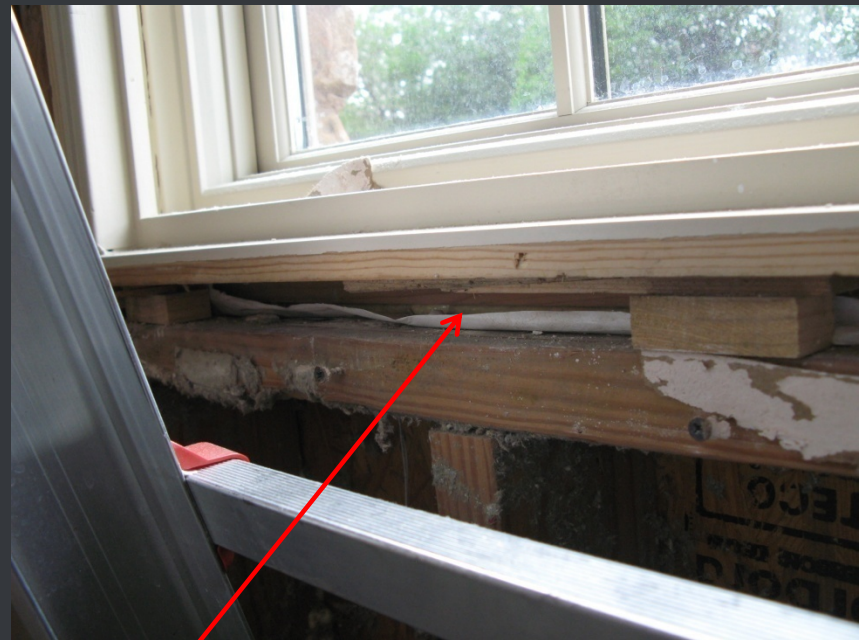
No sill flashing at window sill

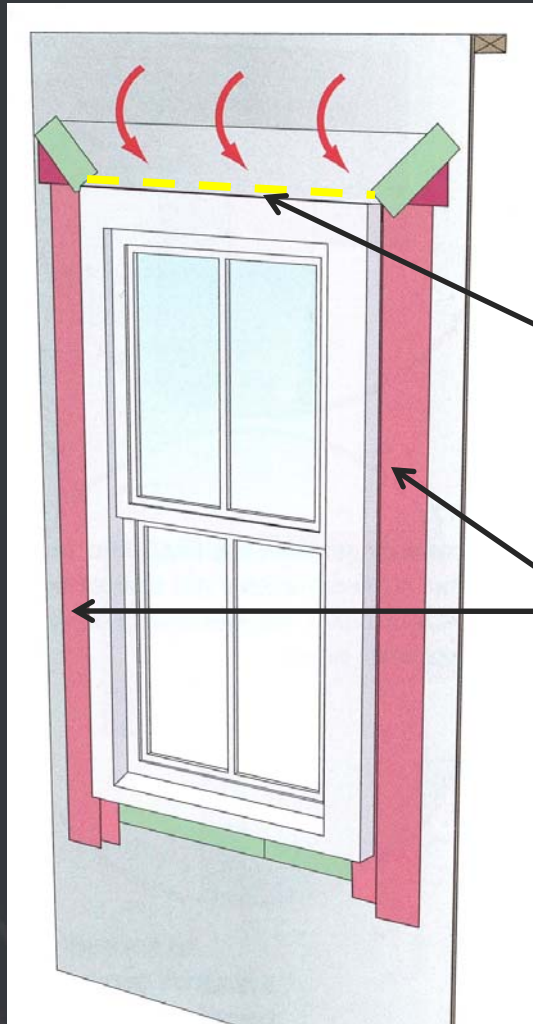
Location of  
Drip Cap

Jamb  
Flashing

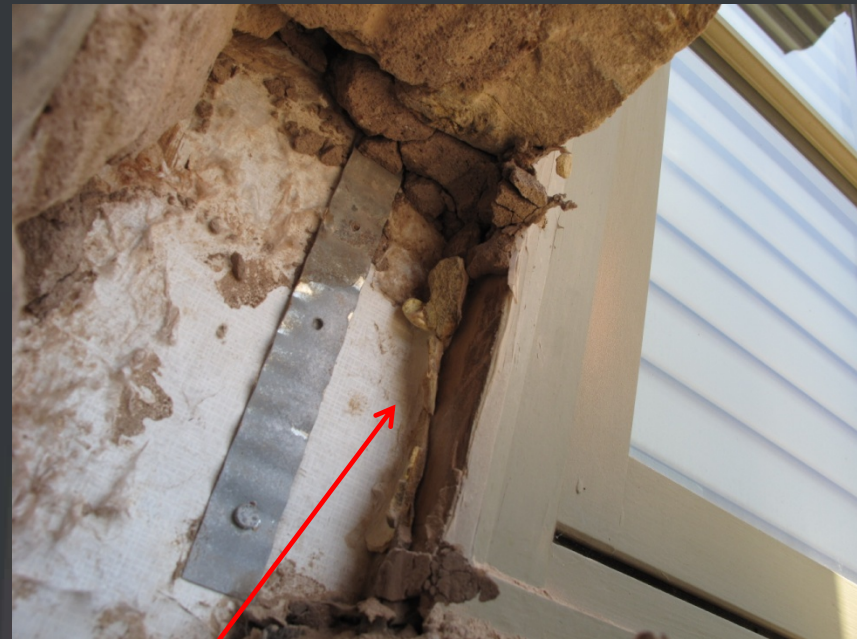
No flashing at window jamb
