# METHODOLOGIES OF FORENSIC ARCHITECTURE INVESTIGATIONS

NELSON  
FORENSICS

# DESIGN AND CONSTRUCTION DEFECT

# WATERFRONT TOWNHOMES

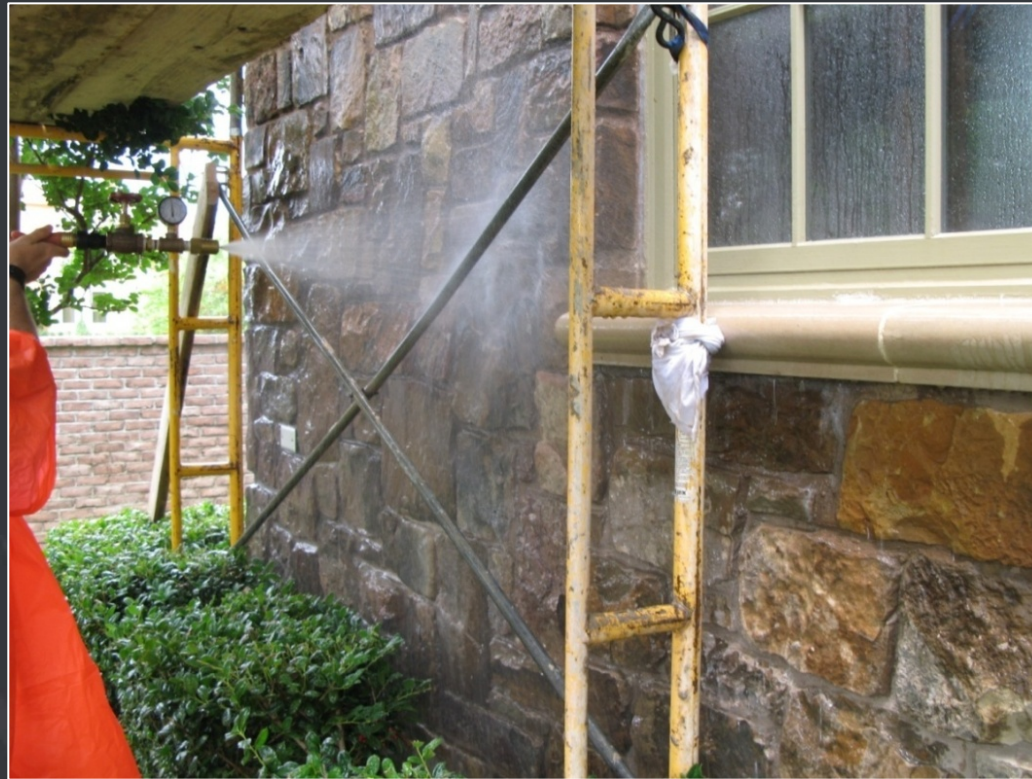
# WATER SPRAY TESTING

*AAMA SIMPLE NOZZLE TEST*

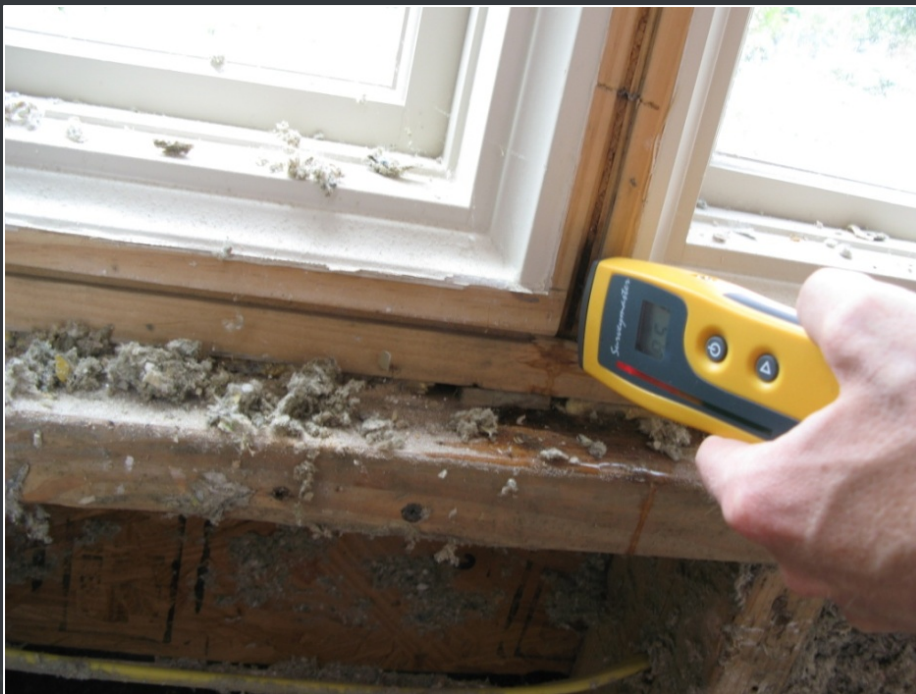
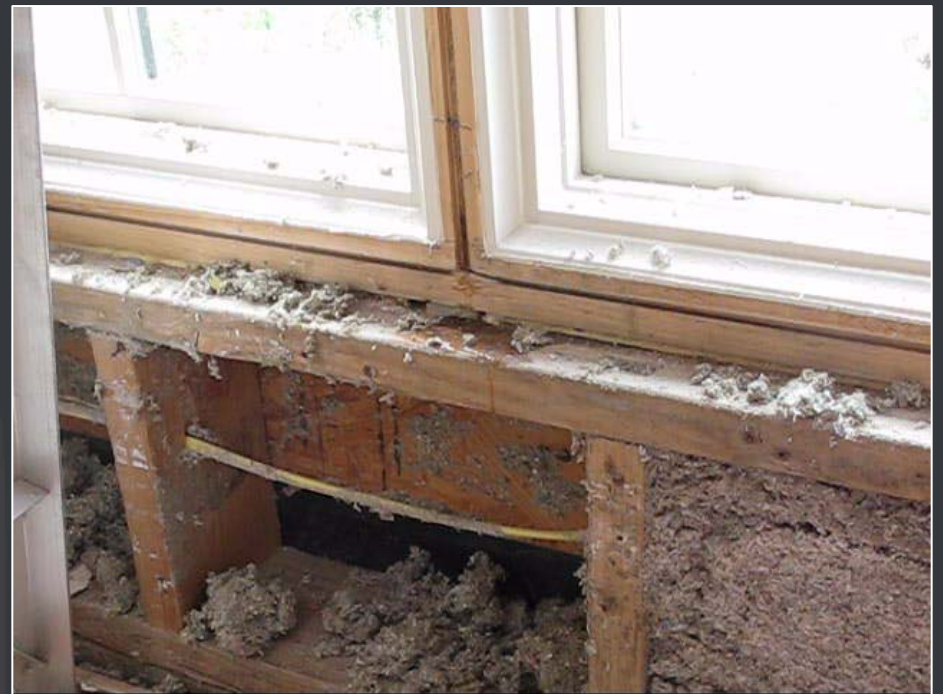
# WATER SPRAY TESTING

Areas around windows chosen based on reports of distress at interior  
Determined leak present at south window of family room

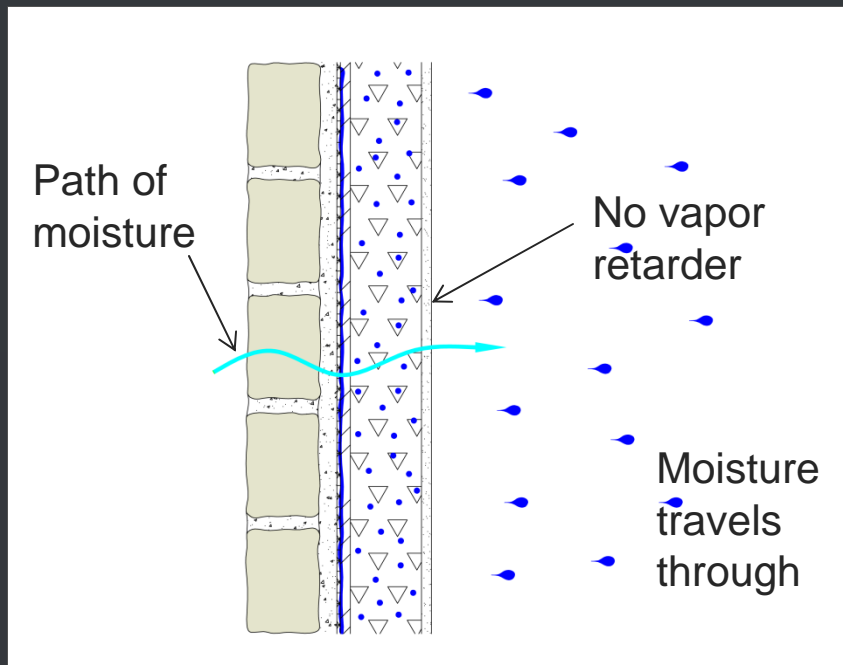
## No Vapor Retarder

Small amounts of moisture can pass all the way through building envelope

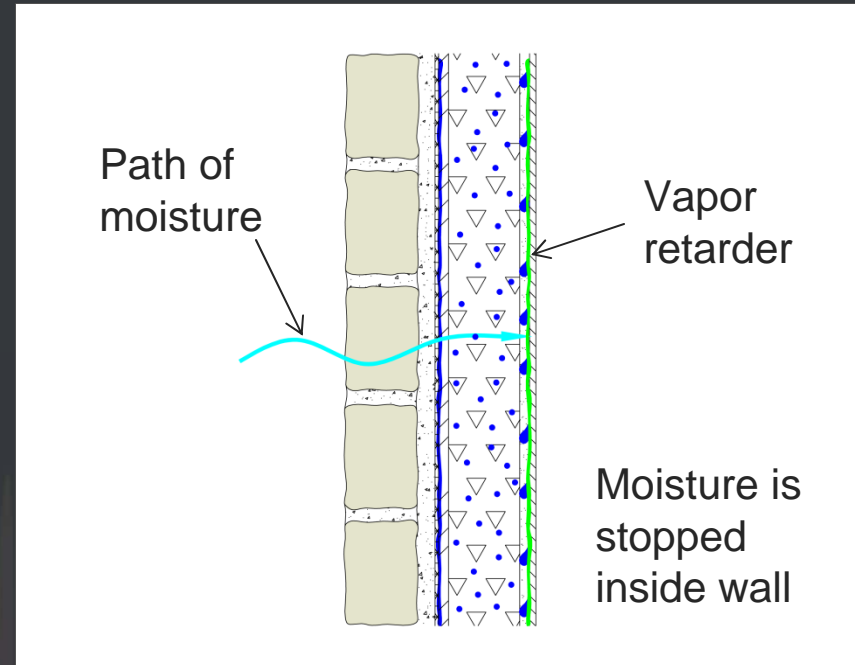
## Vapor Retarder on Interior Side

Once moisture enters building envelope, vapor retarder halts diffusion, trapping moisture

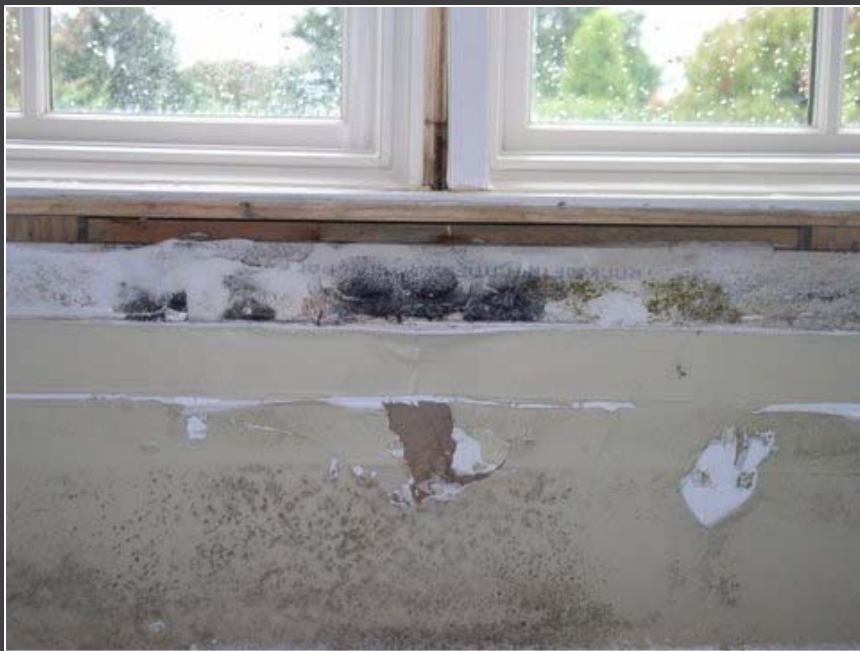
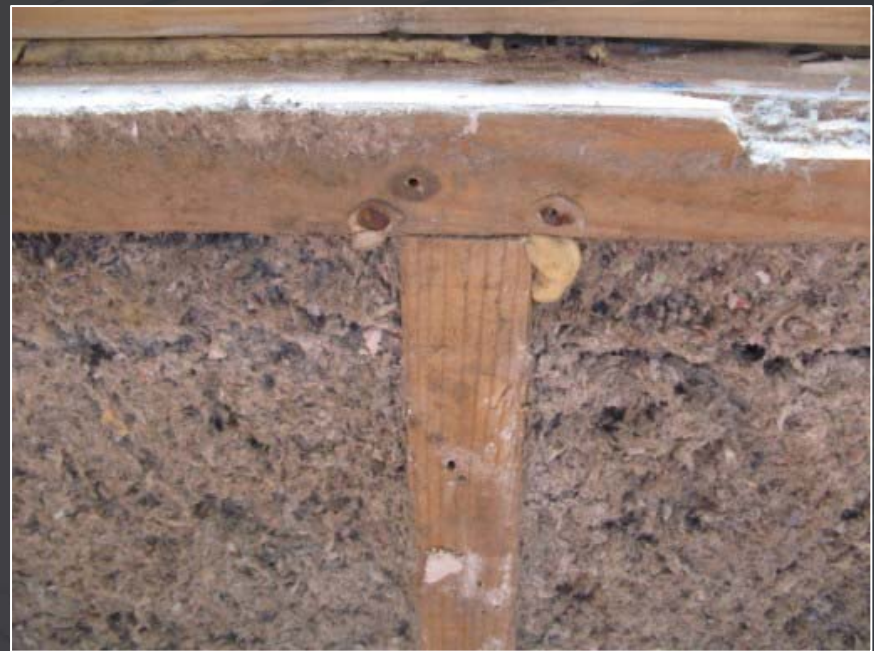
## Removal of interior finishes - **Mold** at exterior walls

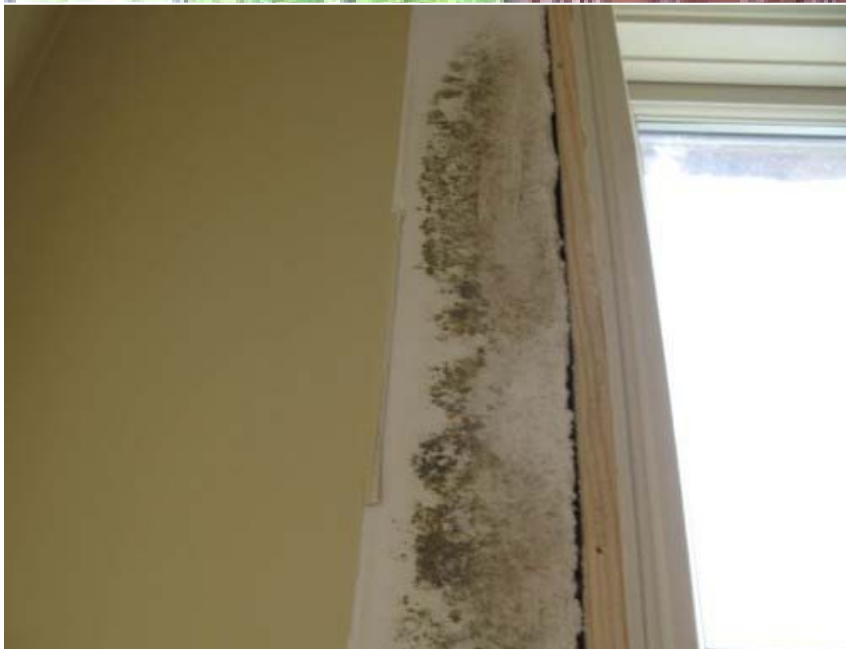
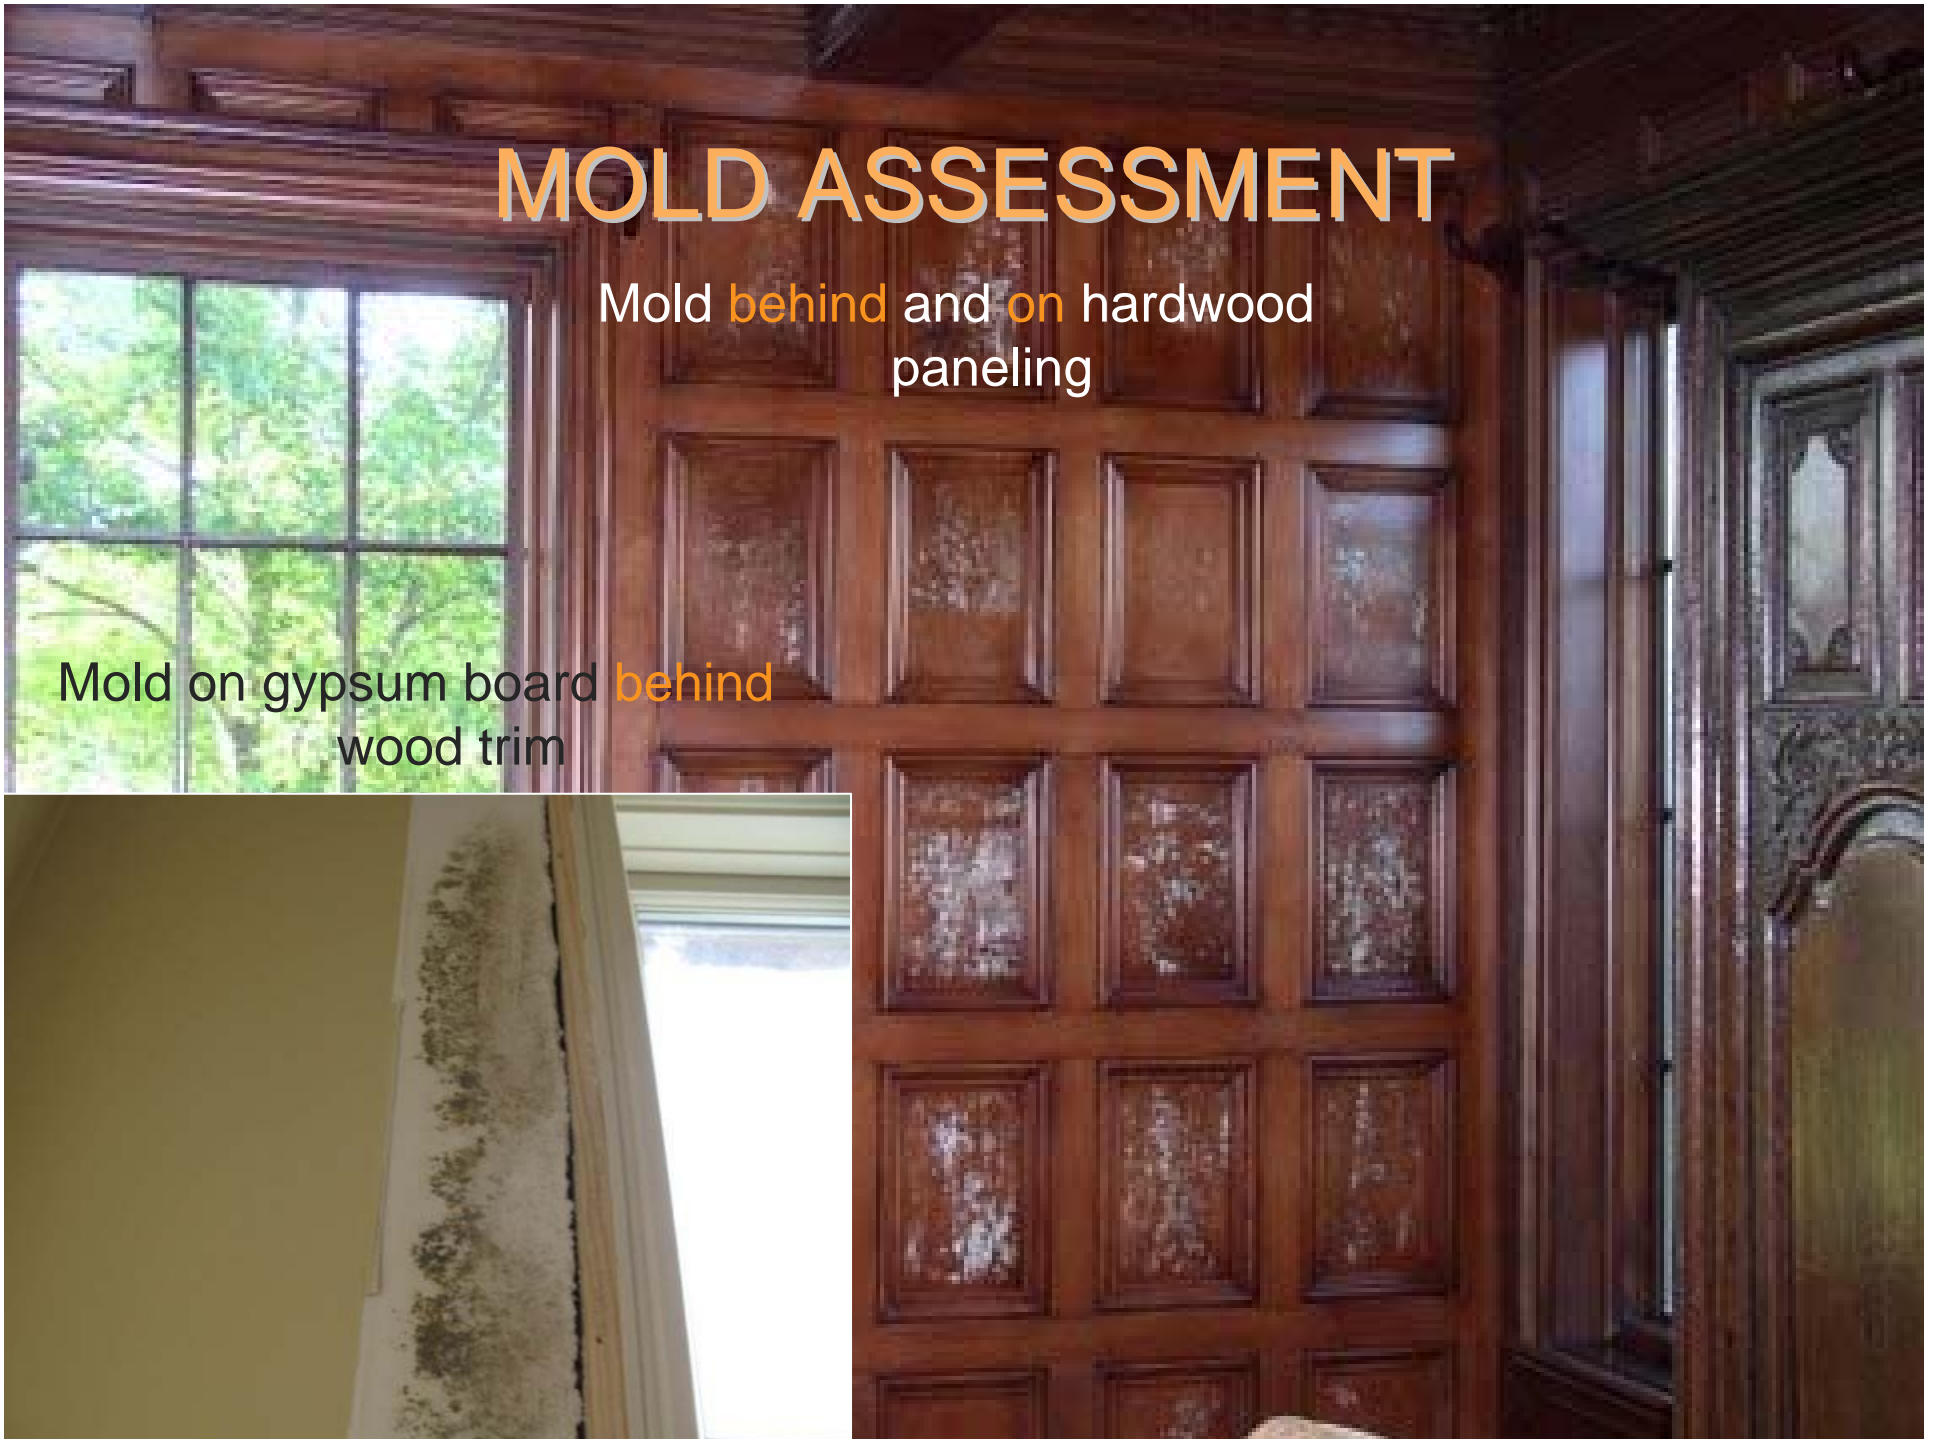
Mold **behind** and **on** hardwood paneling

Mold on gypsum board **behind** wood trim

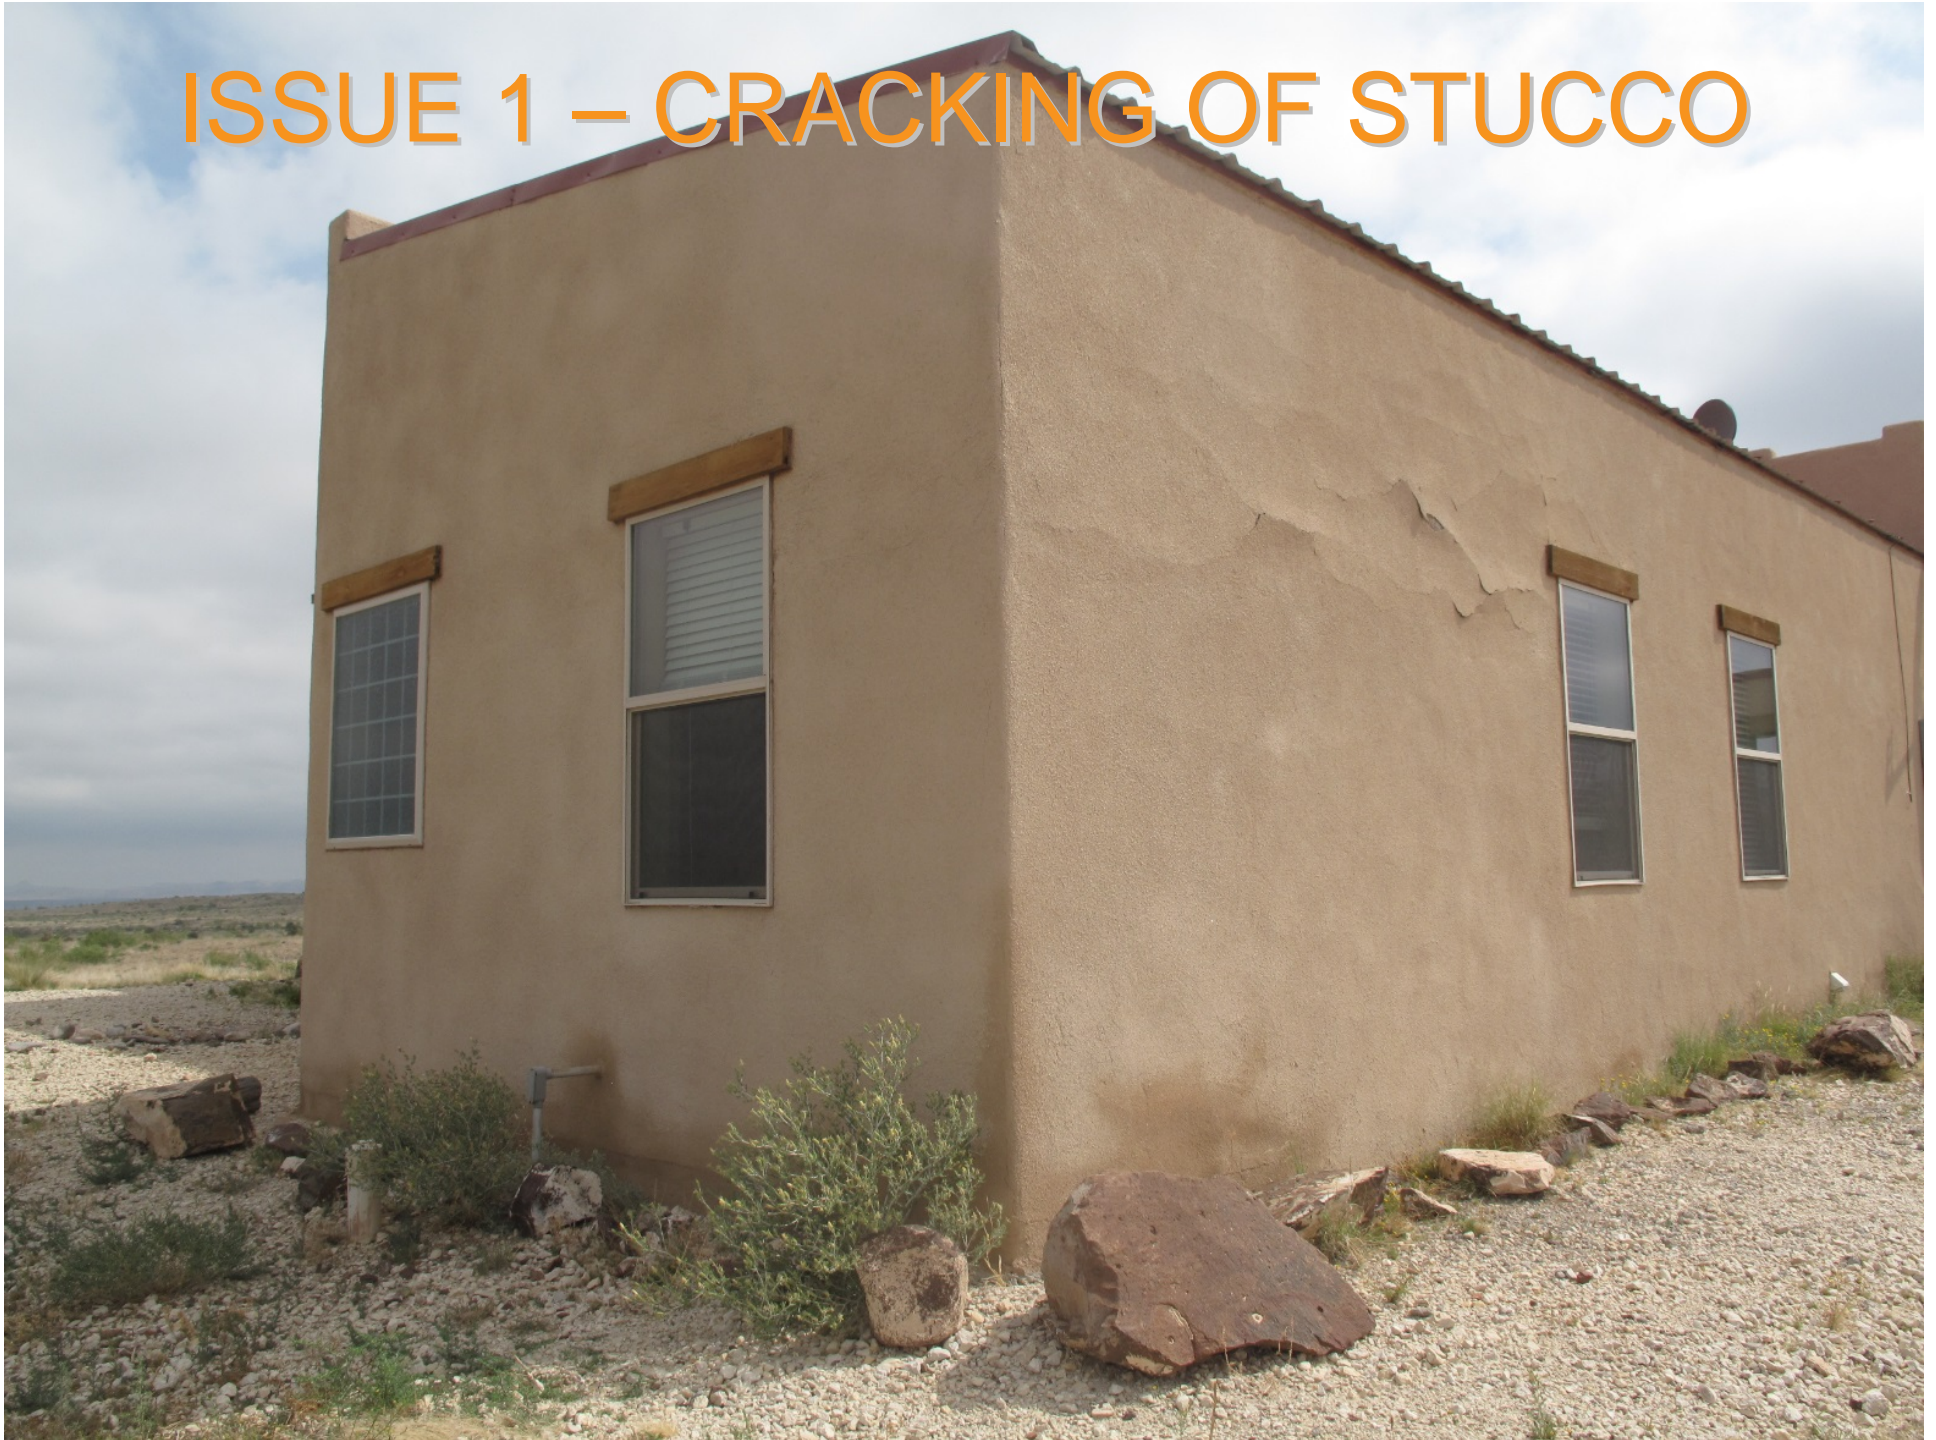
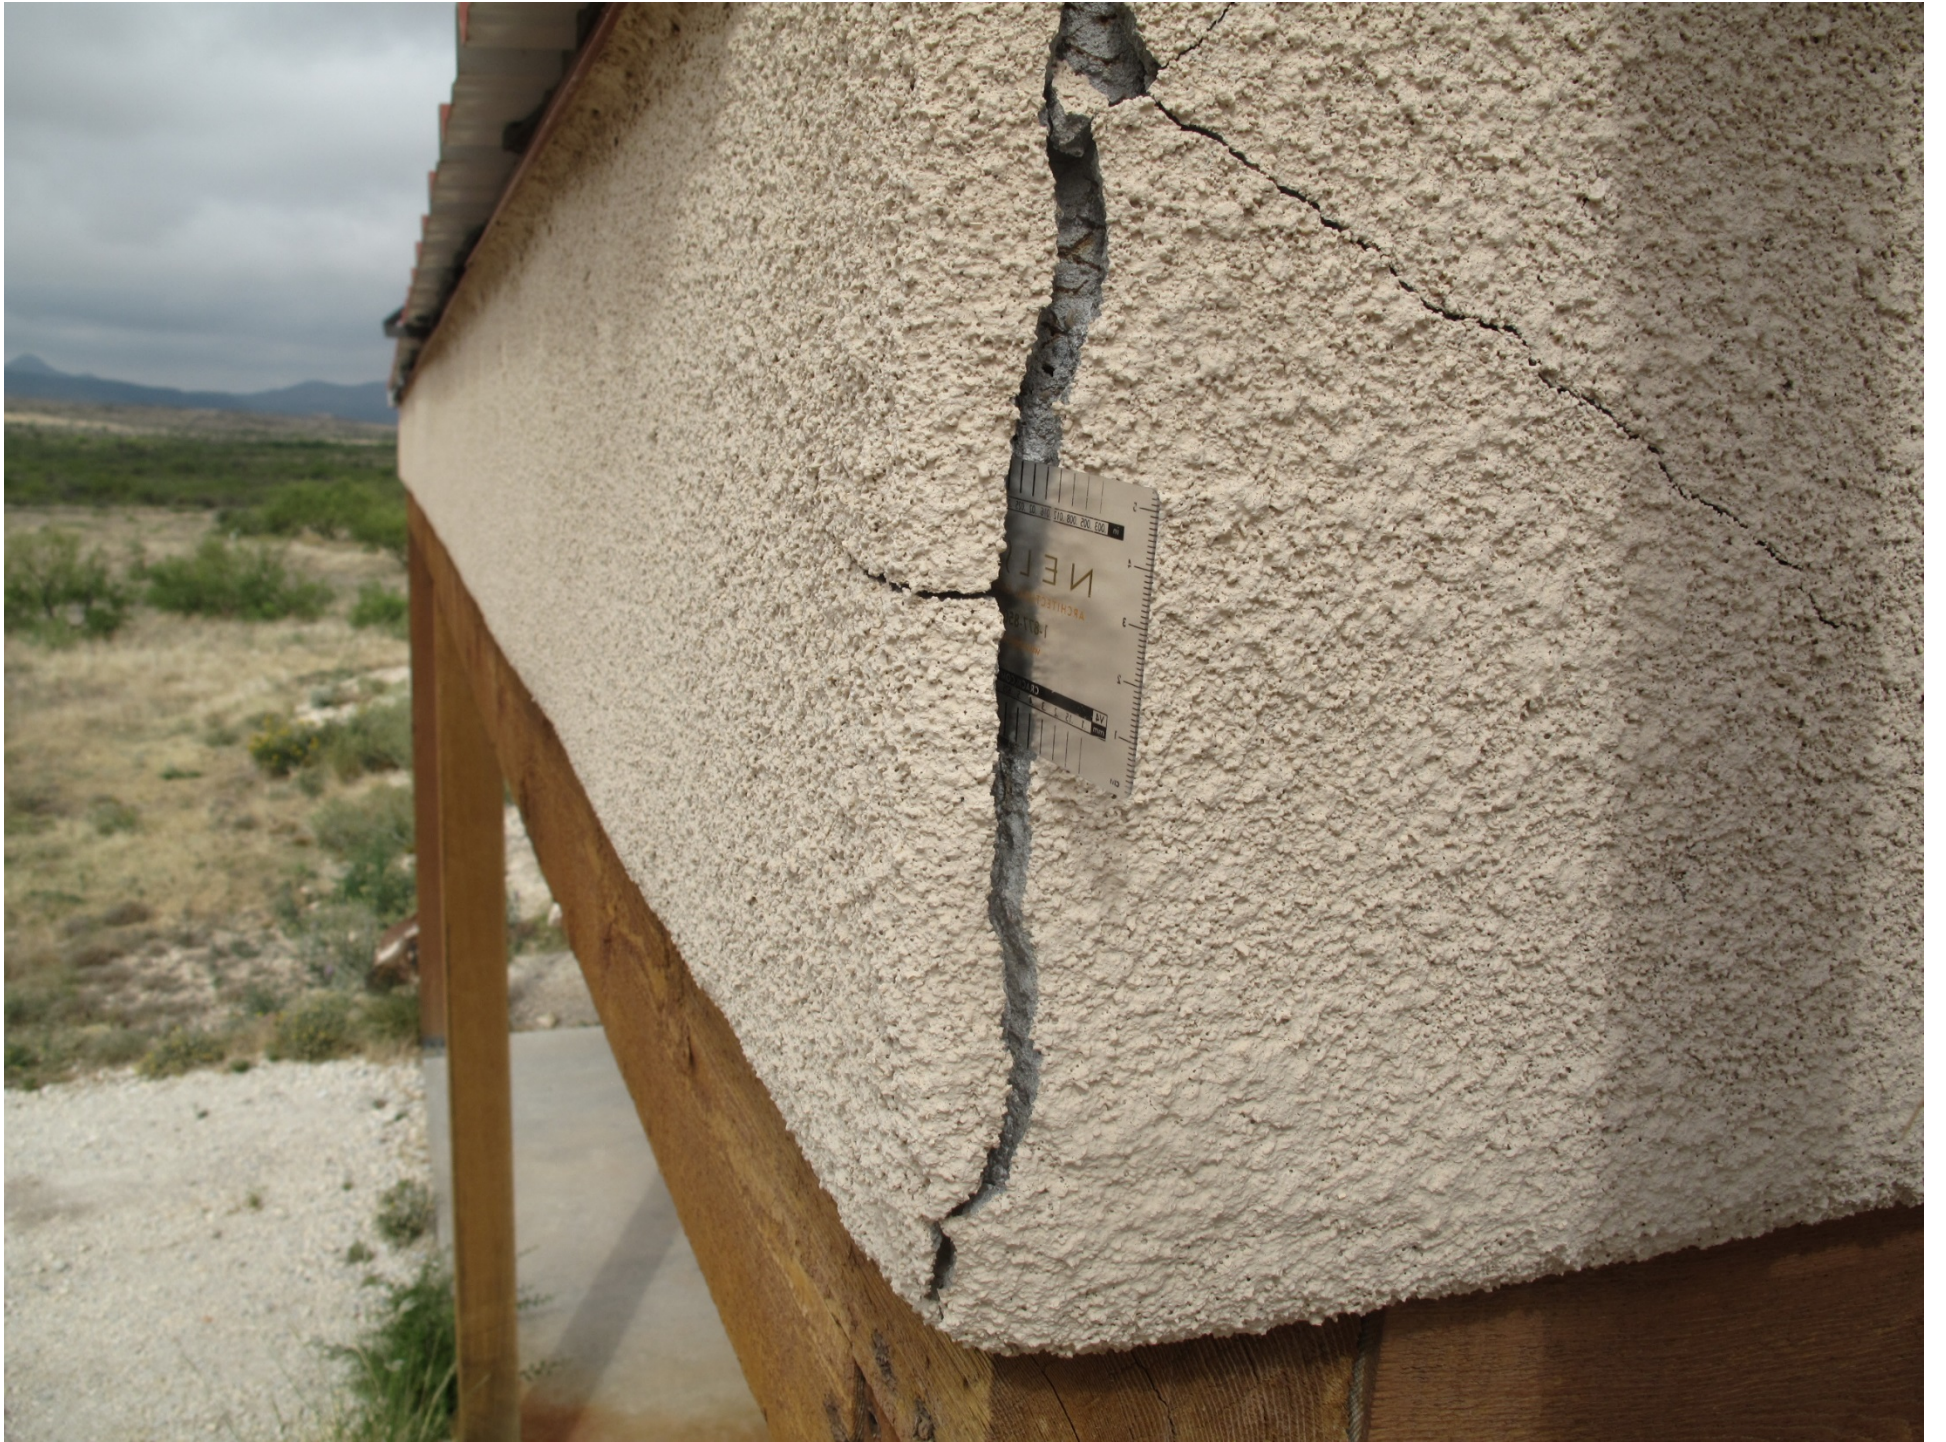
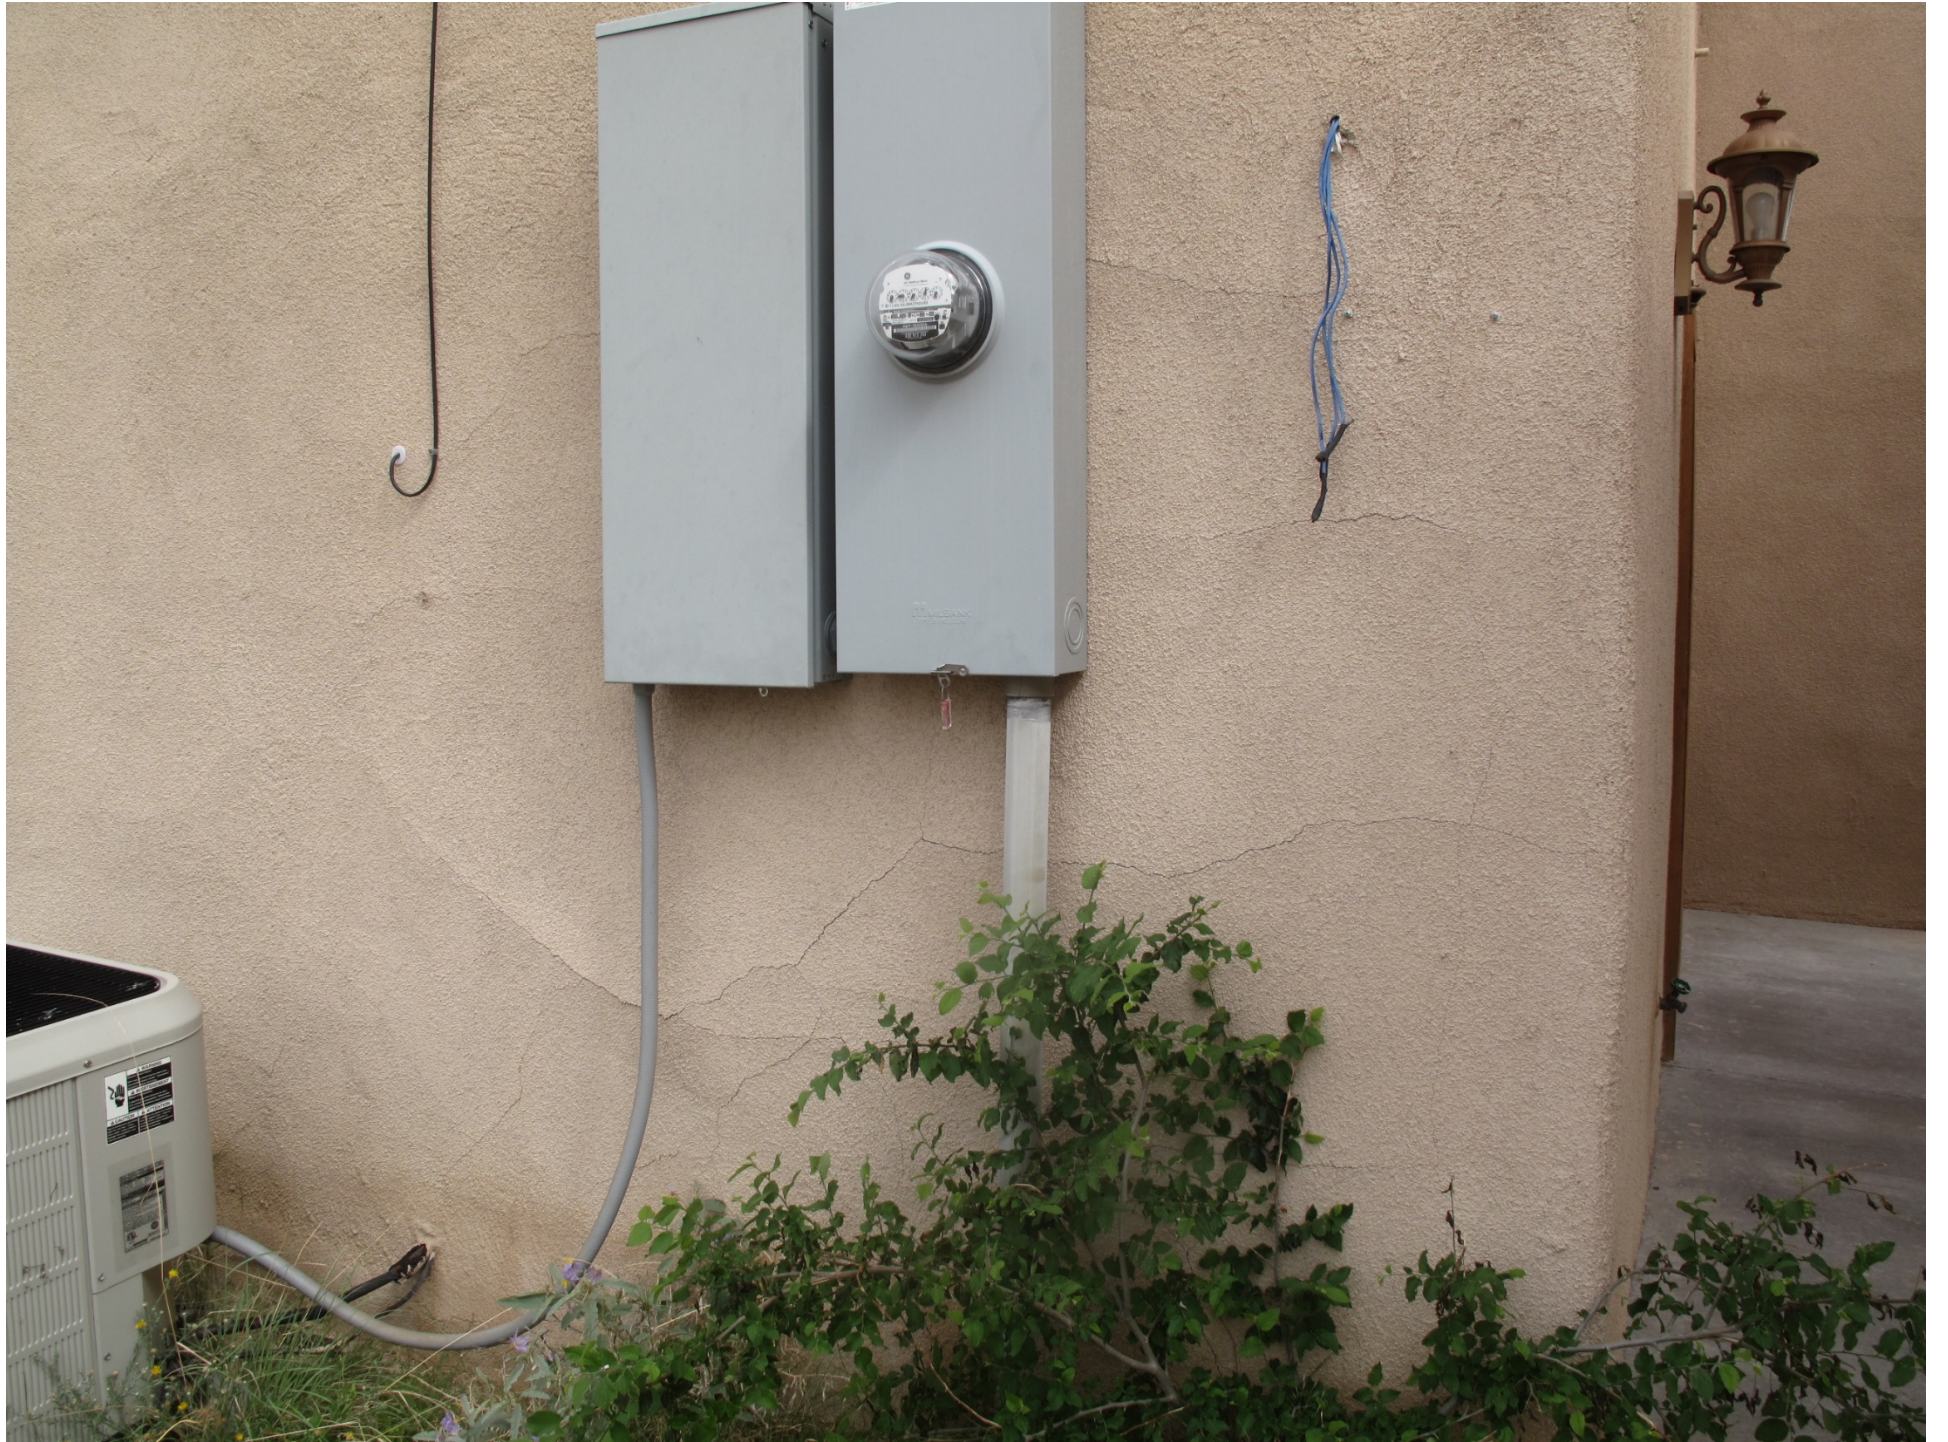
# ISSUE 1 – CRACKING OF STUCCO

- Lack of stucco control joints.
- Moisture intrusion behind the stucco.
- Improper bonding of the stucco/improper installation of the metal lath.
- Other contributing factors include thermal movement and weathering.
