# METHODOLOGIES OF FORENSIC ARCHITECTURE INVESTIGATIONS

NELSON  
FORENSICS

# DESIGN AND CONSTRUCTION DEFECT

# WATERFRONT TOWNHOMES

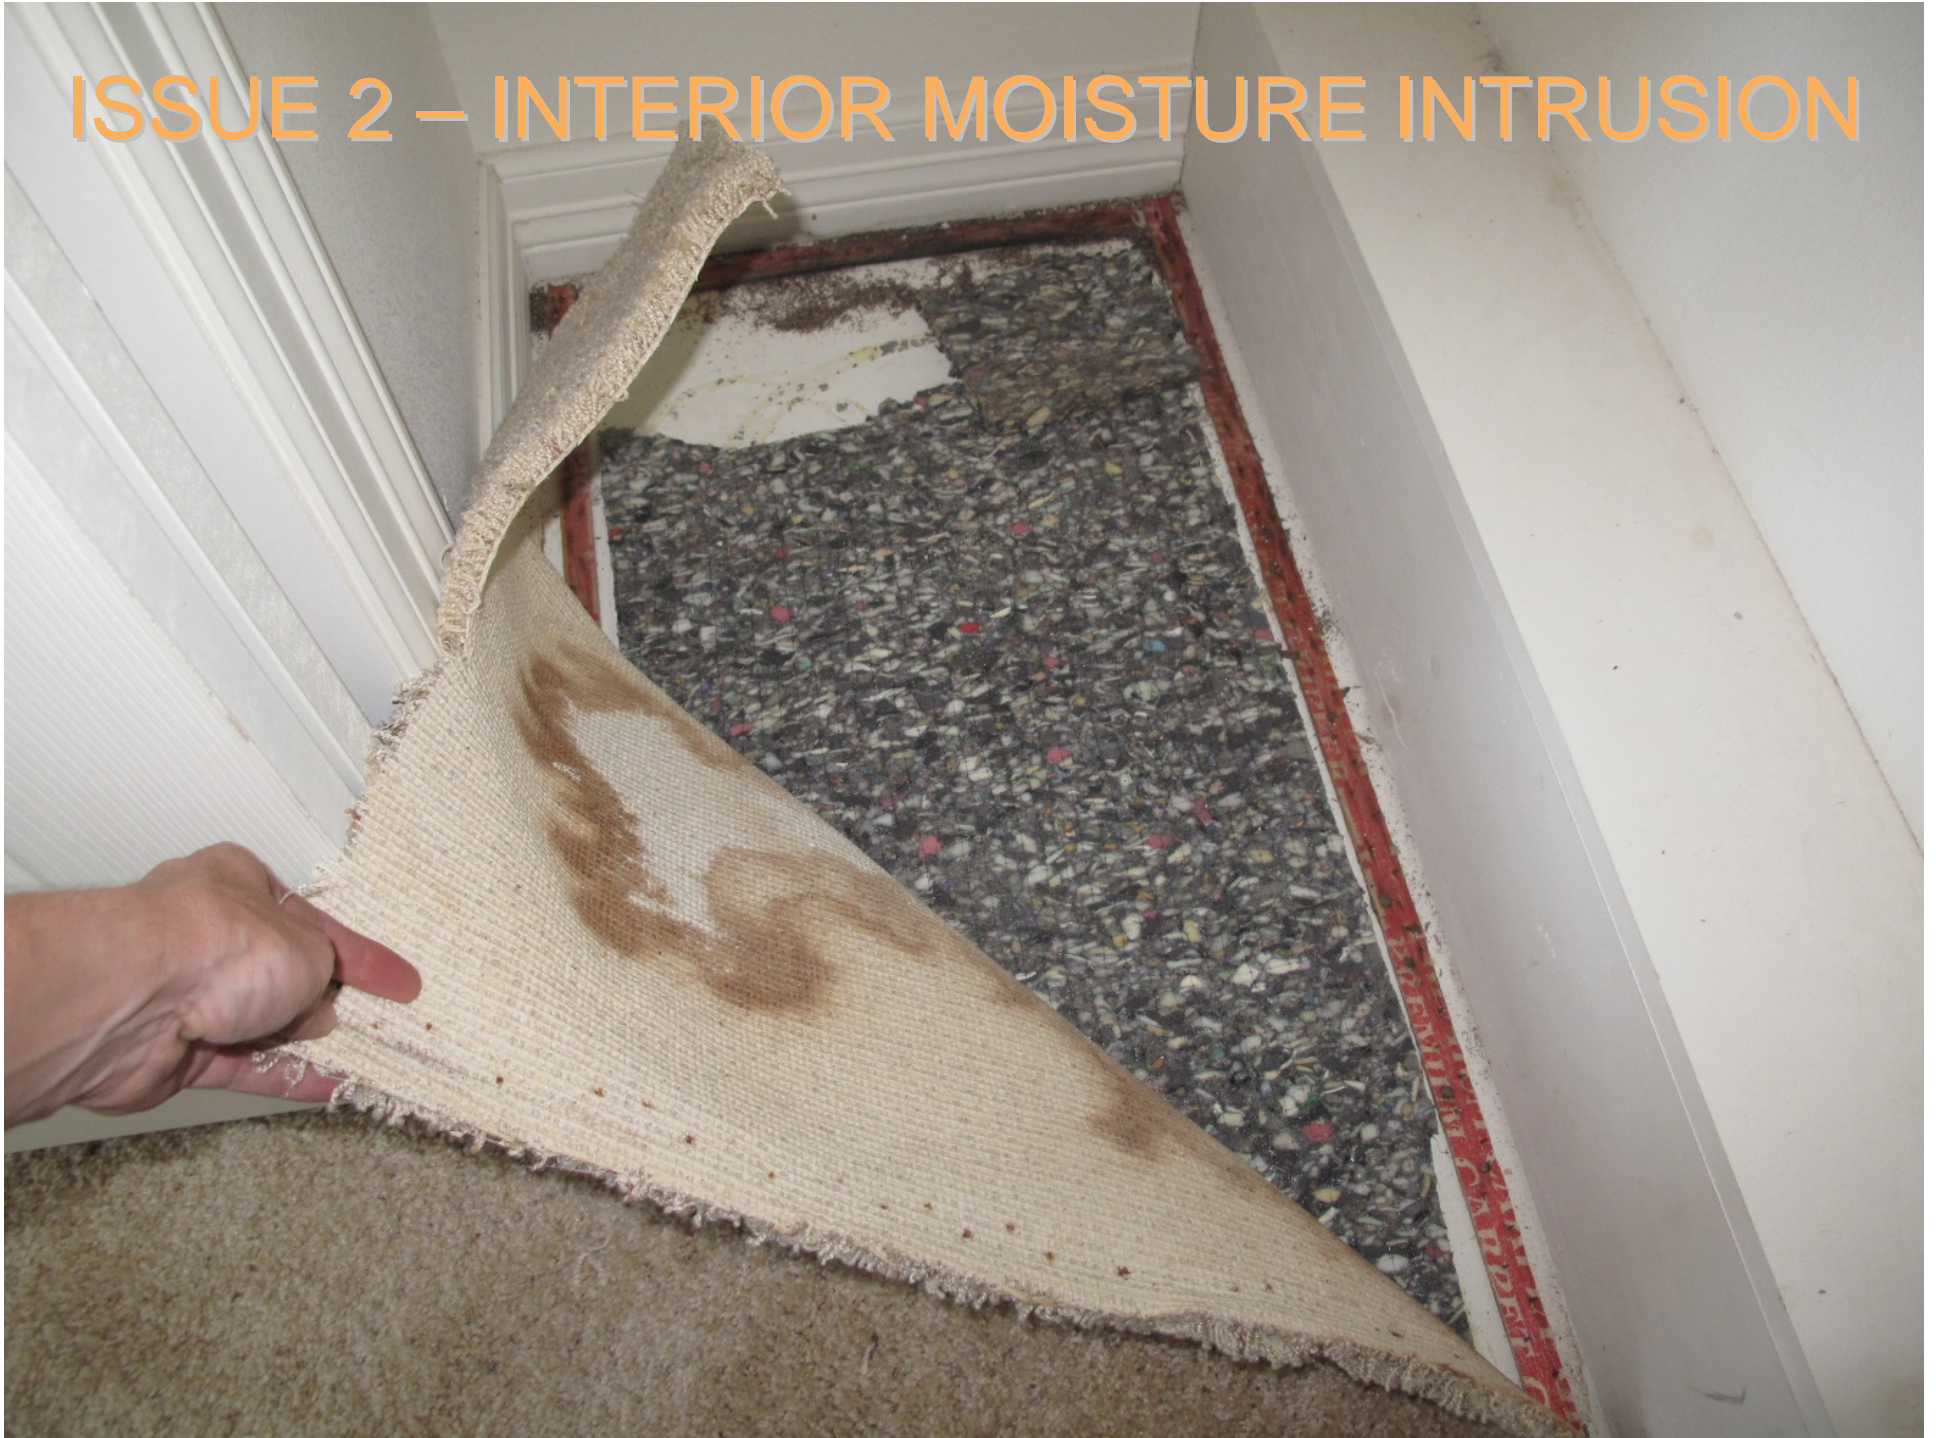
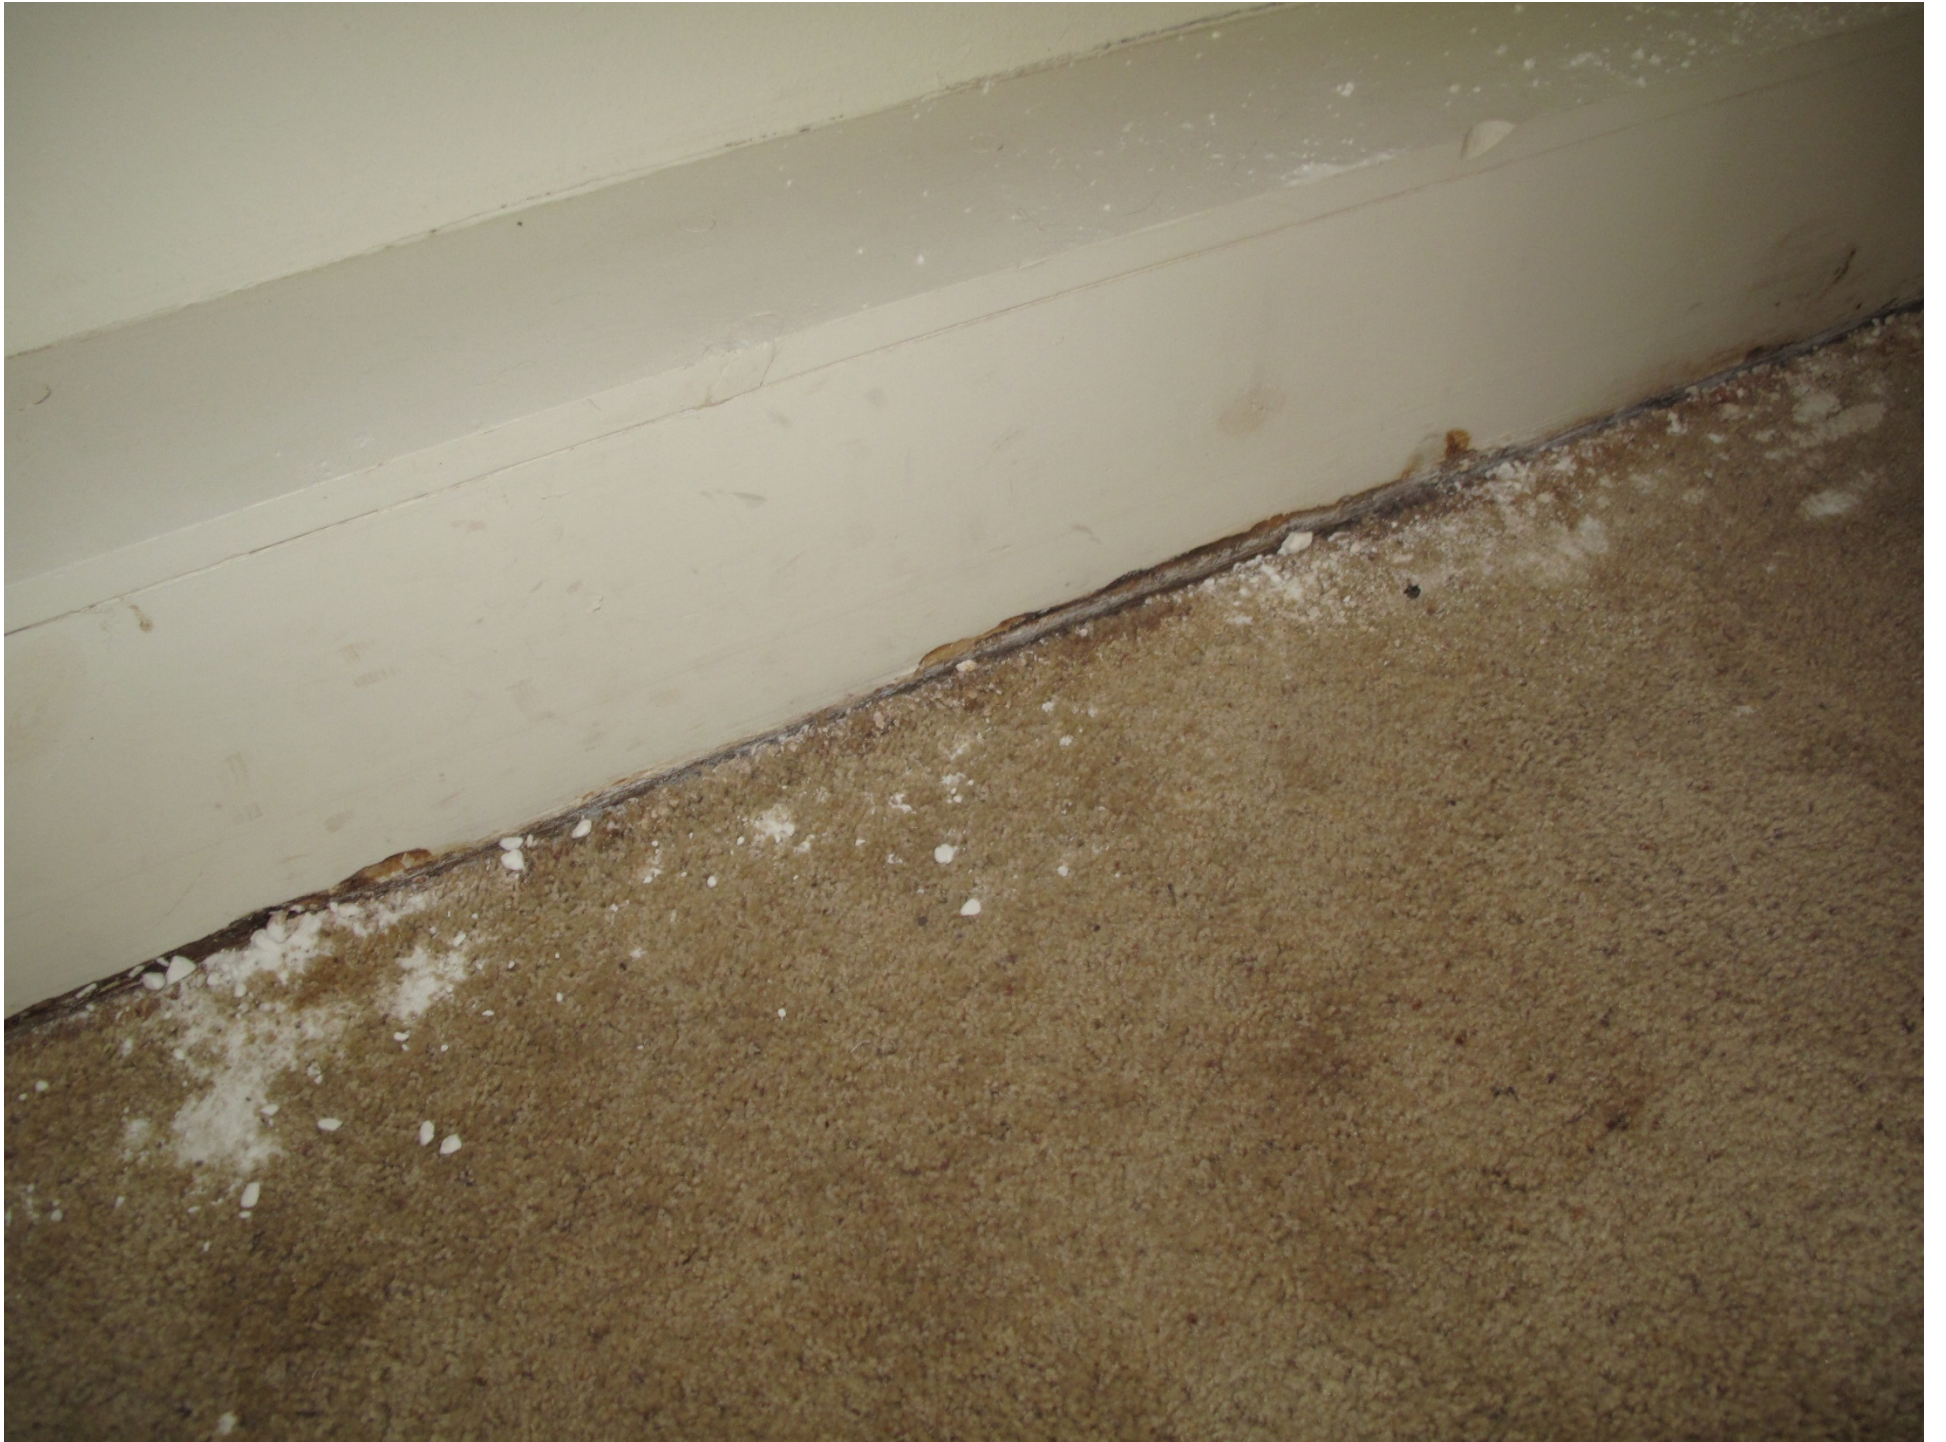
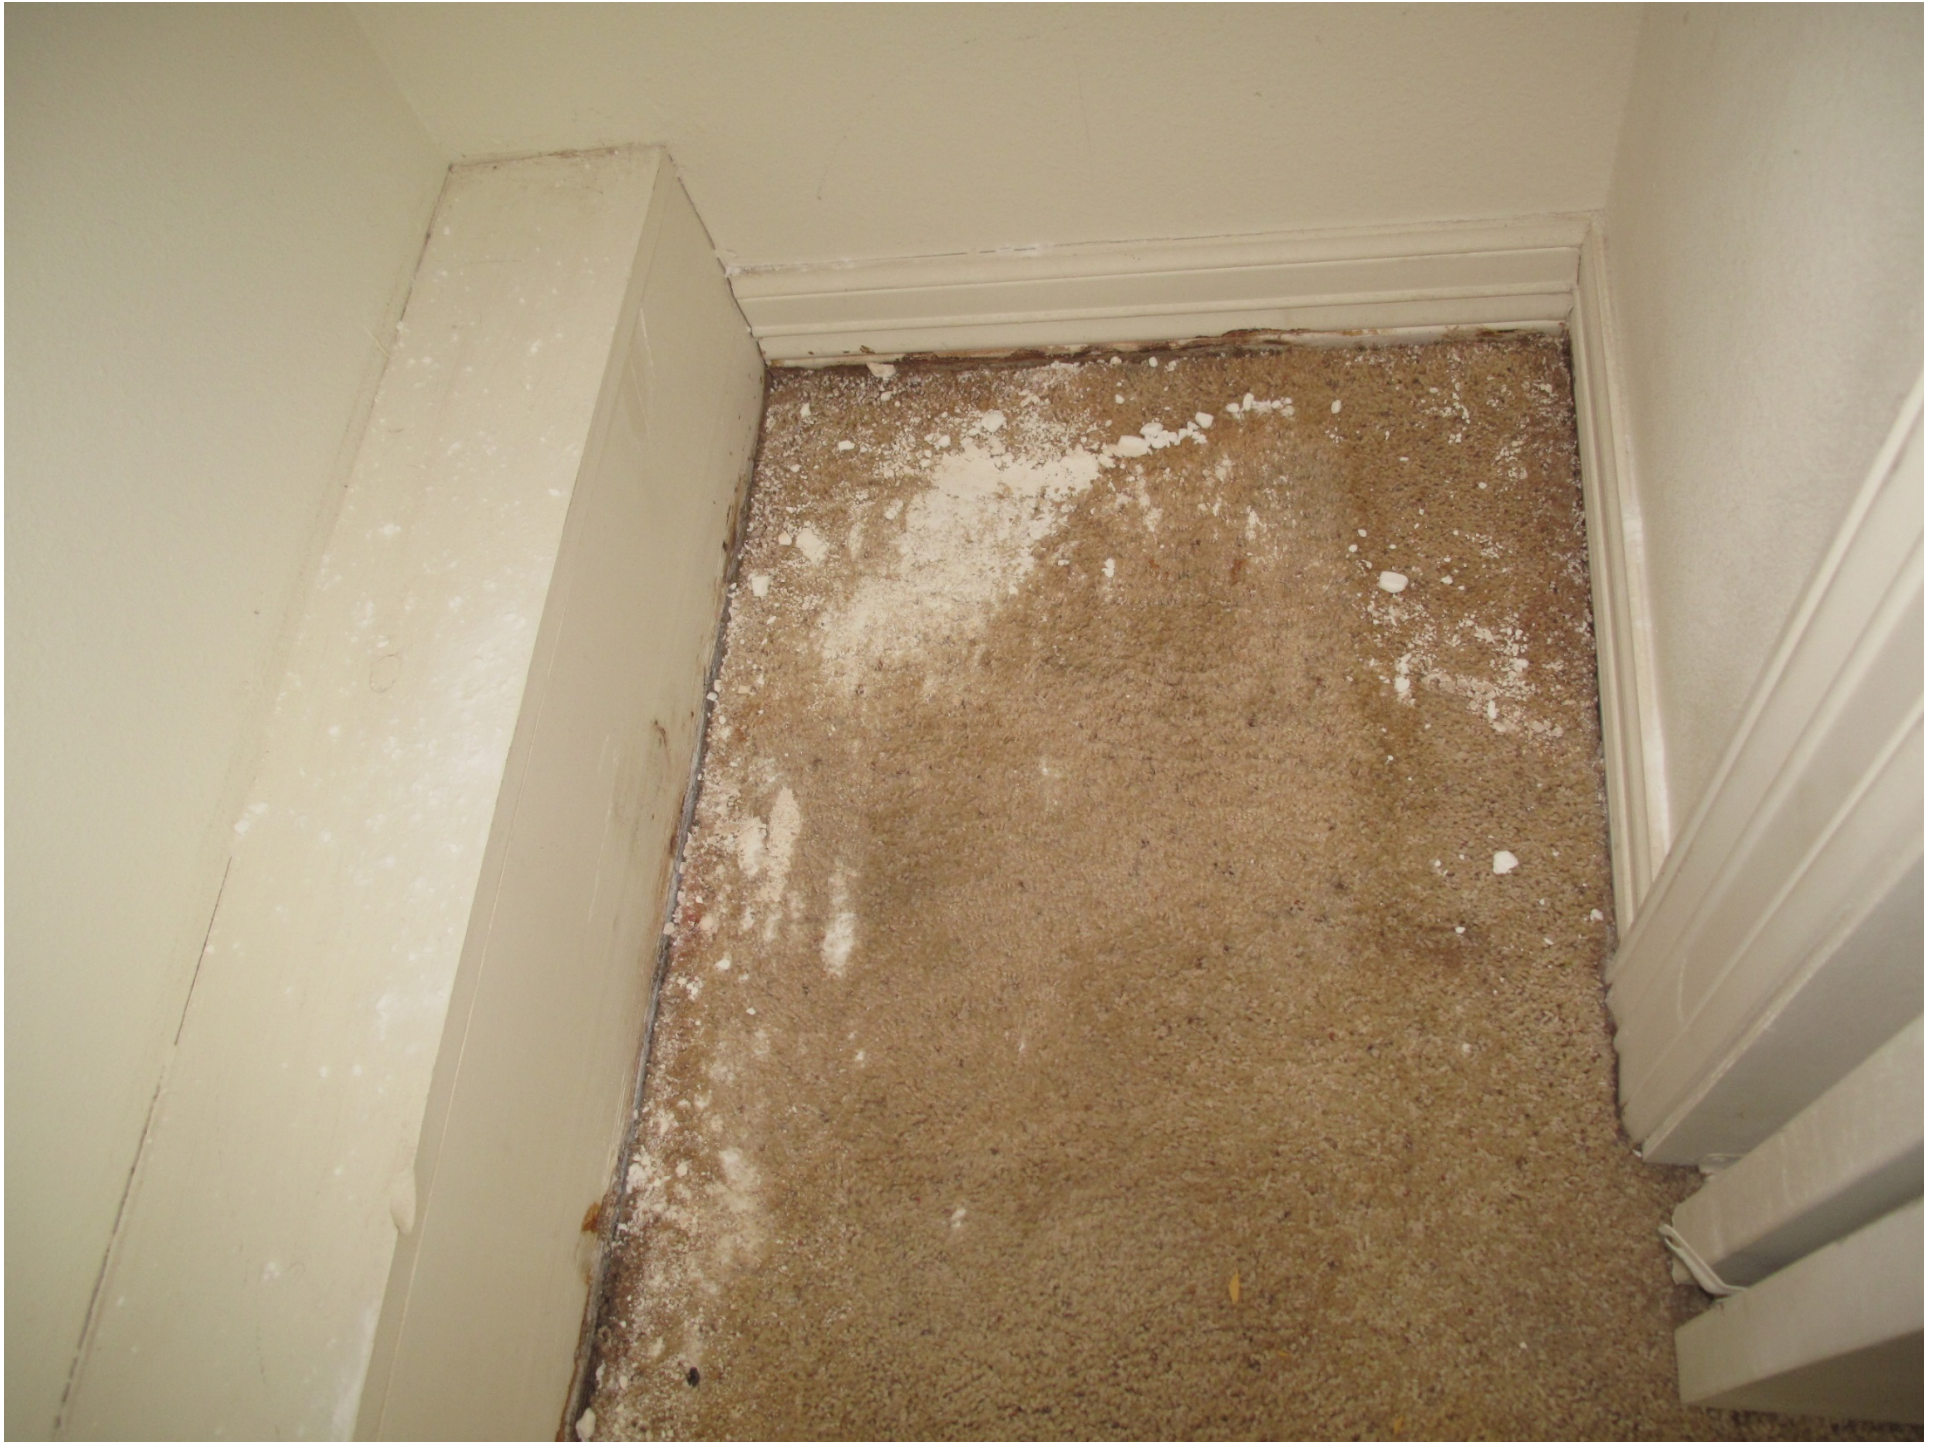
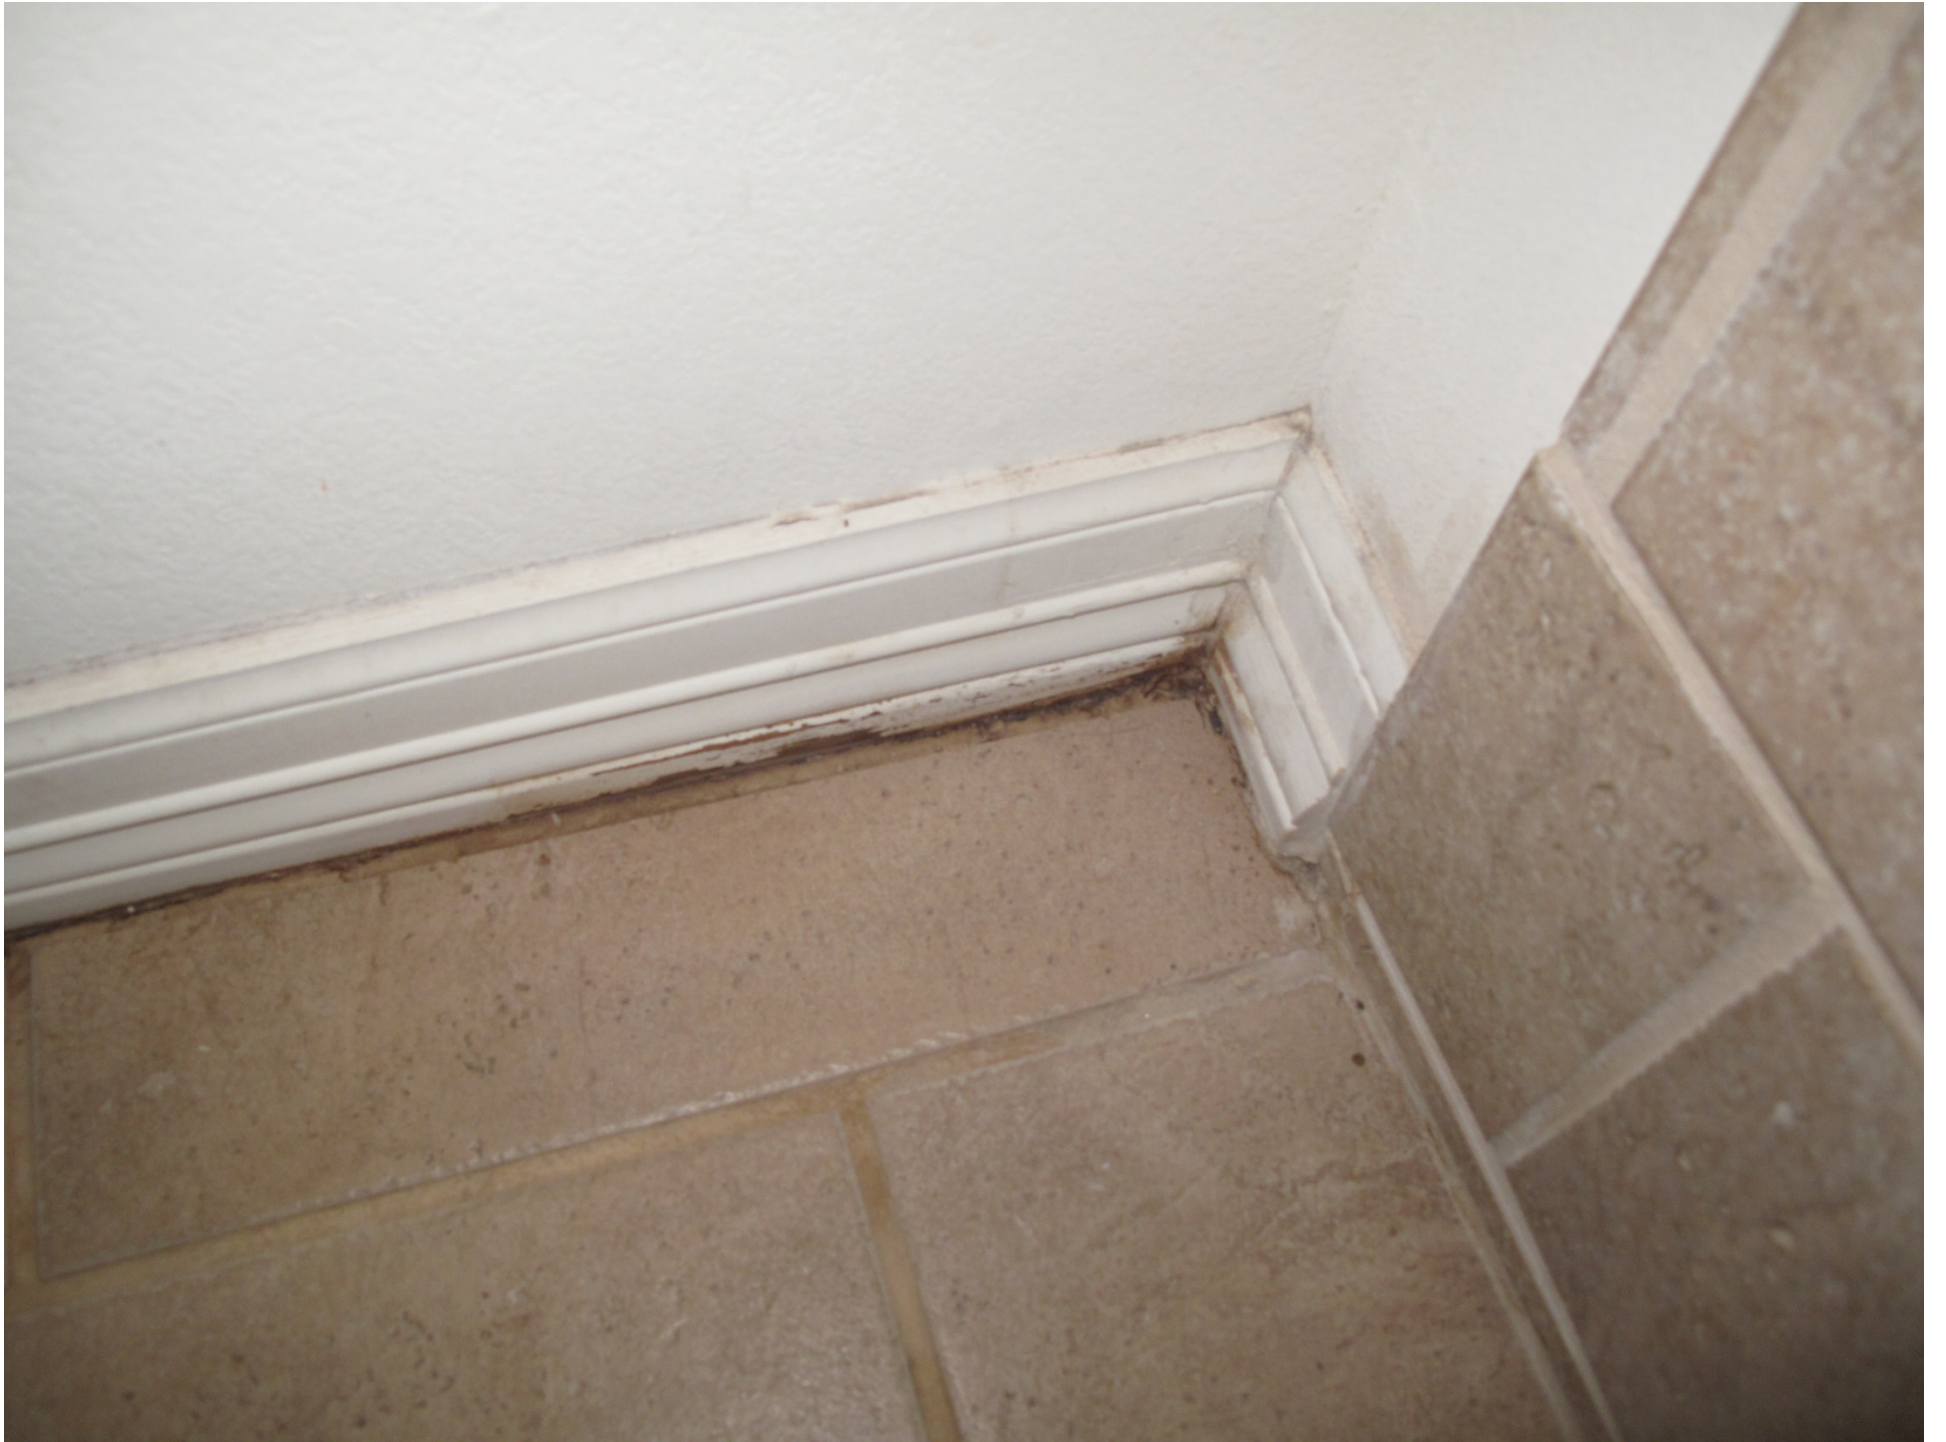
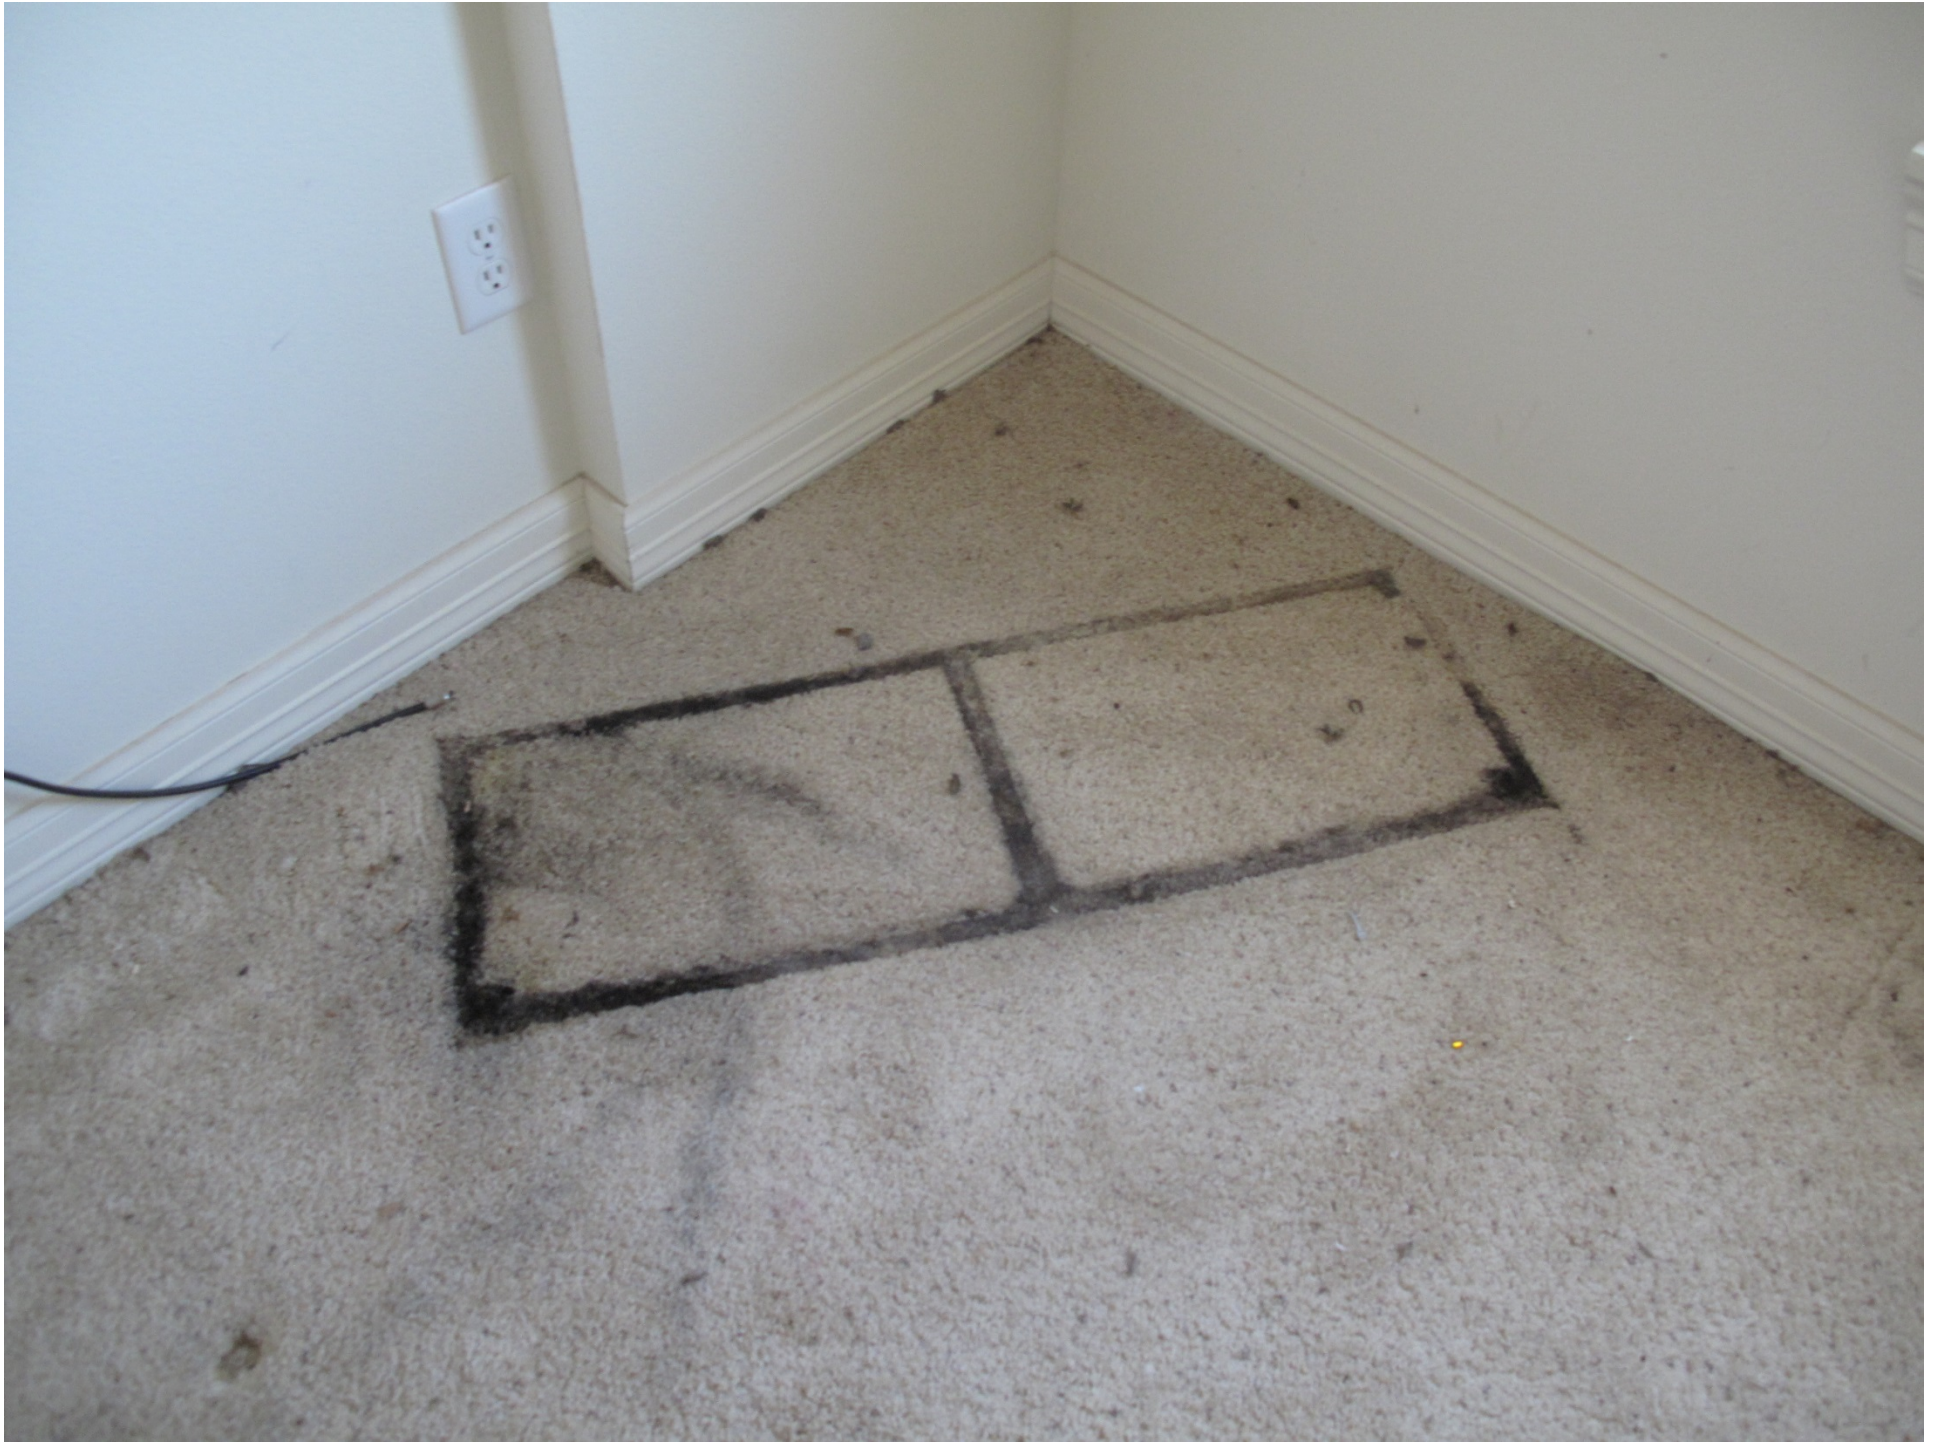
## ISSUE 2 – INTERIOR MOISTURE INTRUSION

- Moisture entering the building envelope via fractures and voids in the stucco at exterior walls and parapet walls.
- Termination of the stucco directly to grade or concrete patios.
- Site grading and drainage was not a contributing factor.
